# Victoria Park – Inventory, Assessment and Project Prioritization

Q23-115 – Report (Phase 1 – Victoria Park Master Plan)

City of Kitchener

March 2025

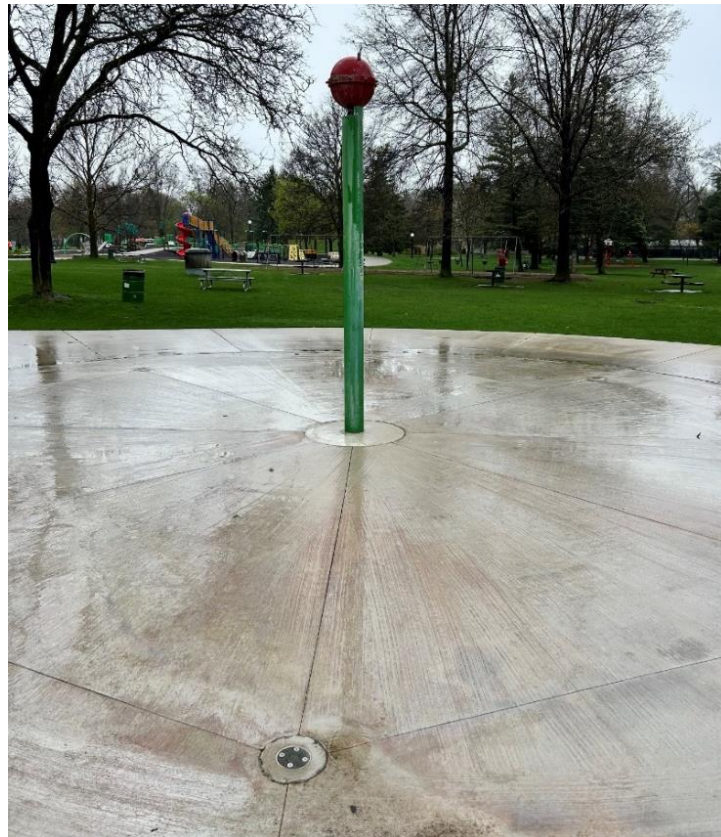
It was immediately apparent that the equipment was in a state of disrepair with many indications of paint missing and large amounts of calcium deposits on the upright features. A more thorough investigation of the site was performed involving a thorough investigation of the vault and splashpad mechanical workings.

**Figure 2: Existing Above Ground Splashpad Infrastructure Consisting of Misting Nozzles and Jet Nozzles Spraying Horizontally, called a Melvinator**

With all the features being of similar vintage, it was determined that it would be extremely difficult, if not impossible, to repair the features in their current state. Removal of the features, repair and then re-instatement was deemed a “good money after bad” situation where it would be more economical and of far greater functionality to simply remove certain features and replace them with a newer, modern version. When looking at the splashpad as a whole unit, to repair or replace some and not all would also be detrimental to the overall success of the splashpad. As such, a complete overhaul of the splashpad features and elements was determined to be the best path forward to the creation of a functional splashpad in such a busy and signature park location within Kitchener.

In summary, the original elements of the splashpad (the features on the pad itself) at Victoria Park are beyond repair or restoration while those more recently upgraded elements (vault, water distribution manifold and controller) are salvageable should the City of Kitchener have an appetite to replace a splashpad at this location.

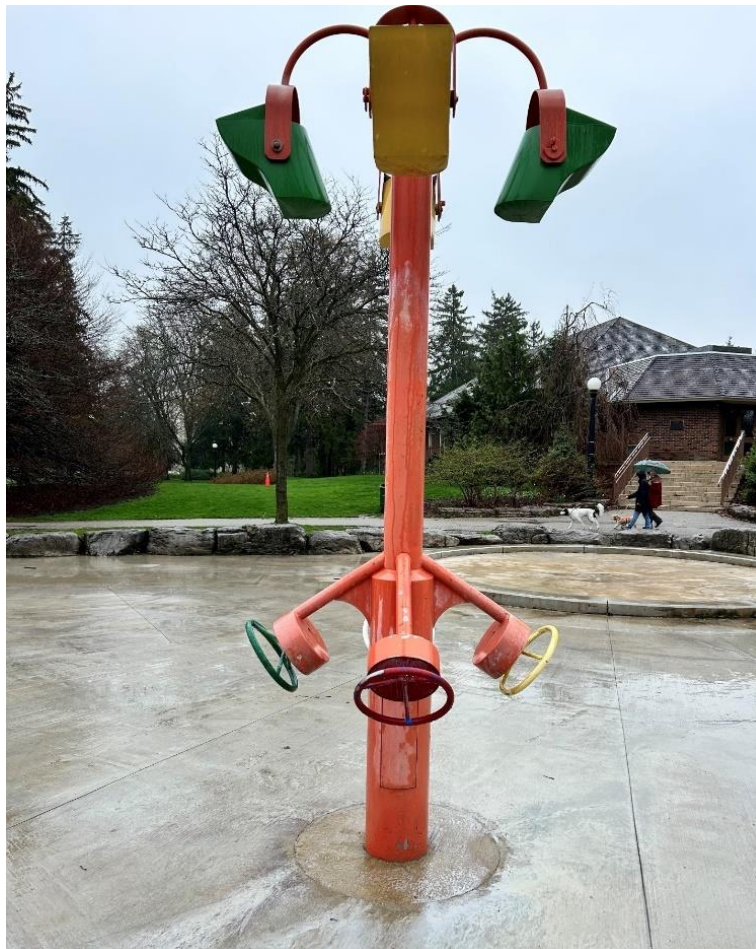
**Figure 3: Existing Above Ground Splashpad Colourful Bucket Dumping Infrastructure**

It was further determined that the current drainage situation for the splashpad is not ideal and a contributing factor to the features (especially some of the ground spray elements) not working optimally. The pad is sloped from one side to the other with a sheet flow orientation. Water from the features gathers as it falls and accumulates as it runs across the pad with enough volume to have a significant impact on the

performance given the sheer volume of water running over them. Water then gathers at the low side of the pad draining to the storm sewer. To increase performance and optimize the functionality of ground spray features, a better approach might be to start with a level pad around the perimeter with a slope to the centre and perhaps add multiple drains to reduce the volume of water accumulating in one spot. This approach would significantly improve the performance of the ground spray features as well as overall drainage performance of the pad.

Finally in an overall analysis of the facility, the current configuration utilizes a subterranean vault to contain the mechanical workings of the splashpad. Best practices would lean toward an above-ground application where the manifold, controller and all electrical components are high and dry from a below grade vault. As such we would recommend abandoning the current vault by removing it and either place an above grade cabinet or bunker style building to house the mechanical equipment.

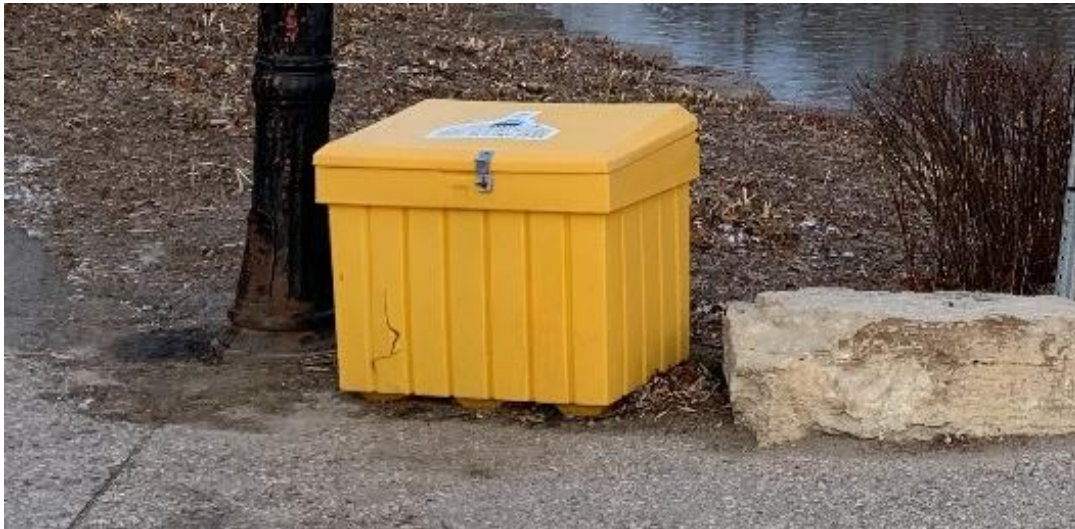
Multiple storage bins throughout the park have developed structural cracks. The replacement of these bins is recommended to ensure that excess salt does not spill out of the bin onto the adjacent soft landscape and unnecessarily spread to other areas of the park. The City replaces the storage bins as needed and are stocked internally through maintenance and operations.

**Figure 4: Temporary Salt Storage Bin**

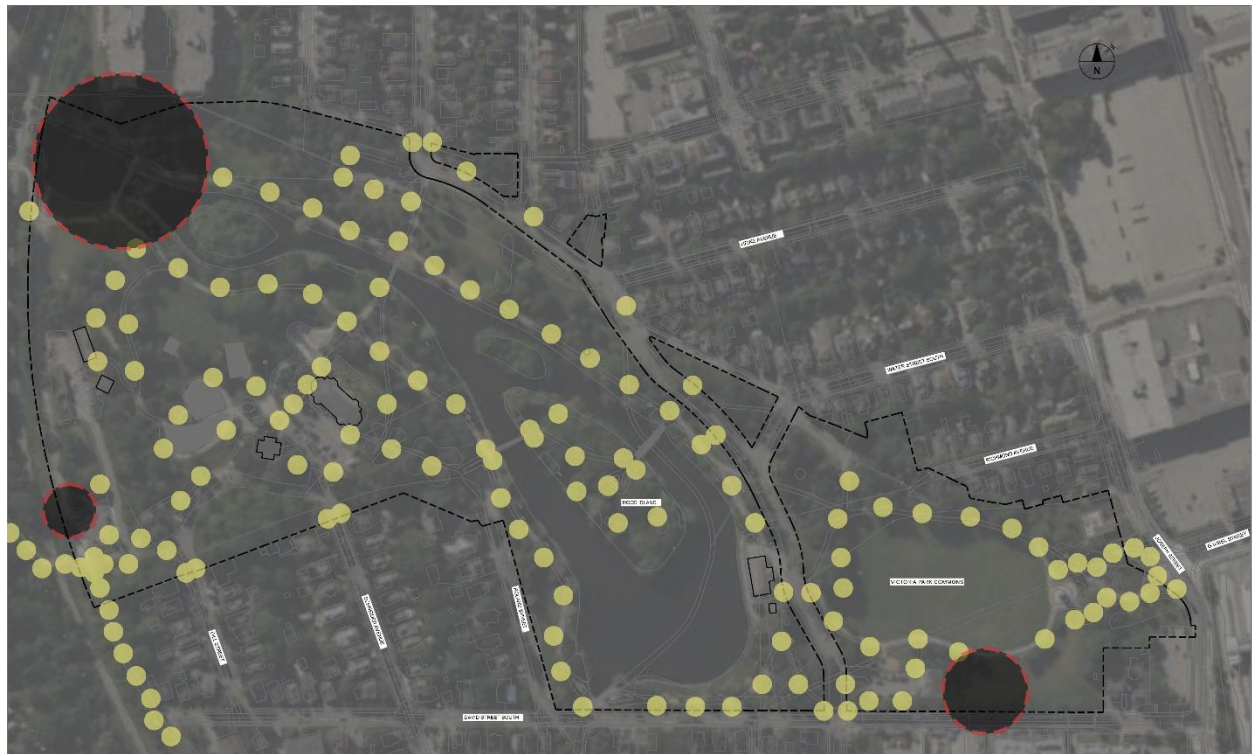
Additionally, to the northeast of the washroom building (Jubilee) a large grouping of trees blocks the surrounding pedestrian pathway lighting and the street lighting along David Street. This is an area that commonly is unsafe for the community due to limited visibility and limited lighting. The addition of lighting can assist with the visibility from the pathway and from the street level for pedestrians and vehicles that are driving by.

### Figure 5: Victoria Park Lighting and Dark Zones

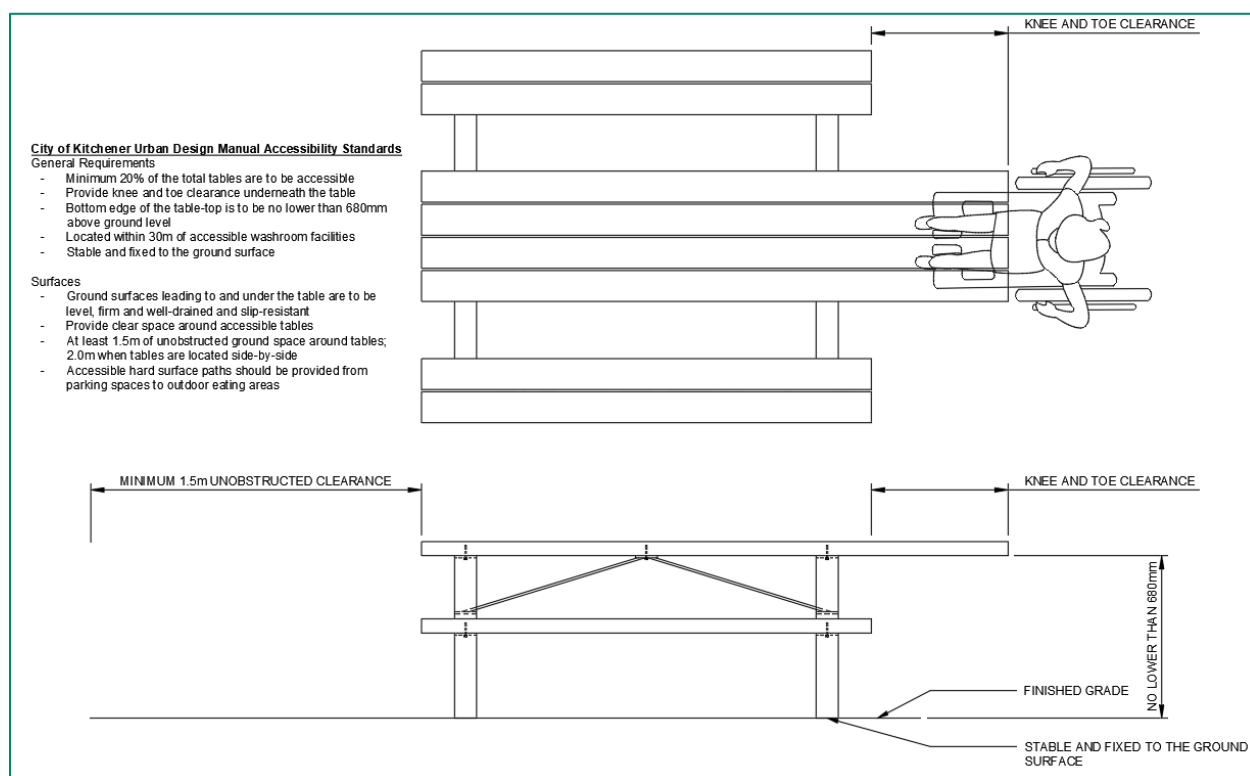
**Figure 6: Outdoor Public Use Picnic Tables**

#### **4.1.3.3.2 Recommended Repairs**

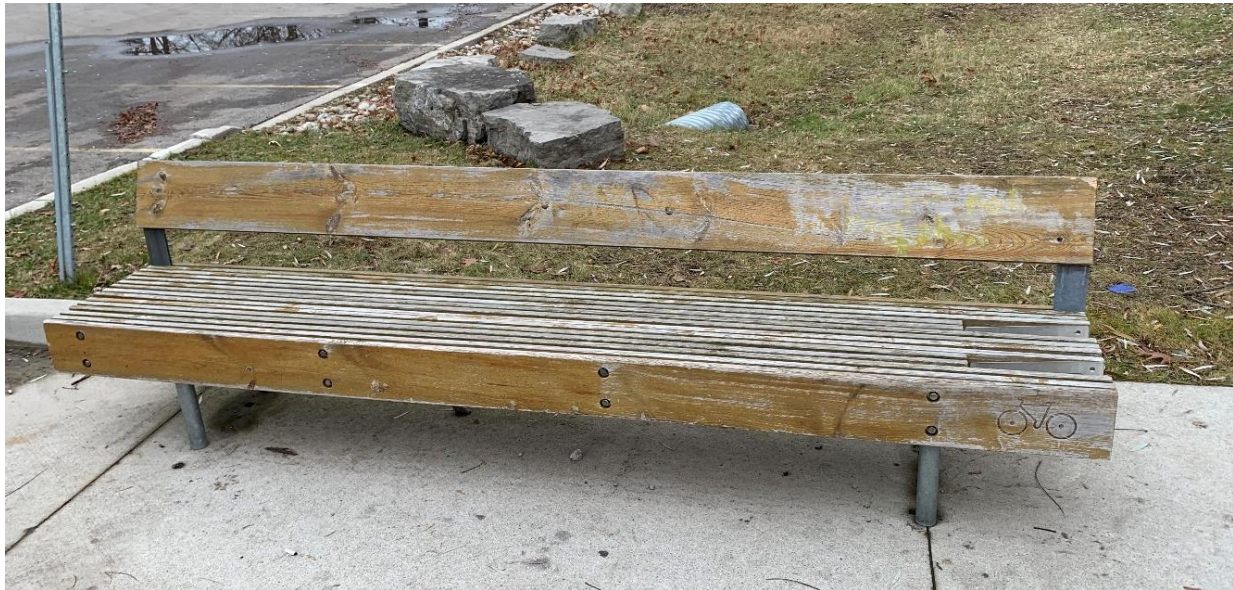
**Figure 7: MMCITE Woody Bench**

The intended design of the wooden slats is to age naturally. The weathering of the wood is as intended but should be monitored to ensure the wood does not start to deteriorate. If it does start to deteriorate then the slats should be replaced. Alternatively, an eco-friendly oil for outdoor wood furniture can be applied to assist with the wood protection against moisture and UV rays. The stainless-steel rods and legs supporting the bench structure are in good condition and have not weathered or deteriorated. Continual monitoring and occasional re-assessment will ensure an aesthetically pleasing, structurally sound bench for park and trail users.

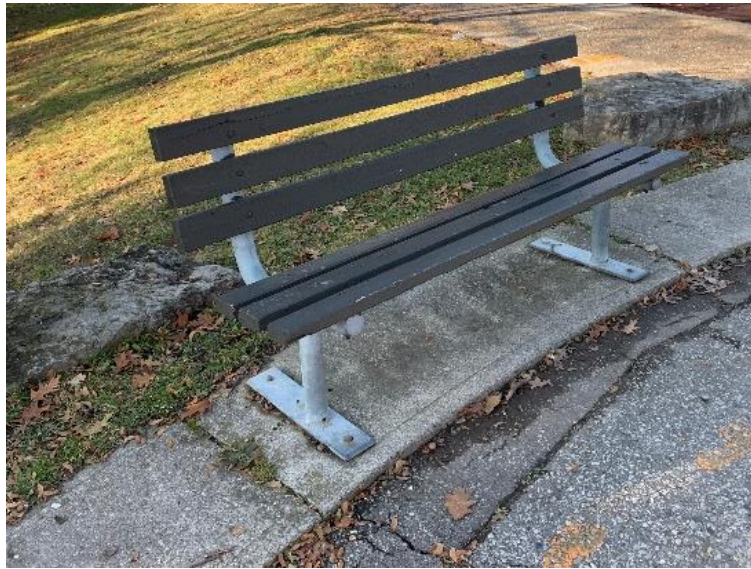
**Figure 8: Bleacher Guys Bench**

It is recommended that the concrete and asphalt surfaces are levelled to ensure a smooth transition and to eliminate the tripping hazard. A short-term solution is for the asphalt paving to be raised and graded to meet the concrete slab edge underneath the bench, while allowing water to runoff unobstructed towards the landscaped open space behind the bench. A long-term solution is to provide one consistent surface, concrete or asphalt, reducing the future possibility of tripping hazards. It is also recommended that planking is monitored for its condition and to be replaced to match other site furnishings within the park, to ensure a cohesive approach for all furnishings within the park. If the bench needs to be replaced due to deterioration then it should be replaced to match the current standard and style of benches within the park.

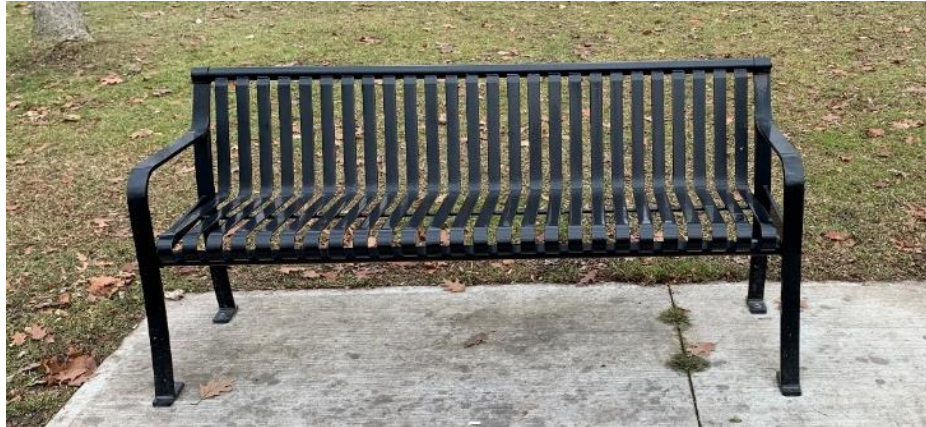
**Figure 9: Maglin Bench**

The bench is in very good condition both structurally and aesthetically. It provides an accessible space near the fitness equipment and the concrete pad is flush with the asphalt trail. As the bench ages, it could be replaced with a bench that matches other benches throughout the park to provide a cohesive common look and feel.

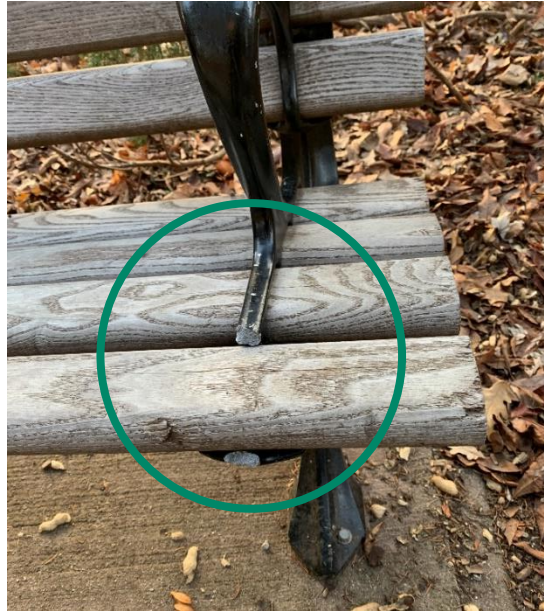
**Figure 10: Memorial with Bench Broken Arm Rest**

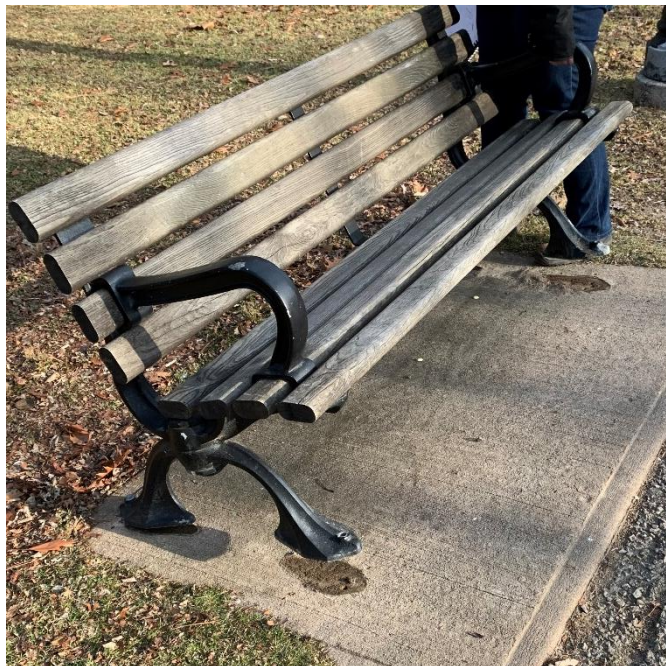
**Figure 11: Memorial Bench Missing Mounting Bolts**

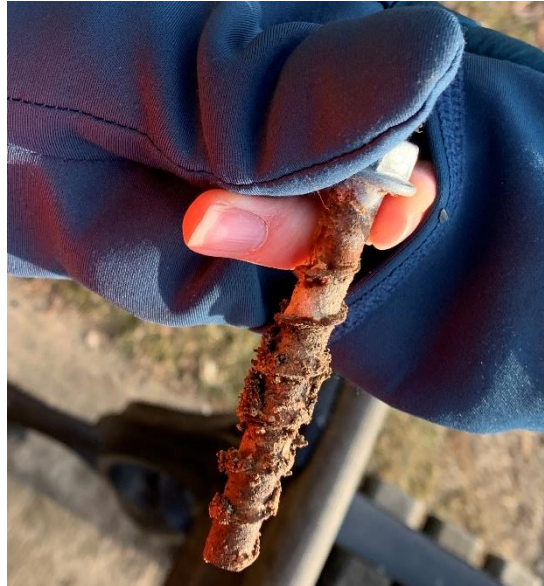
**Figure 12: Memorial Bench Mounting Bolt in Person's Hand**

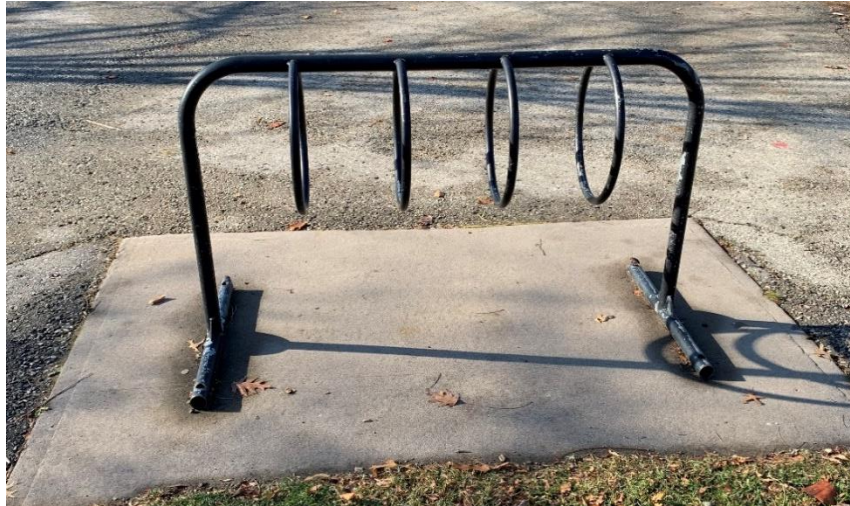
**Figure 16: Quad Bike Rack along Pedestrian Pathway**

Surface mounted onto a concrete pad with a steel frame that is powder coated black. This bicycle rack can support 4 bicycles and is located beside heavily travelled pathways. One of the bicycle racks is located near the Boathouse along Jubilee Drive, located on a concrete pad, but there is not a connection from the trail to the bike rack. Users need to move their bike across grass to reach the concrete pad. The concrete pad is also not large enough for a bike to be placed on the concrete and be off the grass, this will create maintenance issues in the future if the bicycle rack is heavily used.

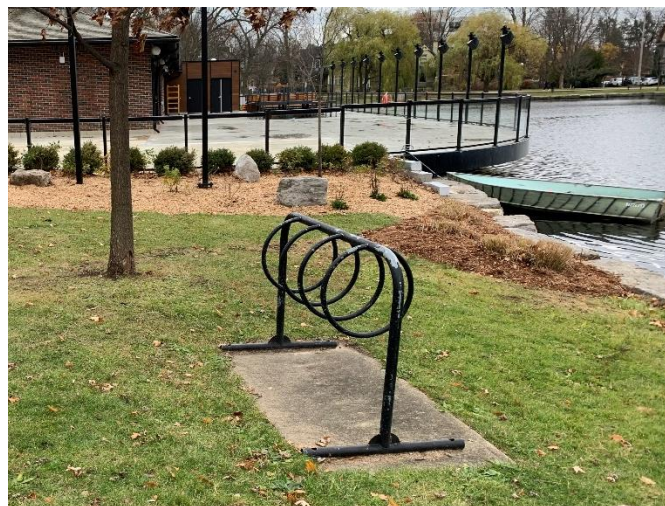
**Figure 17: Quad Bike Rack near Boathouse**

Located adjacent to the Pavilion Building parking lot, the quad bicycle rack has paint chipping and the surface-mounted bars rusting. The structure of the bicycle rack appears to be in good condition but should be monitored to ensure the possibility of rust does not damage the structure. The surface mounted legs can pose a tripping hazard as they extend past the loop structure and have started to rust and bend. It is recommended to have bicycle racks that have flush surface mounted base plates to reduce the opportunity for slips, trips and falls. The bicycle racks should be located along the pathways or have a connection off the pathway to where the bicycle rack is located. The concrete pad that the bicycle racks are placed on should be large enough for a bike to be fully on the concrete and not on surrounding softscape, creating maintenance issues for bicycle racks that are heavily used.

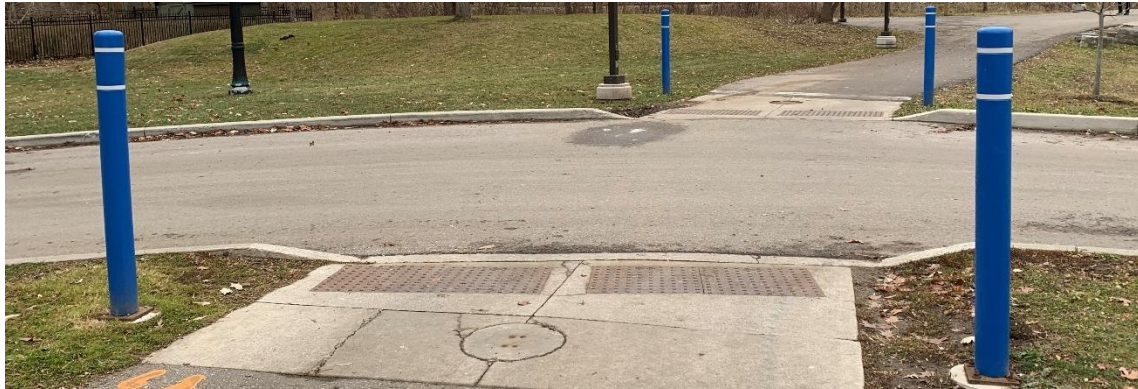
**Figure 20: Post Guard Blue Reflective Striped Bollards**

The surface mounting on the bollards is rusting and should be replaced to maintain the structural integrity of the bollards. The bollard cover is to remain blue to be consistent with the Region of Waterloo’s cycling and trails standards.

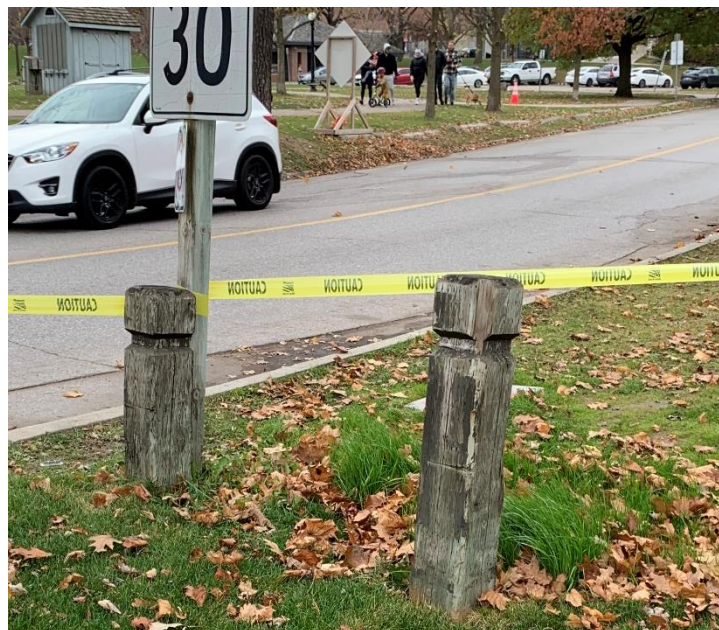
**Figure 22: Timber Bollards at Boathouse**

The bollards have settled over time, leaving the two at different heights. The bollards are remaining from the original timber bollard installations in front of the boathouse prior to 2009. They are no longer providing a functional use in their location and no longer match other bollards within the park. It is recommended to remove the two bollards if there is not a functional reason for their installation at this location.

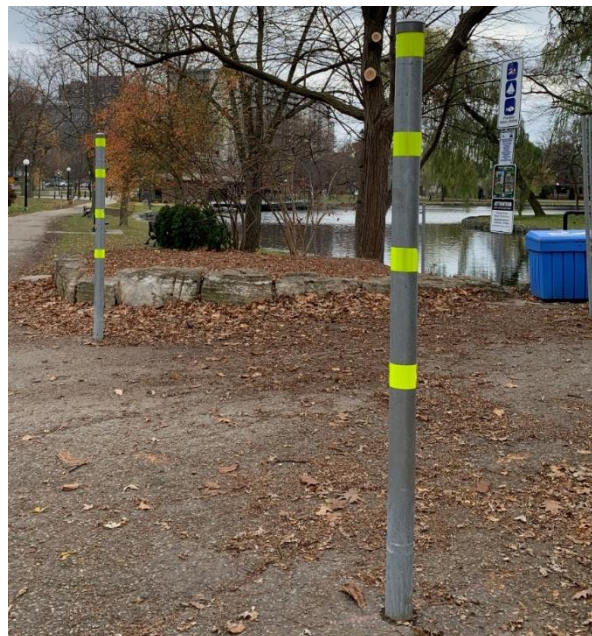
**Figure 24: Metal Skinny Bollards**

The bollards were installed in the spring/summer of 2024 and do not require any repairs now. It is recommended that any future bollards installed, are co-ordinated with existing

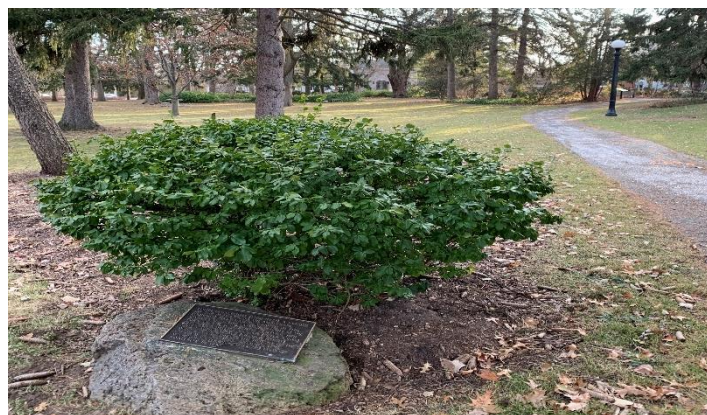
**Figure 26: Location of Tuhbenahneequay Plaque**

It is recommended to have the plaque located off the ground to increase the visibility and recognition of Tuhbenahneequay. The plaque should be located 450 millimetre – 600 millimetre off the pathway. Increasing the height of the plaque allows the plaque to

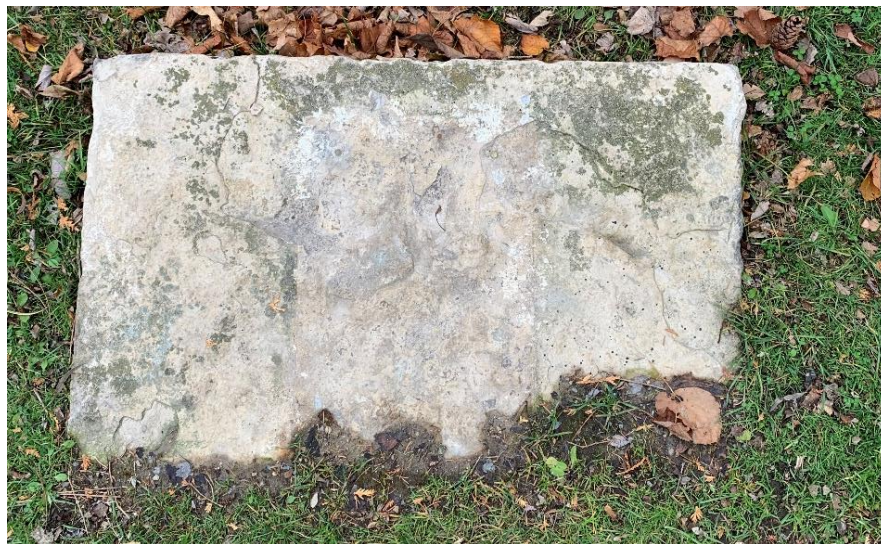
**Figure 36: Plaque Stone without Plaque (November 2024)**

### **Recommended Repairs:**
