## Victoria Park Lake

### *The Lowdown on the Clean-up*

January 27, 2012

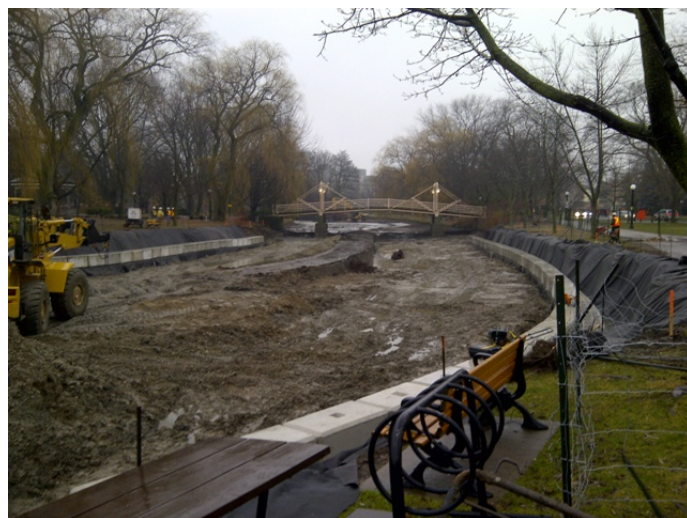
Over the past month, many visible changes have occurred at Victoria Park Lake. These changes include the excavation of sediment and native material from the lake and installation of the new lake edge along parts of the lower end of the lake. The lake edge consists of a precast concrete block retaining wall topped by armourstone. The armourstone layer will be the only portion of the lake that is visible once the lake is filled later in the spring.

You might notice a concrete path in the middle of the lake. This path is not a road but a concrete capping which covers a trunk sanitary and storm sewer. These sewers do not link to the lake but flow underneath with a concrete capping for protection. This concrete pad will no longer be visible once the lake is filled.
