city of kitchener

# civic centre neighbourhood

## heritage conservation district plan

# CIVIC CENTRE NEIGHBOURHOOD HERITAGE CONSERVATION DISTRICT PLAN

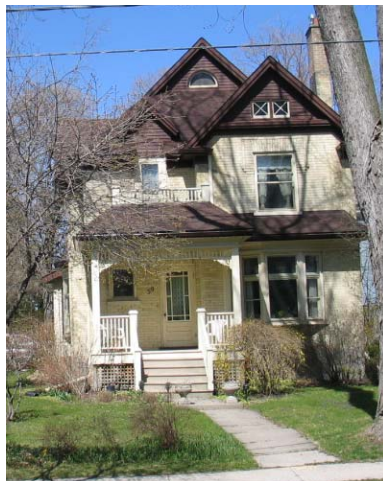
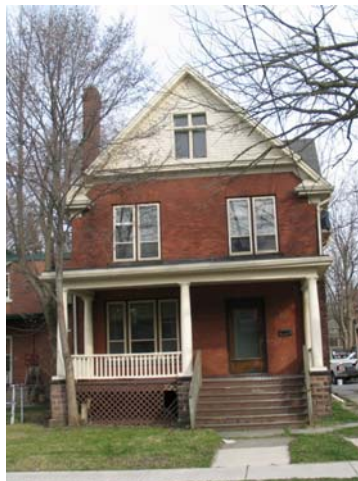
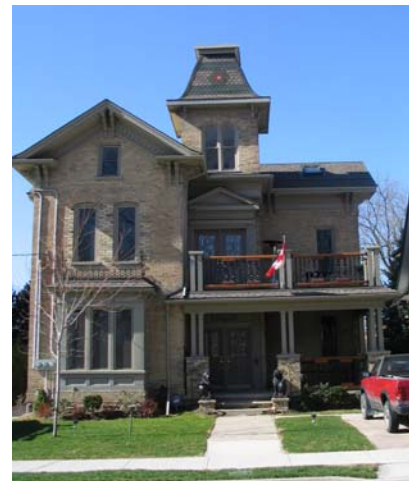
*Attic Gable*

*'Berlin Vernacular'*

*Italianate*

*Examples of architectural styles found in Civic Centre Neighbourhood*

The Civic Centre neighbourhood is one of Kitchener's older neighbourhoods and retains a large number of original buildings that are well crafted and maintained. Architectural styles and influences are consistent with the more popular styles of the period in which they were constructed, including Queen Anne, Georgian and Italianate styles. Of particular note in the neighbourhood are a substantial number of dwellings termed 'Berlin or Kitchener Vernacular' which reflected a local interpretation incorporating traces of decorative Queen Anne elements in the wood trim, gables, eaves and fascias. A variant on this style, referred to as the Attic Gable style, is also a local interpretation frequently found in the Civic Centre Neighbourhood which boasts a highly articulated and decorative triple gable roof line.

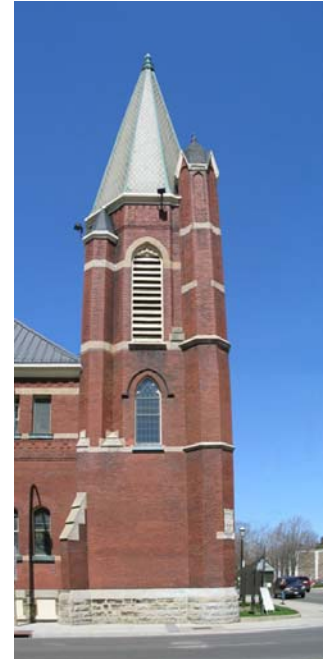
*St. Andrews Church – slate, brick and stone landmark*

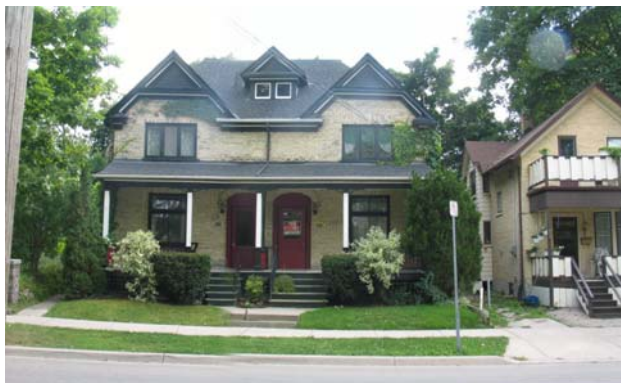
*67 – 69 Ahrens – two semis cooperating*

- 67-69 Ahrens Street West – Double house (entire façade and roof) associated with Woelfle family
  - 25 Maynard Avenue – Front façade
  - 108 Queen Street North – Queen Street façade, Margaret Avenue facade and other exterior features as noted in the designation by-law

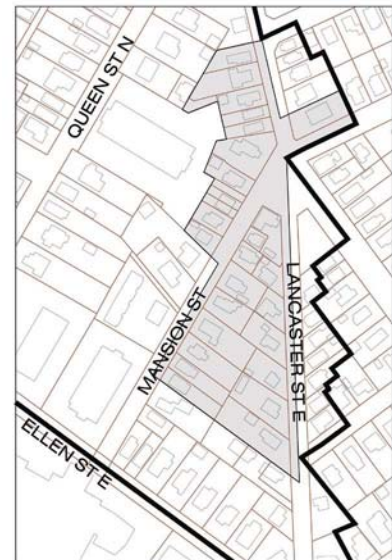
**MANSION / LANCASTER AREA - POTENTIAL BUILDING HEIGHTS**

The Low Density Multiple Residential designation exists along most of Mansion and Lancaster Streets. It is intended to maintain the overall low density, low rise residential character of the neighbourhood while also allowing for some integrated development in the area. Specific policies pertaining to redevelopment on Mansion Street state that it should be of a height, siting and design which will prevent it from encroaching on single detached dwellings on Queen Street North. At the present time, the majority of structures in this area are still the original detached dwellings. Properties in this area are currently zoned R7, which permits a range of housing from single detached to multiple dwellings, with a floor space ratio of 1.0 and a maximum height of 24 metres (approximately 8 storeys) for multiple dwellings.

While it is recognized that there may be some limited opportunities for “integrated redevelopment” in this area, a height of 24 metres does not appear to be appropriate or consistent with the Municipal Plan policies that specify the intent to “maintain the overall low density, low rise character of the neighbourhood”. With a floor space ratio of 1, it would also be quite unlikely or difficult to achieve heights beyond three storeys, using typical or required setbacks, even if property consolidation occurred as shown in the chart on the following page. Consequently, it is recommended that the zoning in this area be changed to the R6 zone along Mansion Street which will still permit a full range of housing forms, but with a maximum height of 10.5 metres (approximately 3 storeys), and to the R5 zone along Lancaster Street. This would be more consistent with the policies of the Municipal Plan as well as more compatible with the surrounding context in the event of redevelopment in this area. The R5 zone proposed for Lancaster Street mirrors that on the east side of the street and is intended to protect the unique single family dwellings that are set at an oblique angle to the street.

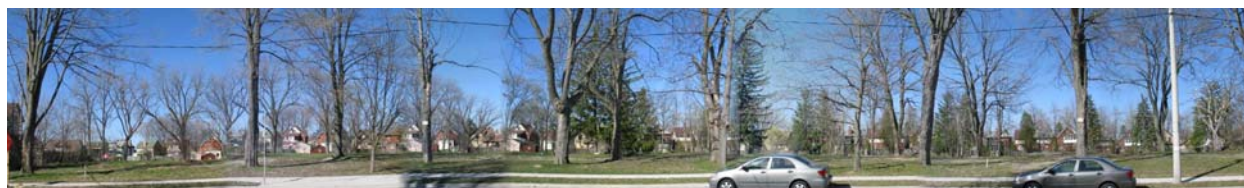
**Medium Density Multiple Residential Designation – Margaret Avenue**

The large vacant lot on Margaret Avenue is also currently designated Medium Density Multiple Residential, which is intended to permit some integrated medium density development while maintaining the overall character of the neighbourhood. Zoning for the large vacant parcel is R8, which permits a floor space ratio of 2 and a maximum height of 24 metres (approximately 8 storeys) for multiple dwellings. The majority of buildings beside, across from and backing onto the large vacant site on Margaret are still the original detached dwellings, primarily 2 to 2-1/2 storeys in height. One high rise apartment is situated across from the east end of the site. While the zoning would allow for construction of an 8 storey building, it would be more difficult for a building of this height to “maintain the overall character of the neighbourhood”. Actual architectural and design elements, along with siting of buildings would likely play an equally important role in whether new development was compatible with the character of the neighbourhood.

With the permitted floor space ratio of 2, it would be very possible to achieve the maximum floor area within a building envelope of 5 storeys or less as shown below. As a result, consideration should be given to reducing the maximum permitted height in this area to approximately 16.5 metres to reduce potential height impacts on the street and adjacent neighbours. Height impacts could also be addressed through the addition of angular planes and/or stepback requirements in the zoning by-law or guidelines to minimize building heights nearest the street. In addition, a maximum frontyard setback of 10 metres is recommended to establish a street edge similar to the opposite side of Margaret Avenue.

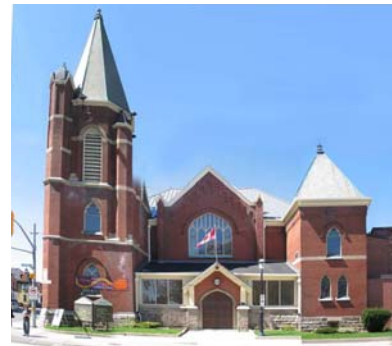
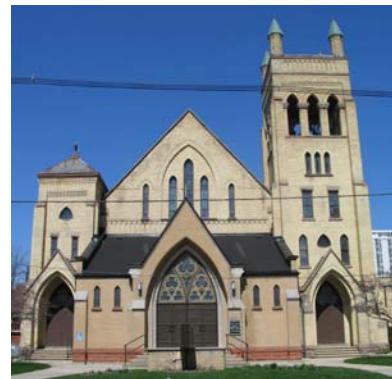
*Churches on Weber Street,  
illustrating greater height*

No changes to the land use designations or zoning for the two churches are proposed. Should any changes to the uses or buildings be proposed, the policies and guidelines of this plan are to apply.

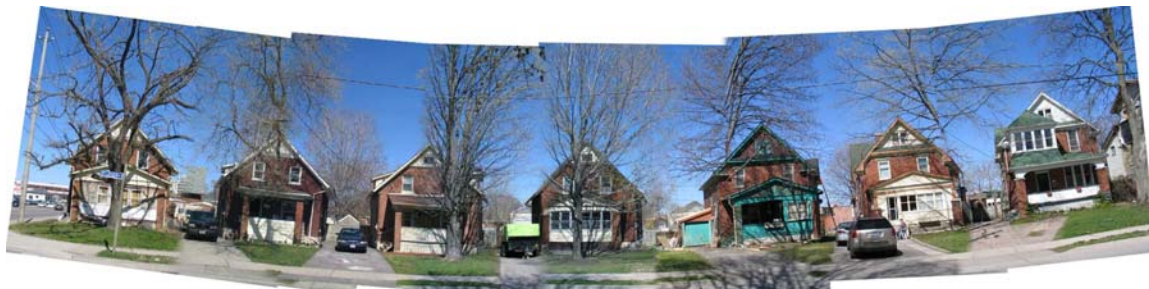
*St. Leger Street , north side 46-22*

The most apparent influence of a building on the character of the district is its overall size and shape as perceived from the street. A building that is significantly larger or smaller than its neighbours, or long and low in a tall and narrow neighbourhood will be recognized for those unique qualities rather than contributing to the massing norm of the district. Variation is not necessarily a bad quality, except in a grouping of similar items, like organ pipes or teeth, where there is an established expectation of continuity.

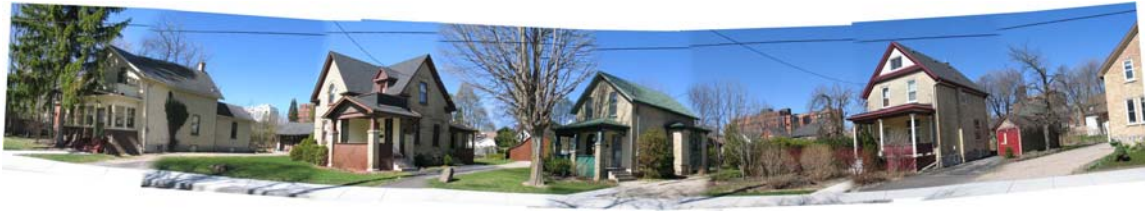
*Lancaster Street East, south side 99-79*

A building that would otherwise be consistent with its neighbours because of form and massing, can have a disturbing effect on the recognizable consistency of the neighbourhood if it sticks out in front of the general line of building facades or leaves a noticeable gap. In CCHCD there is the unique rhythm established along Lancaster of similar sized houses all turned to 45 degrees from the street, generating a saw tooth street elevation of primary and secondary building faces. Here, the norm is established as the oblique relationship to the street, and is reinforced by the repetition of houses at uniform spacing. For the benefit of the neighbourhood coherence, most buildings in the sequence follow the same setting on the property. There are worthy exceptions for special locations and landmark buildings, but we expect to see a consistent alignment and spacing of building facades along a street unless there is good reason for a break.

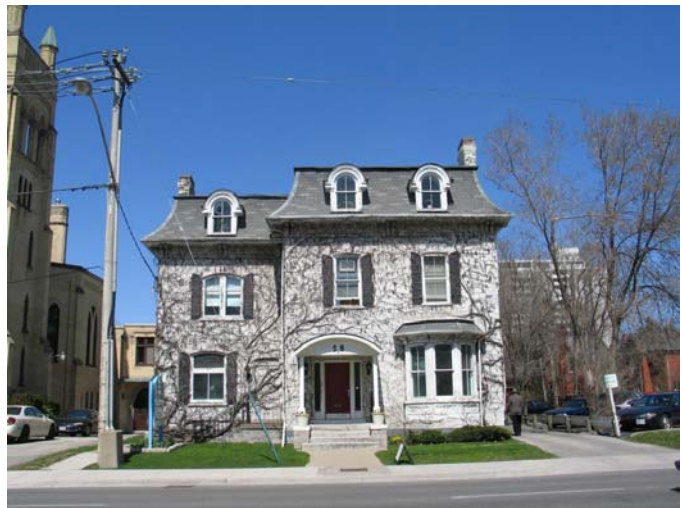
*28 Weber Street West – Second Empire style with mansard roof and dormer windows*

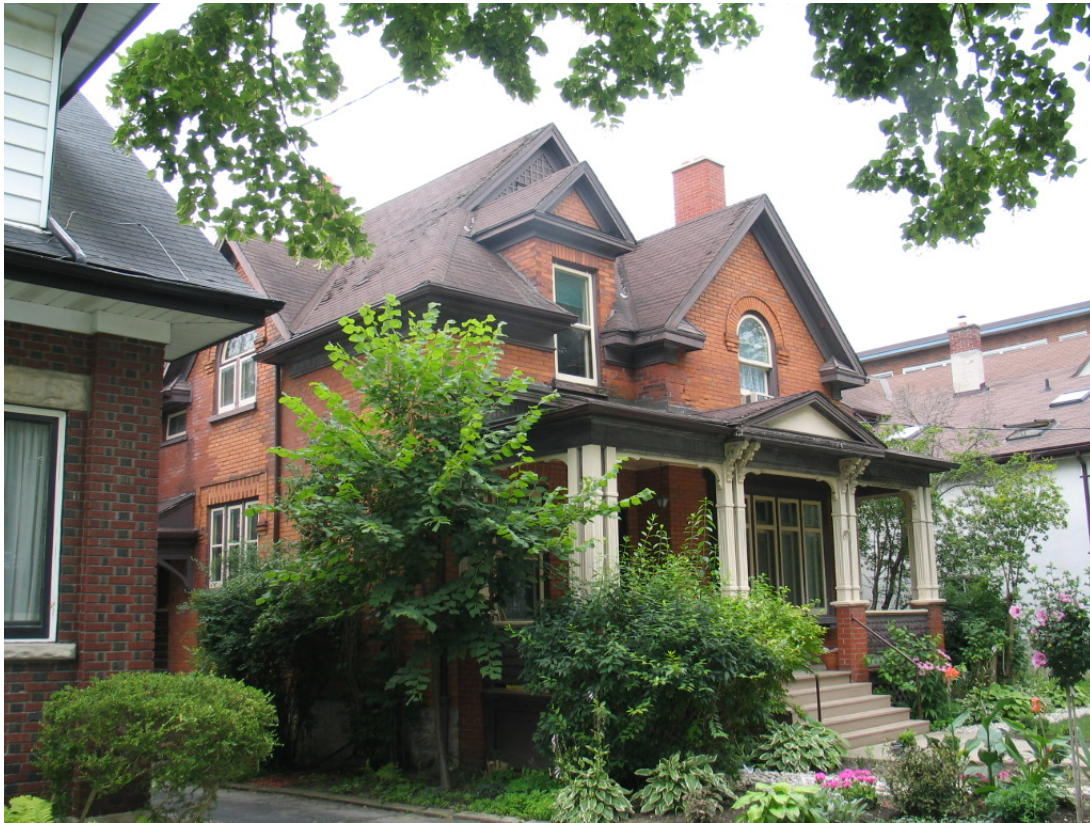
*37 Margaret Avenue – Some Queen Anne elements in a vernacular style well crafted.*

Whereas the architectural style nomenclature may be a pedigree that appeals to the scholarly review of the worth of a building, to many residents, the name of the style is of less importance than the combination of projecting bays, inset entrances and rhythm of other major facade elements that contribute to the texture of the street elevation in combination with adjacent buildings.

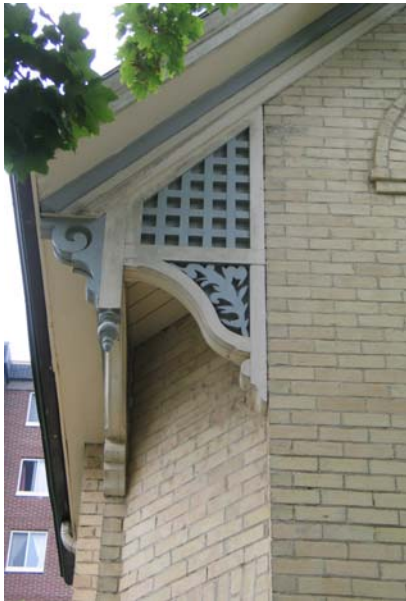
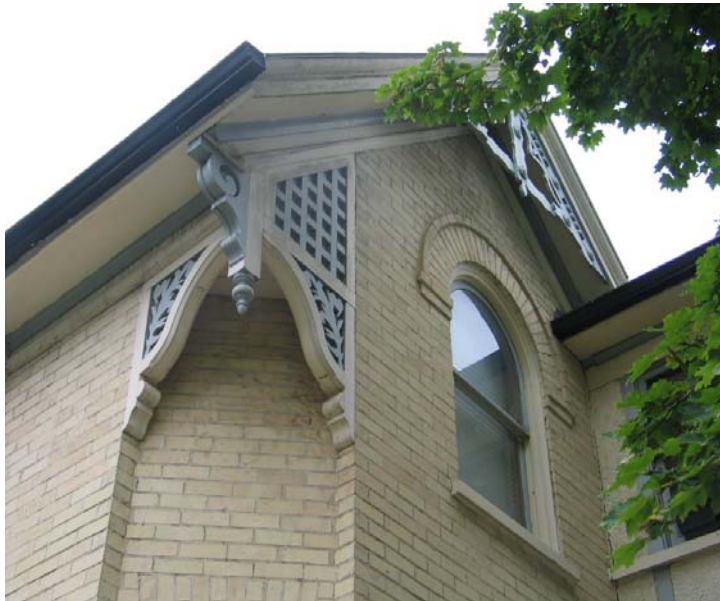
*83 Ahrens Street West, subtle brick detailing with ornate wood trim.*

These elements are part of the basic structure of the building and add to the decorative character of the appearance. Some of these elements may have been added to the basic design for utilitarian purposes, such as roof dormers to allow a building's attic to be habitable with windows, others are almost purely decorative in nature, such as corner turrets and cone-shaped roofs that could easily have been incorporated into a slightly larger box for the small amount of floor space they contribute. All of these geometric solutions to the enclosure of space provide additional opportunities for the designer to embellish a simple box. All of these protrusions provide visible locations for additional decorative treatments as noted in “trim and decoration” below.

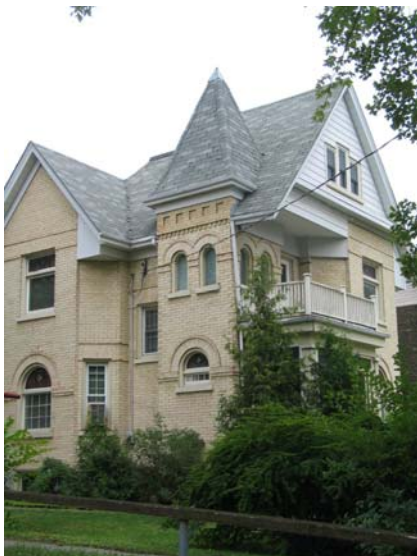
*Turret at 18 Maynard Ave*

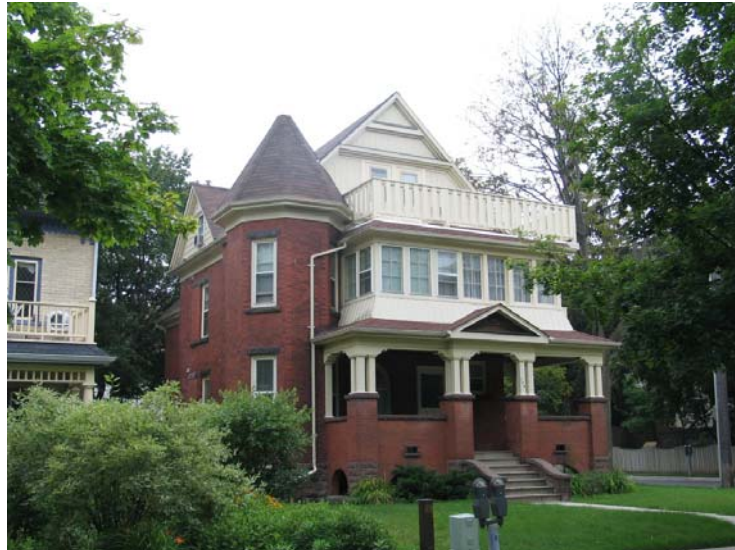
*Turret at 119 Young Street*

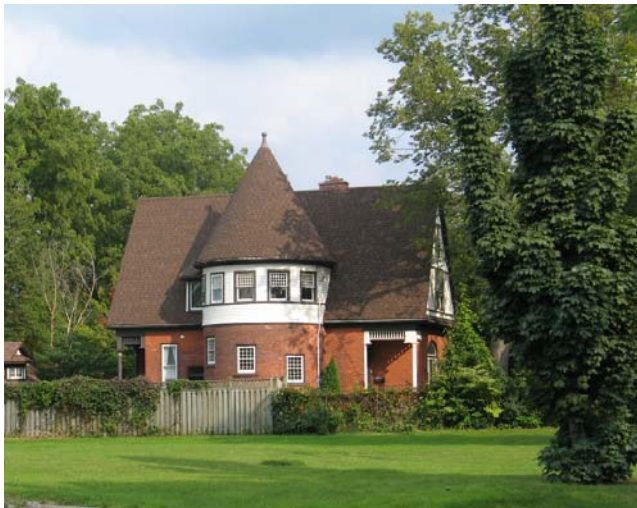
*54 Margaret Avenue – round turret*

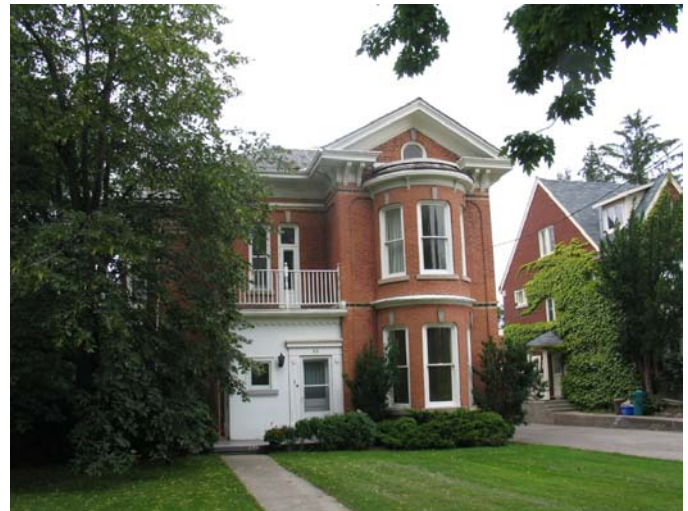
*55 Margaret Avenue – round bay and trim*

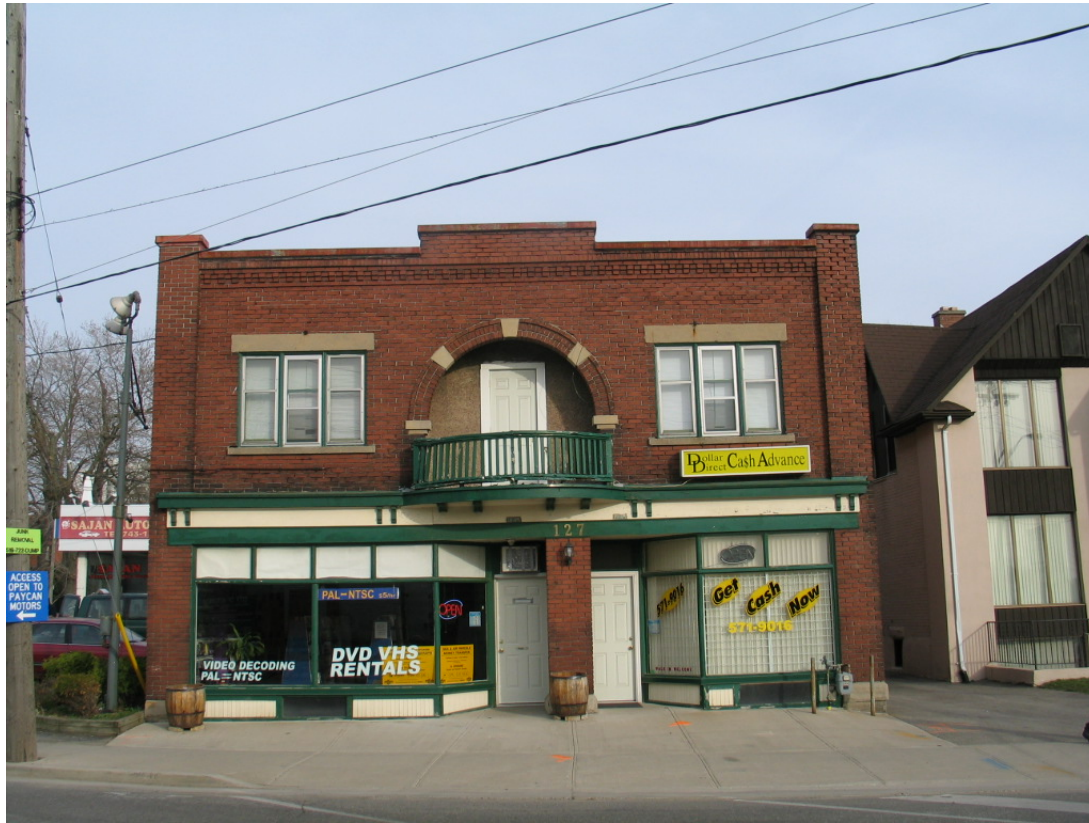
*Purpose built shopfront at 127 Water Street*

The purpose built commercial structures, like the store at 127 Water Street North, used materials that were similar to the adjacent houses, but combined in a layout and construction technology that better suited the intended purpose of the building. To provide visual and physical access to the goods for sale, the building is moved closer to the street line, the ground floor is lowered almost to ground level, and the front façade is enclosed with large amounts of glass at the ground floor facing the street. There is a prominent cornice, or decorative band, just above the shop window, that can be used for signage, advertising, and in some cases the mounting of adjustable awnings to protect the shopfront, window contents and any display extending to the sidewalk in front of the shop from excessive sun or rain. Purpose built retail buildings were most frequently constructed along major streets to benefit from the increased traffic and exposure to clientele, and were most often built in conjoined rows to benefit from the close commercial exposure to each other and to the pedestrian traffic on the sidewalk. The close proximity of the adjacent buildings created new problems of fire protection and rain disposal that were solved by the new built form. The sloped roof and overhanging eaves of residential construction gave way to masonry parapet walls extending vertically above flat roofs. This design contained fire from spreading to adjacent buildings and contained rain and snow from falling onto the sidewalk or adjacent properties or loading areas. This design also provided a street façade that could be joined to other similar facades, but made unique by the materials, openings and signage at street and roof level.

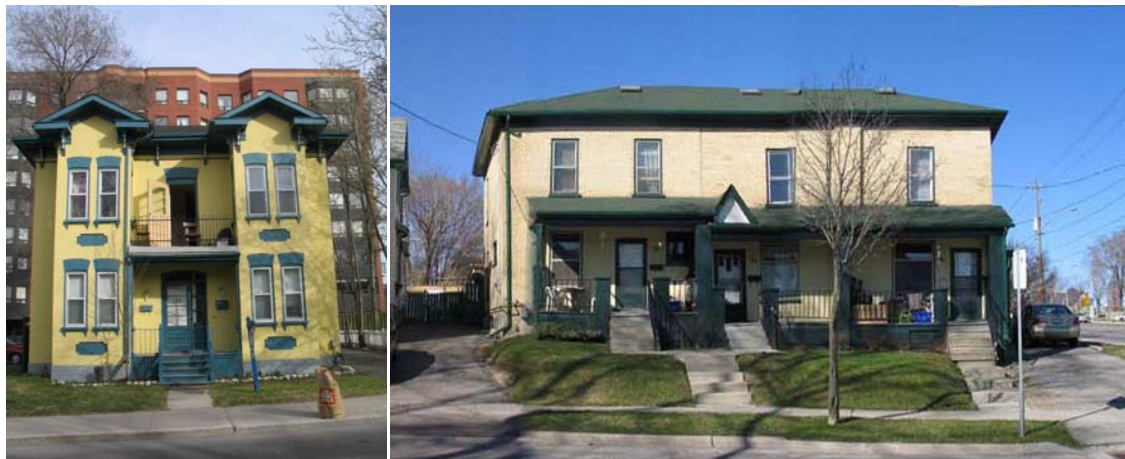
*143 Queen Street North & 57-61 Ellen Street West*

The early versions of multiple unit housing styles were closely related to single family styles in construction technology and appearance. Most semi-detached houses appear to be very similar to other housing, only that they are designed to be contacting on one side.

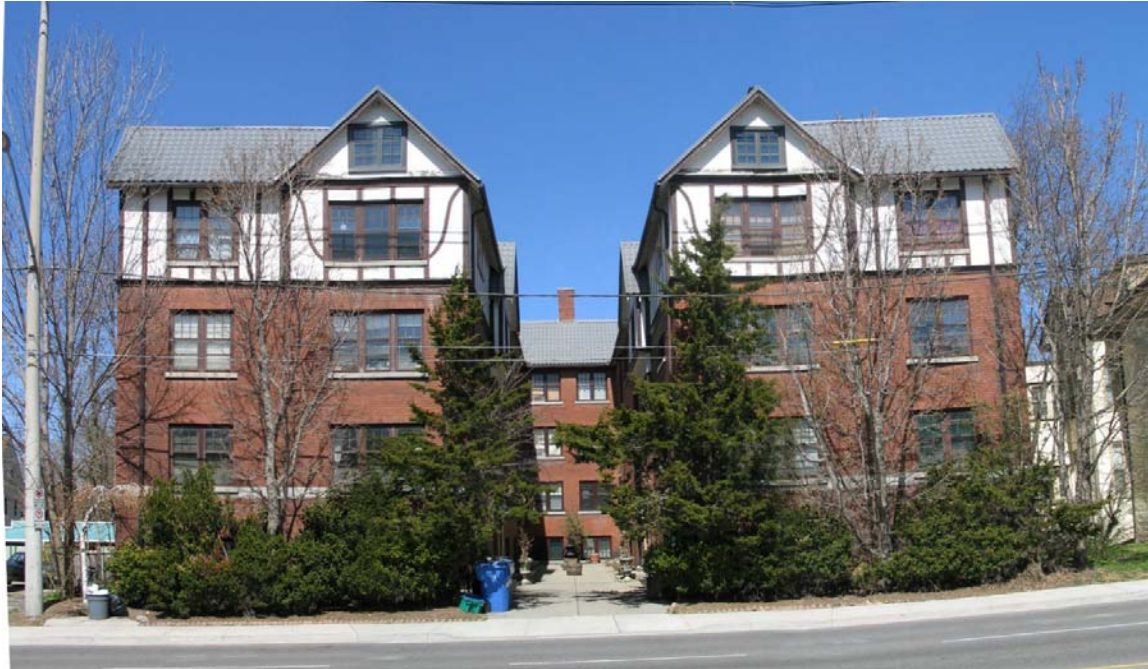
*48 Weber Street*

The example of early purpose built apartments at 48 Weber Street illustrates an effort on the part of the builder to design a building that closely resembles the adjacent housing stock in material and design, but increasing the scale and number of units accommodated. The overall height is similar to other three storey residential buildings, and the massing presented to the street is of two slightly enlarged house forms separated by a common entrance courtyard. The progression of materials from masonry at the lower two floors to stucco with Tudor decoration at the third floor is consistent with other single family buildings in the district (187 Queen, 26 Roy). The elevation is punctuated with window designs and spacing similar to other large houses and the elevation is surmounted by a decorative gable element similar in scale and design to other single family residences. This is a building working hard to fit in well with its neighbours while accommodating an increased density of housing units.

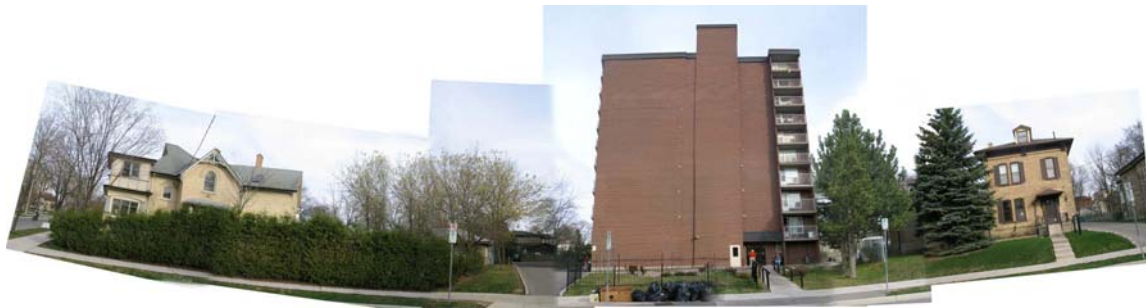
*Apartment building at 119 College Street*

When these types of apartment towers were first envisioned, most forward thinking designers (notably Le Corbusier) advocated for them to be constructed in park-like settings liberating the ground for healthy communal recreation and avoiding conflict with traditional housing construction. Kitchener CCHCD accepted the high-rise apartment towers, and in some locations benefited from the park-like setting and the communal activities on the ground level, such as the convenience store at 100 Queen Street. However, some of the post-1945 apartment blocks appear to be designed and situated in a fashion that does not complement the surrounding low-rise residential buildings, and would not be much of an asset to a streetscape. The apartment block at 119 College Street exposes a large blank expanse of solid wall to the street with a pair of entrance doors that would be less than inviting even to tradespeople.

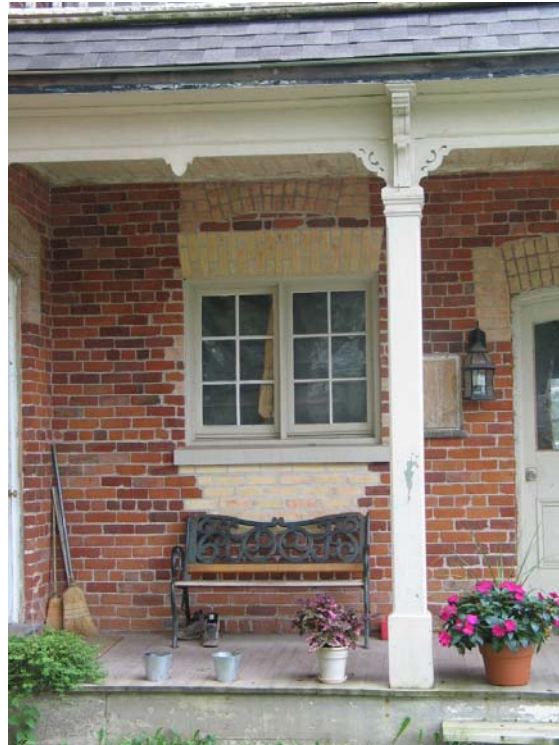
*108 Queen Street North –side elevation details*

In this example at 108 Queen Street North, the original masonry exterior wall has been modified to change two original openings. The work has been undertaken in a fashion that is sympathetic to the details and construction of the original building, but clearly identifiable as an alteration.

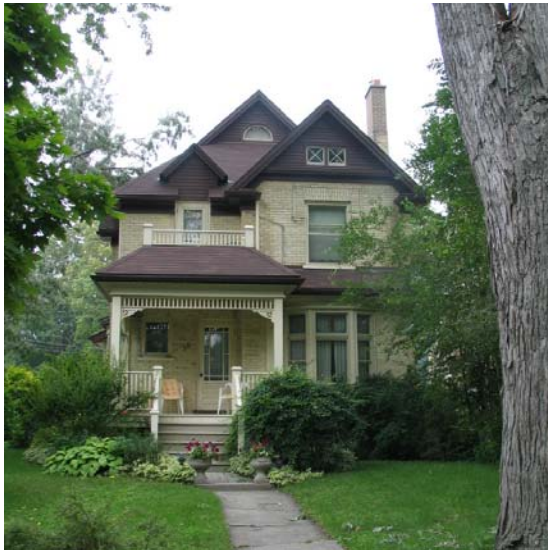
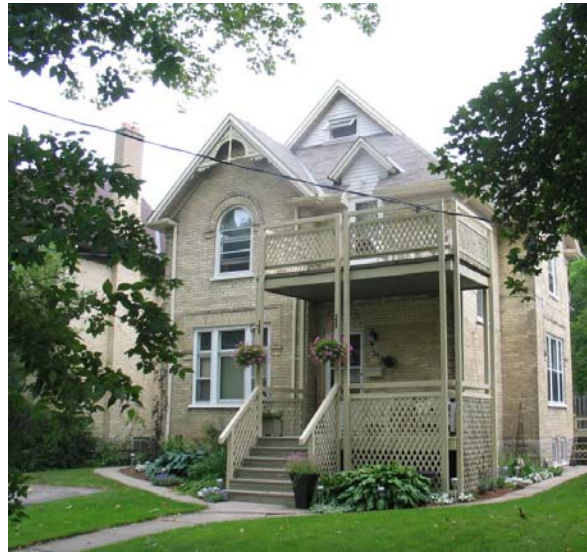
*Traditional and updated porch details*

Because of the severe exposure to weather, a projecting porch is subjected to accelerated deterioration and requires increased amounts of work to be maintained in original condition. In spite of effort, or in most cases because of the lack of adequate effort, porches frequently are in very poor condition and the owner is required to remove the porch entirely and replace it. The new construction option requires the decision to replicate the original or use a new style. If there has been no change in the functional requirement of the porch, the design should replicate the original to conserve the best reflection of the Heritage Conservation District.

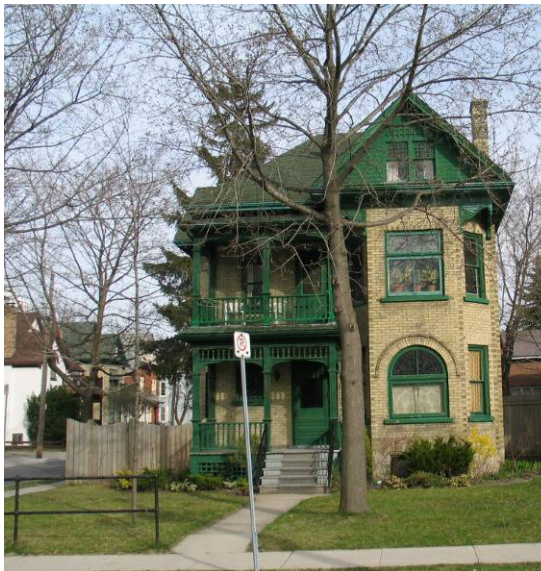
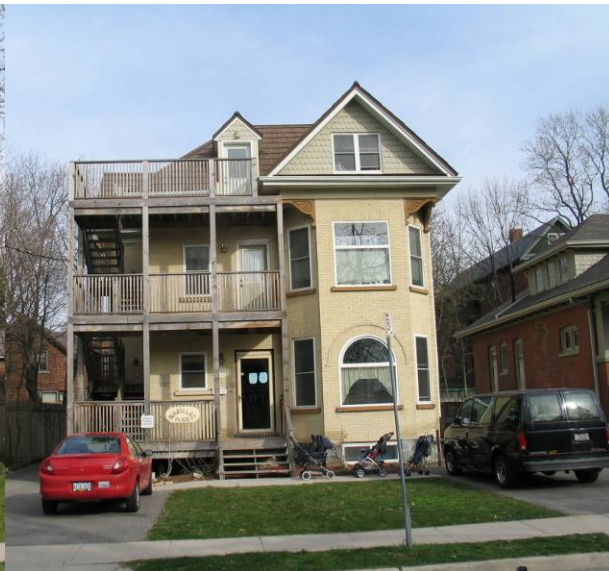
*113 & 109 Young Street – Replacement of original materials*

A number of new materials that were not available at the beginning of the 20<sup>th</sup> century are readily available now at building supply yards. The sales staff at those supply depots are correct to recommend preservative treated wood in locations that are subjected to moisture exposure and rot. The disadvantage of these products is that they sometimes claim to be weatherproof and do not need the additional protection of a good paint film. Good practice for the replacement of deteriorated wood porches is to fabricate the new components to match the profiles and details of the original, saturate the new wood with a liquid preservative, particularly ends and joints, and coat with a good quality exterior paint. Inspect the paint and retouch to repair damage on a regular basis to keep wet out of the wood.

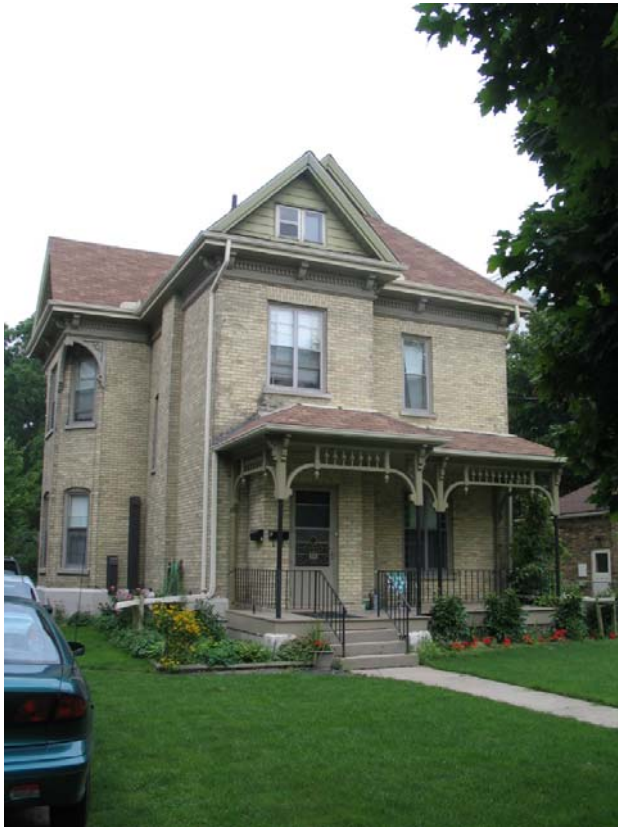
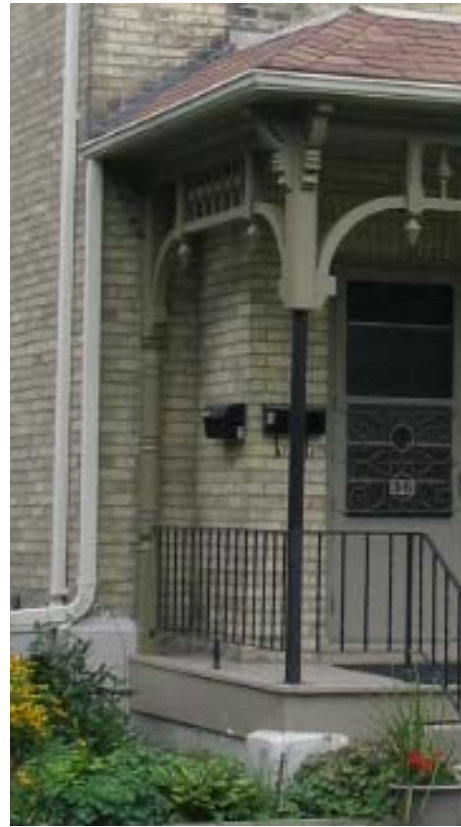
*36 Ahrens Street West, updated porch detail*

It is understandable that the bottom of a wood porch post can soak up moisture and rot. In most cases, a new portion can be fabricated to match the original profile and spliced onto the sound portion of the post without the radical change to a steel prop. The bottom of any newly installed wood posts can be well protected from pre-mature deterioration by the insertion of a cast metal shoe that is discrete in appearance and effectively supports the bottom of the wood post while isolating it from direct contact with the source of moisture below.

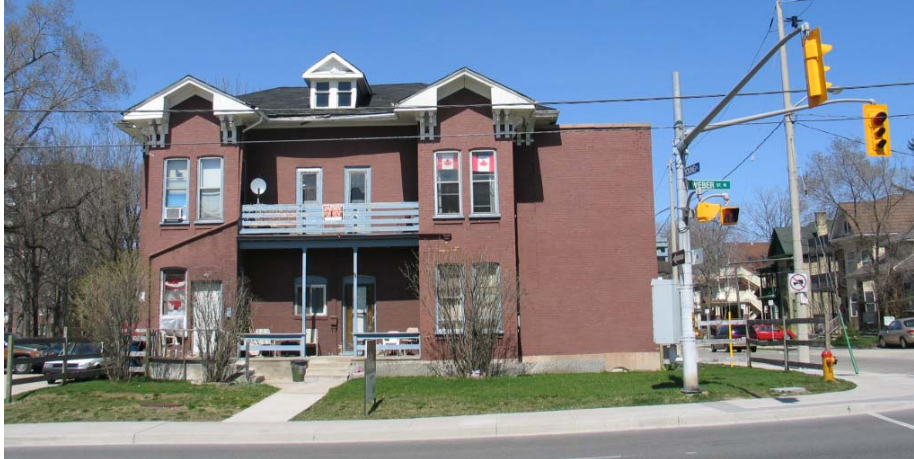
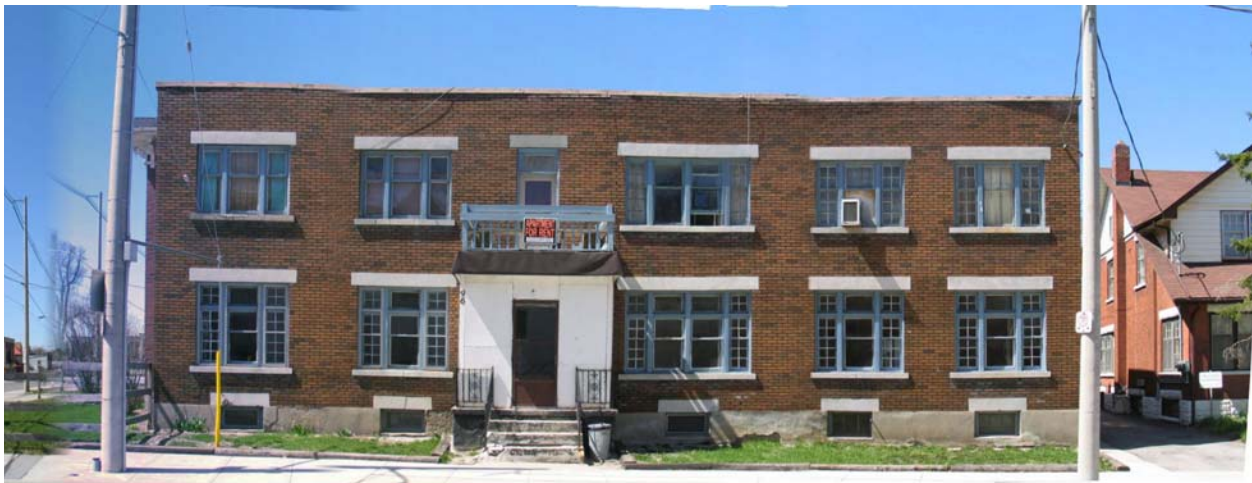
*58-60 Weber Street, 96 Young Street, two faced addition*

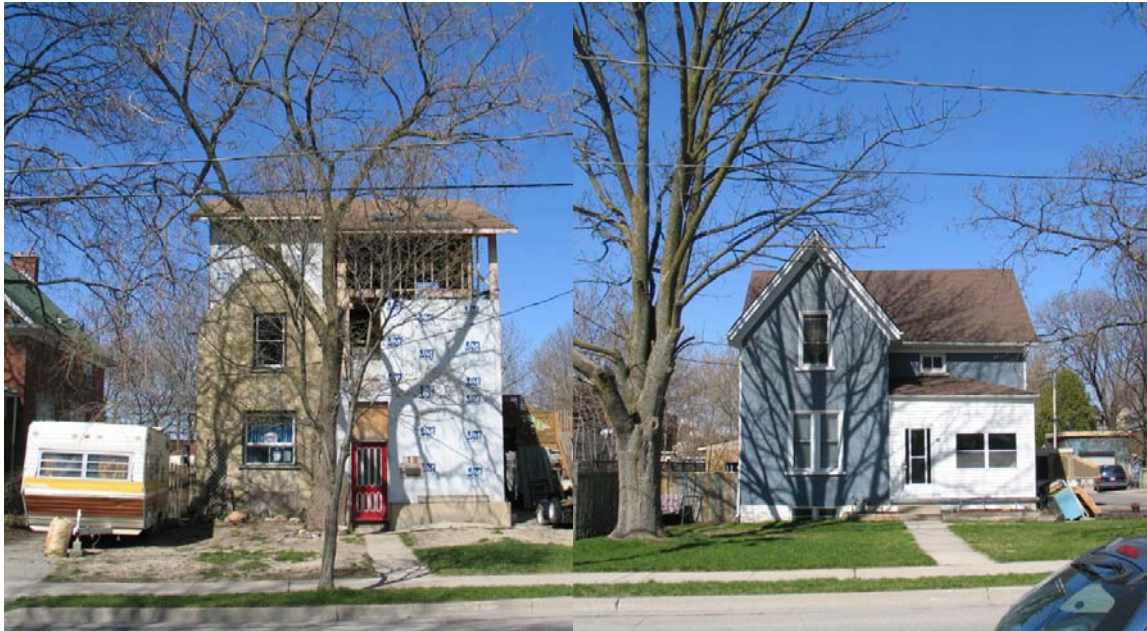
*LESS PREFERRED (LEFT) 18 – 14 St. Leger Street*

Two adjacent houses on St. Leger Street have taken different approaches to the design of front additions. On the right, the entrance that was once protected by an open porch with a simple roof has been enclosed from the weather, painted white and fitted with windows and a door that are substantially different in style from the original building. However, the massing and architectural style of the original building are still very evident in the appearance, and restoration of the original is still possible.

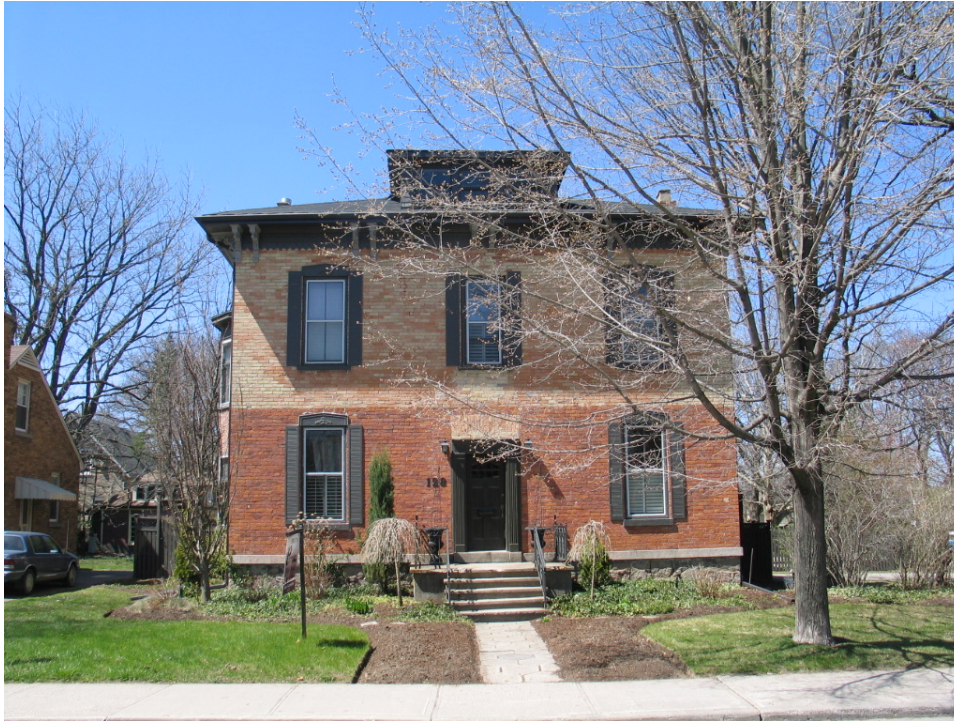
*128 Queen Street North (original built prior to 1879)*

This major second floor addition to the original house (128 Queen Street) made a radical change to the design and massing of the building. Time has now established this addition as the historic condition. However, the design of this very visible and very significant addition was at the time respectful of the original building and of the neighbouring buildings. The addition, which is distinguished from the original, probably unintentionally, uses window types, sizes and layout that reflect the original design and roof and eave details that are consistent with the period. The large side yard ensures that the second floor addition did not have a significant impact on the existing neighbours.

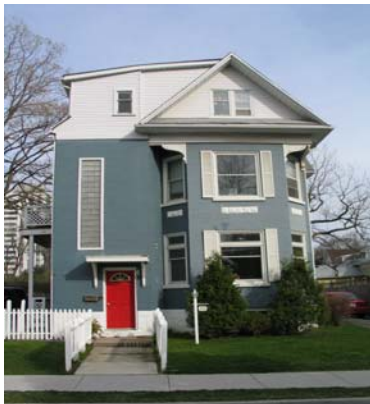
**LESS PREFERRED**

*149 Young Street and side of 58 Ahrens Street West*

An addition to a heritage building should respect the original construction by being independent of it or subordinate to it or by mimicking materials and details to flatter the original by copying. An addition that is in a prominent location and competes for attention by size and conflicting construction details does not serve the design intent of either the original or the addition.

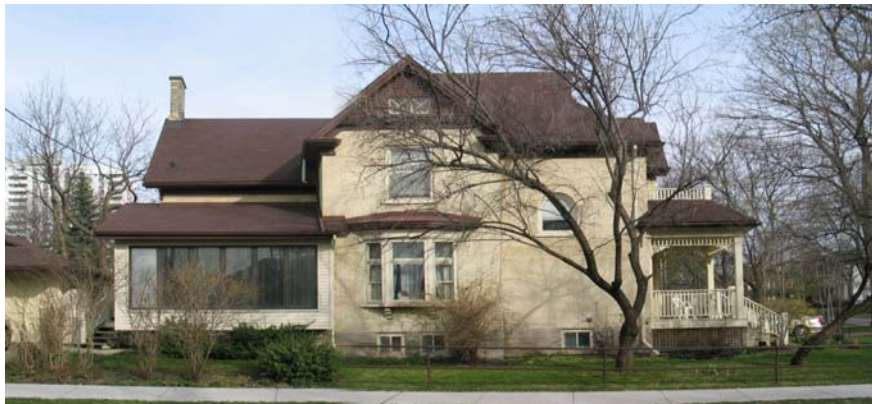
**MORE PREFERRED**

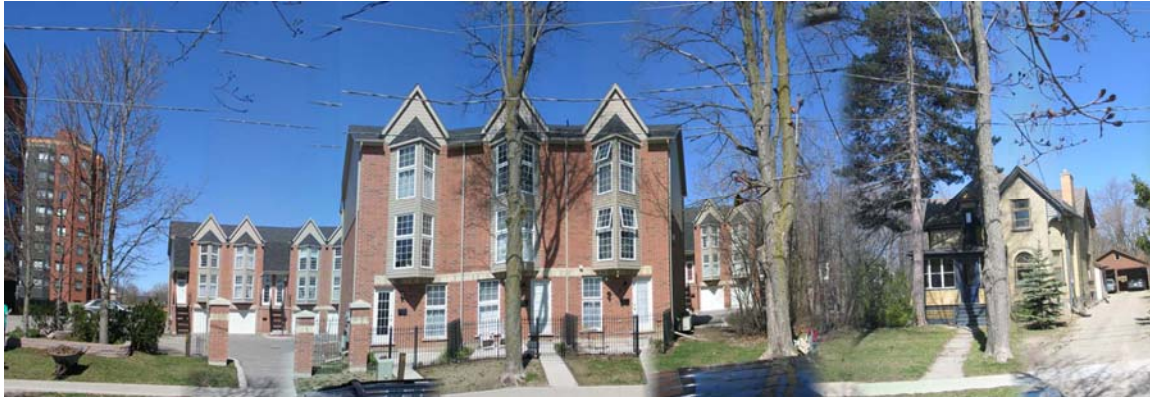
*New Construction at 28 Mansion Street*

**MORE PREFERRED**

The new townhouses at 28 Mansion Street provide a good example of new construction in a Heritage Conservation District that is sensitive to the heritage character of the street. These houses provide an increased density and accommodate the parking of vehicles without having a negative impact on the surrounding buildings. While the form of the new construction is not directly mimicking century old construction, the materials, roof gables, window styles and the building setback from the street are all respectful of the historic precedent in the district.

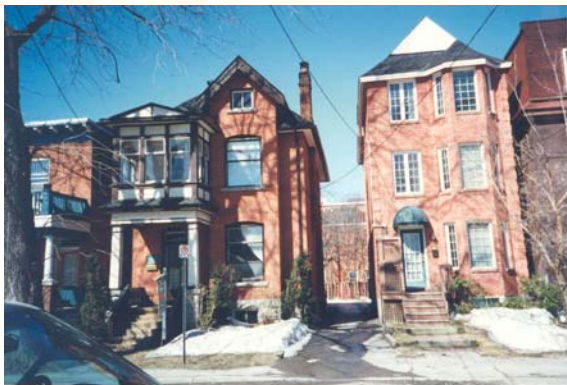
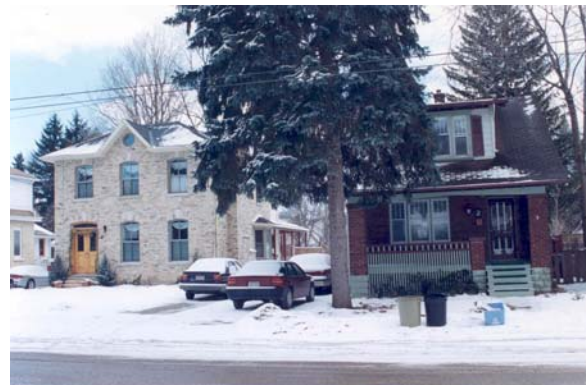
The examples below illustrate new buildings that are relatively compatible with their surroundings with respect to height, mass, material, type of roof and window style and proportion. However, both examples could have been improved through greater articulation on

the front façade or the incorporation of porches or more substantive entrances, in keeping with the adjacent heritage buildings.

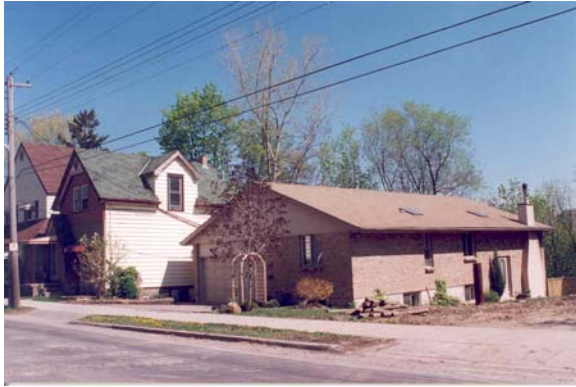
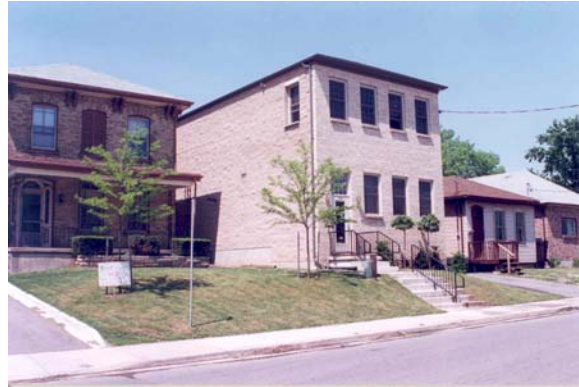
The following examples represent the type of development that is discouraged in the Civic Centre Neighbourhood. While the building setback and selection of materials may be appropriate in both cases, there is little sensitivity to the height, style, scale or detail of adjacent dwellings. In addition, front attached garages as shown in the example on the left, are clearly inconsistent with the streetscape of heritage districts.

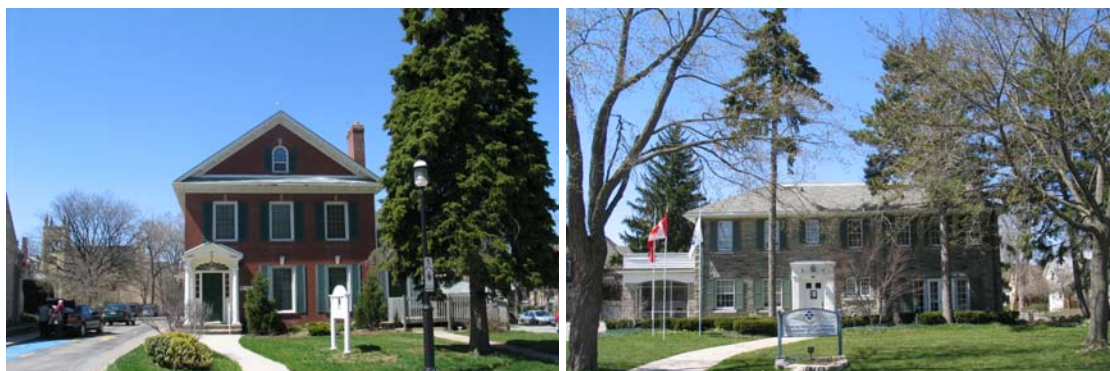
*68 Queen Street North & 80 Queen Street North*

Many of the conversions in the Civic Centre Neighbourhood have been done with appropriate care and sensitivity to the heritage character of the original building. In many cases, the exterior has been preserved intact and maintained in good condition to represent the original appearance and contribution to the character of the street. Minor modifications to the exterior of the front façade allow for the incorporation of identification signage, easier access for clientele and better visual contact with the street through the window openings. Other reasonable changes to the building and site include additions to the rear of the original building and changes to the paving and landscaping to permit additional vehicular access, deliveries and parking.

*MORE PREFERRED*

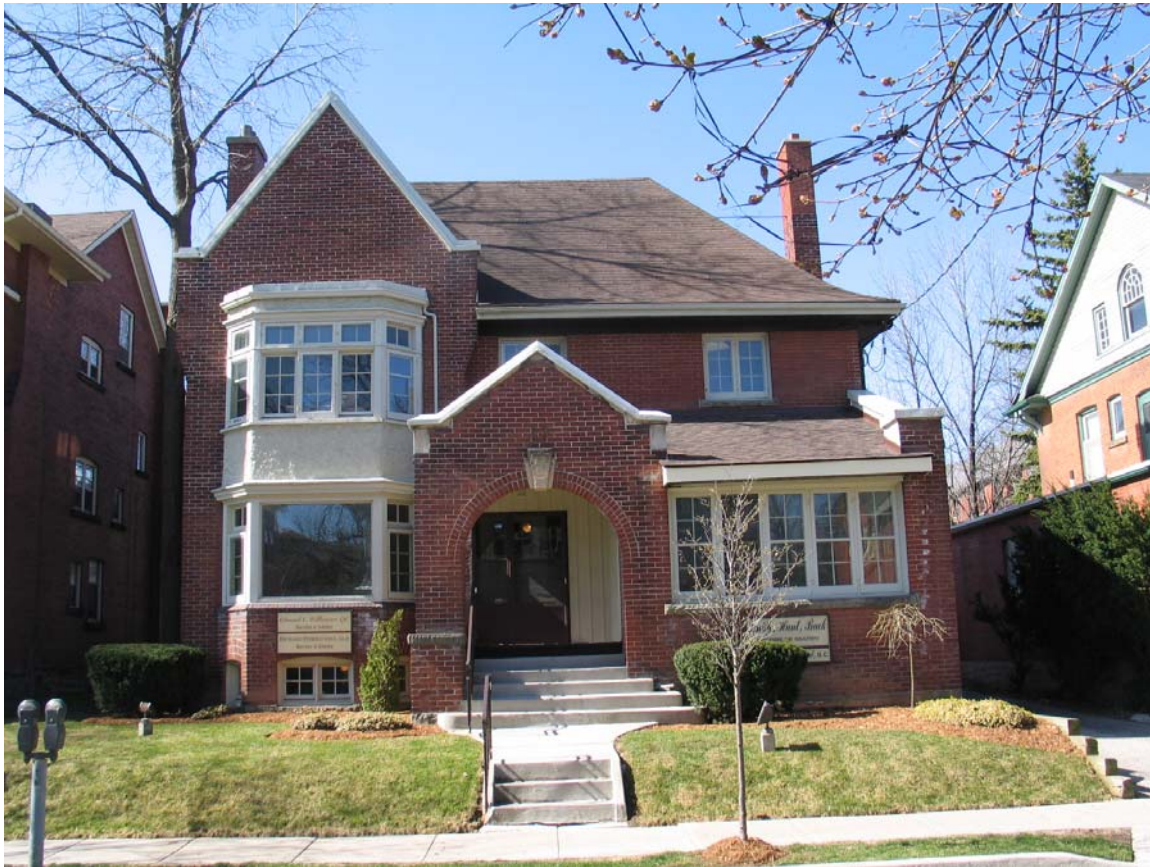
*MORE PREFERRED*      53 Roy Street

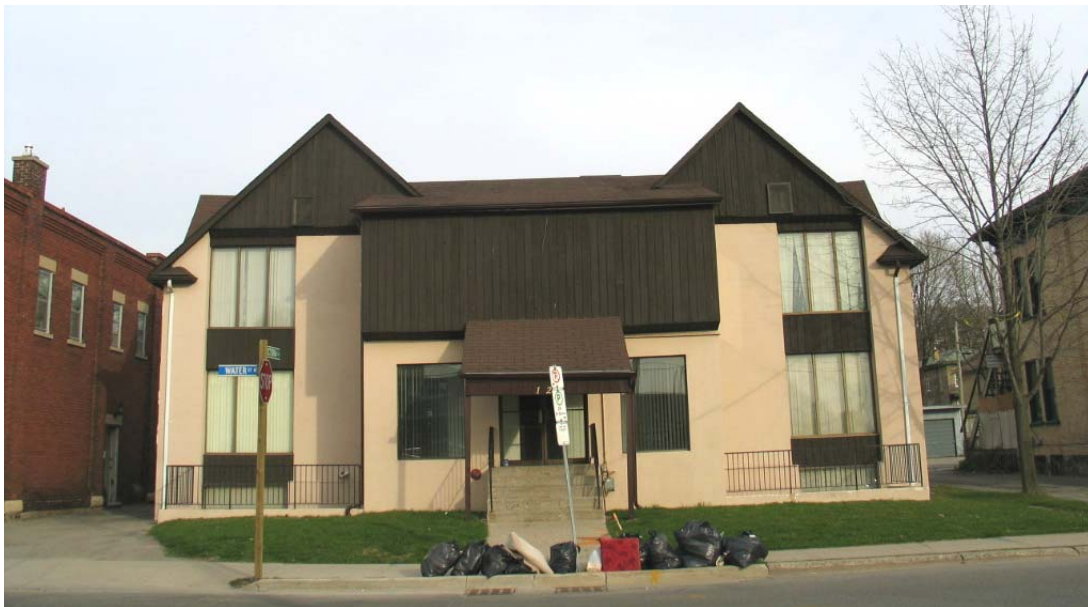
*LESS PREFERRED*      125 Water Street

Some of these conversions have diminished the original architectural character and would have benefited from guidelines for the appropriate preservation of the heritage building stock. Some use very good modern materials and commercial construction practices to “update” the original appearance of the building, but even in the best examples of updating, there remains a basic conflict with the form of the original building showing through as if from behind a mask or ill-fitting costume.
