city of kitchener

# civic centre neighbourhood

## heritage conservation district plan

# CIVIC CENTRE NEIGHBOURHOOD HERITAGE CONSERVATION DISTRICT PLAN

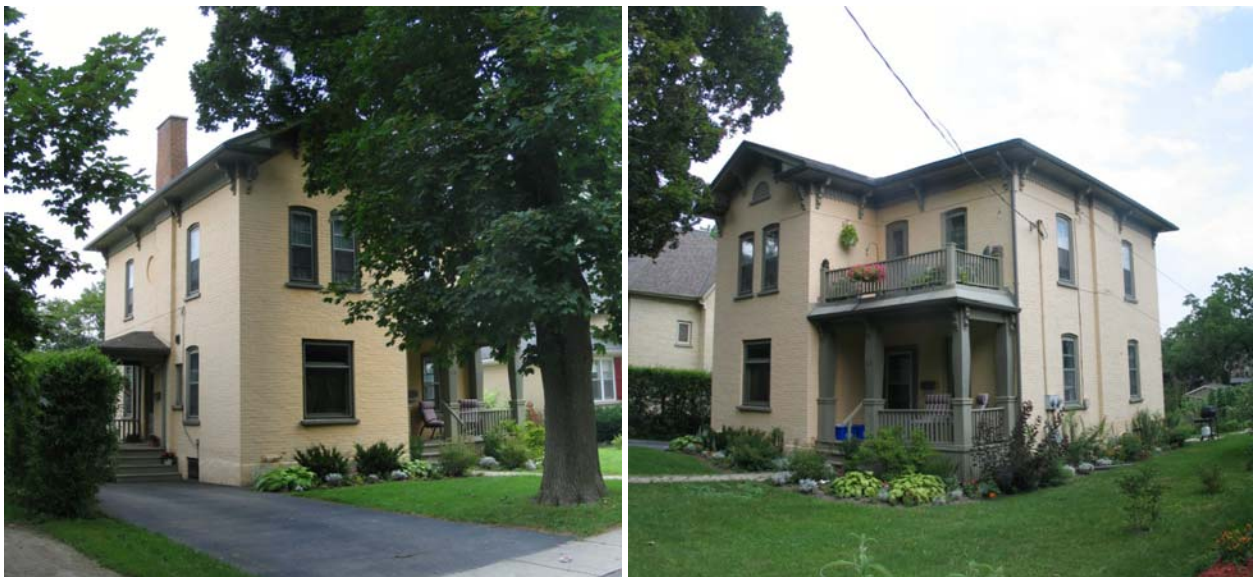
*26-28 Ellen Street West -one building well converted to two residences*

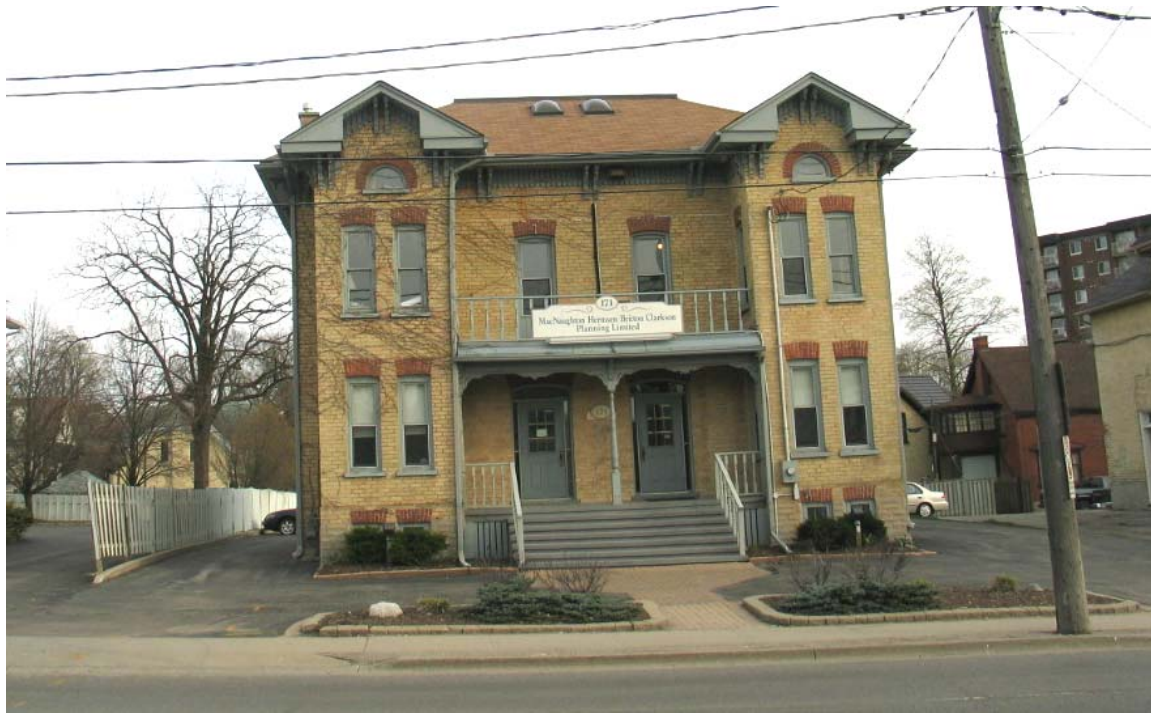
*171 – 173 Victoria Street North*

#### **MORE PREFERRED**

The property at 171-173 Victoria Street includes a large brick building that was probably constructed as a pair of prestigious semi-detached residences. The building is over a century old and dates from the year 1887 from city records. During conversion to commercial use, the building has been well restored to very good condition. The masonry is in good repair and well cleaned to exhibit the contrasting colours of red and buff brick. The decorative wood details in the roof eaves and brackets have either been meticulously maintained or expertly restored to original condition. The decorative wood details for the stairs, porches and railings have been replicated using good skill and judgment in the provision of replacement pieces. The windows

appear to be the original double hung windows, well maintained, or excellent quality replacements. The front doors have maintained the transom window design as a prominent feature of this historic era.

The conversion to commercial use has required paving and landscaping changes to accommodate access and parking. Sympathetic signage has been added to identify the company. The front doors have been replaced with commercially available doors that can withstand frequent use by staff and clientele. This building provides a good example of the quality conversion of residential properties to commercial use.

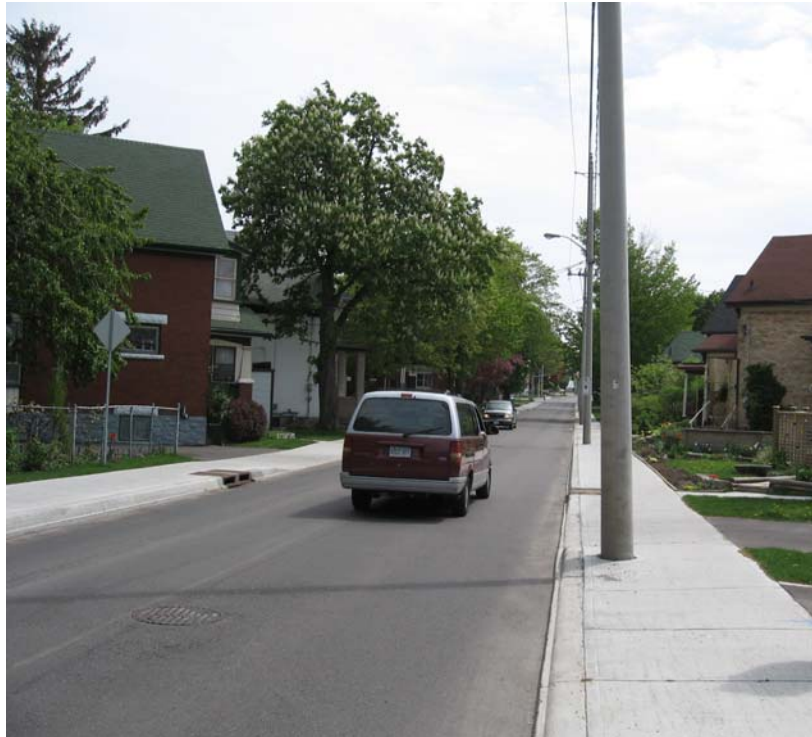
*Lancaster Street, where road reconstruction eliminated the historical boulevard, leaving the streetscape more sterile*

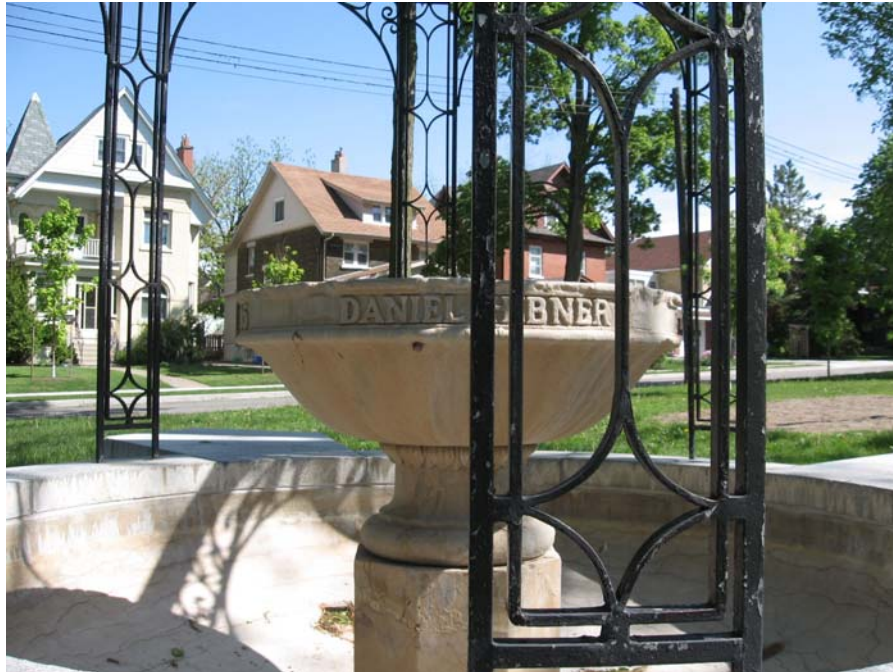
*The fountain at Hibner Park*

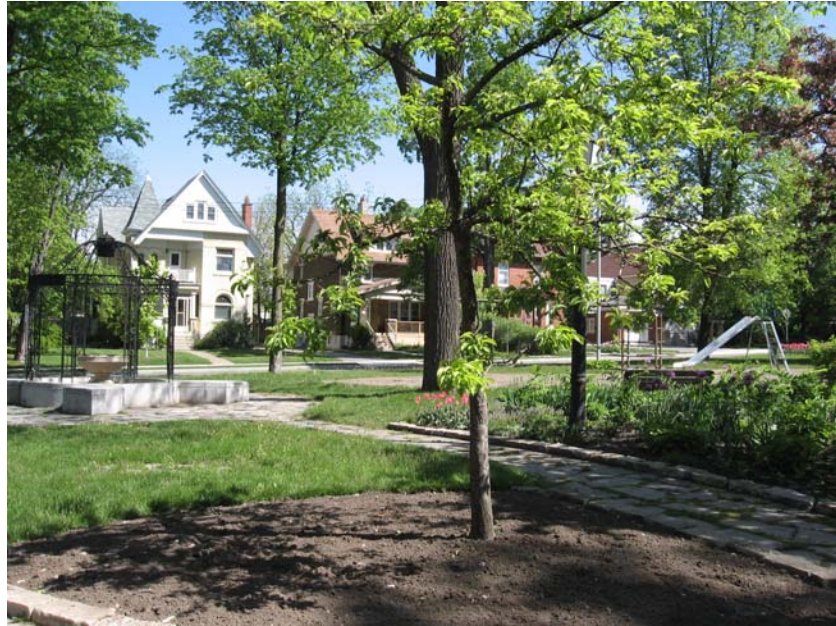
*A view of the mature trees, plantings beds and playground equipment within Hibner Park*

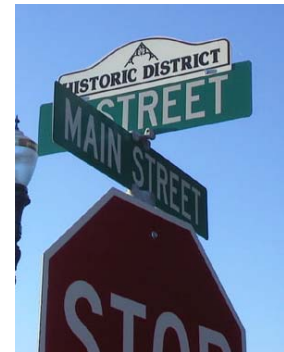
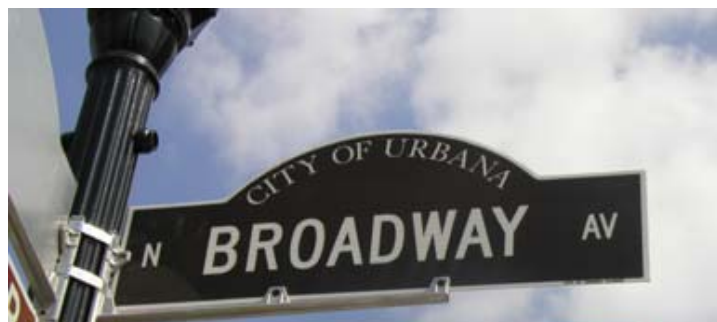
*Examples of street signage used within historic area in other communities*

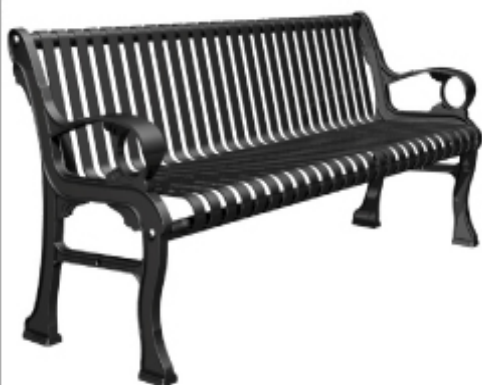
- Ornamental furniture should be coordinated, and if possible sourced from the same supplier in order to achieve economy of scale. A bench such as the MLB 310M bench available from Maglin Site Furniture Inc., finished in black polyester powder coat, made from solid cast aluminum. The MLWR 200-32 trash receptacle and the MBR200 bike rack are also available in the black powdercoat finish, and co-ordinate with the bench.

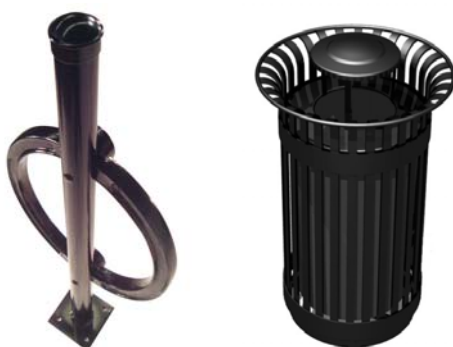
*Recommended Street furniture available from Maglin Site Furnishings Inc.*

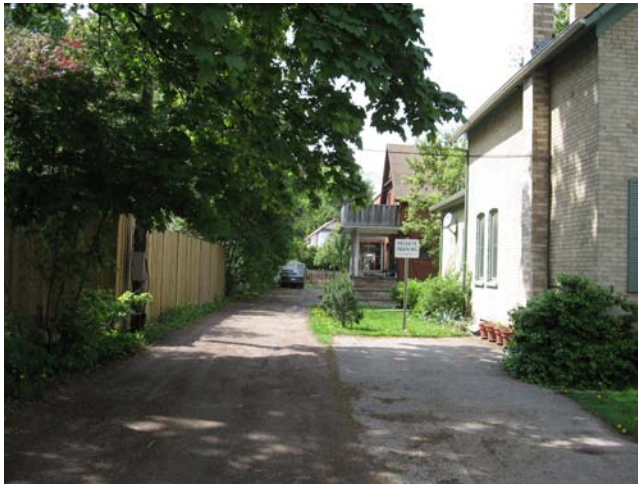
*An example of the intimate scale created on some of the laneways within the area*

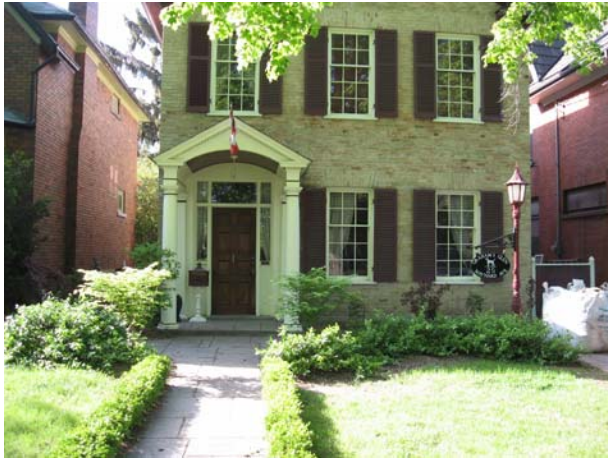
*An example of a common front yard treatment in the area, employing symmetry and emphasizing the front entrance to the home*

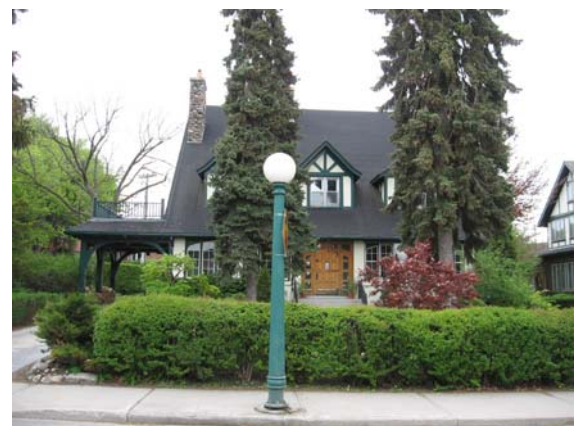
*An example of a well-maintained hedge on Queen Street*

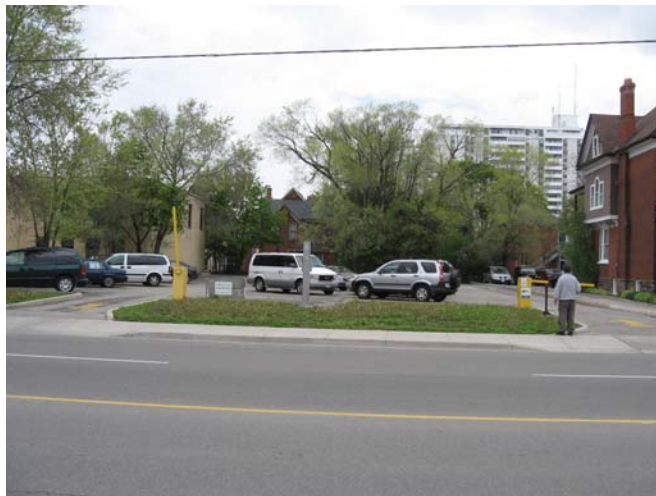
*An opportunity for decorative plantings in front of a parking area on Weber Street*

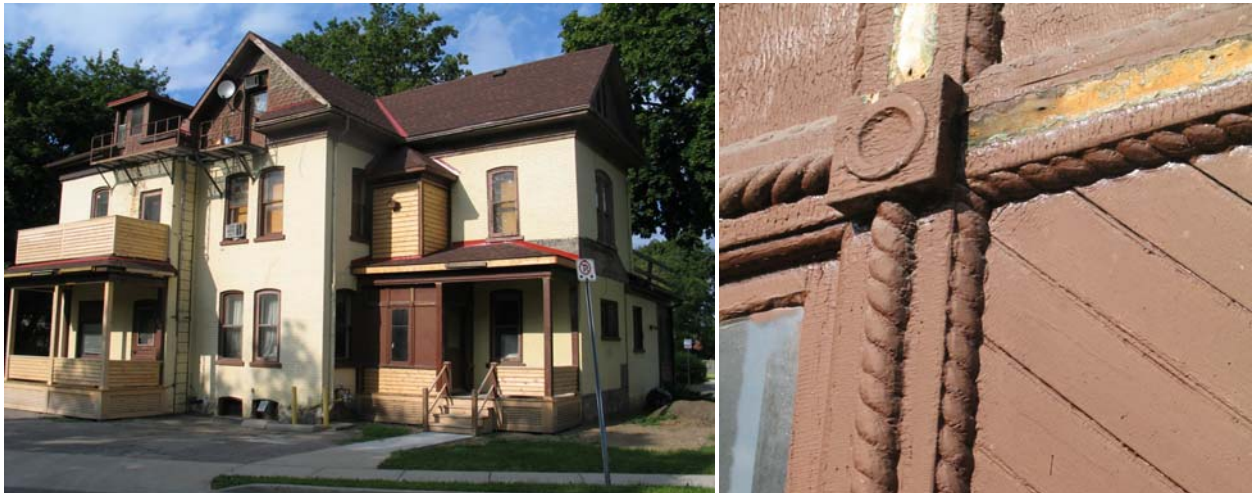
*115 Lancaster Street East - repair of wood trim*

*Deteriorated wood siding and trim is being selectively replaced with similar material, texture and appearance while preserving as much of the original construction as possible.*

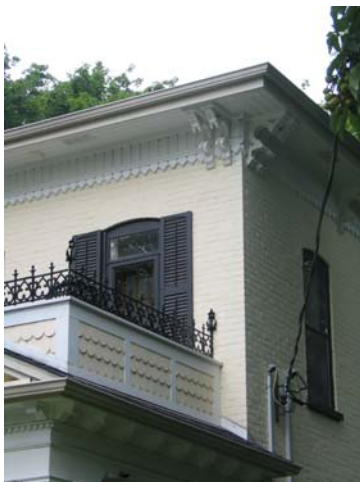
*124 Young Street*

*Well maintained and restored house introduced new, inconspicuous attic vents in soffit of eaves to aid in the removal of moisture build-up and potential moisture problems of mold and rot in the attic space. Current lifestyle choices result in more moisture from showers, dishwashers, clothes washers and cooking than existed when these houses were built and minor changes to the exterior appearance will help to preserve them indefinitely.*

124 Young Street – ventilated soffit

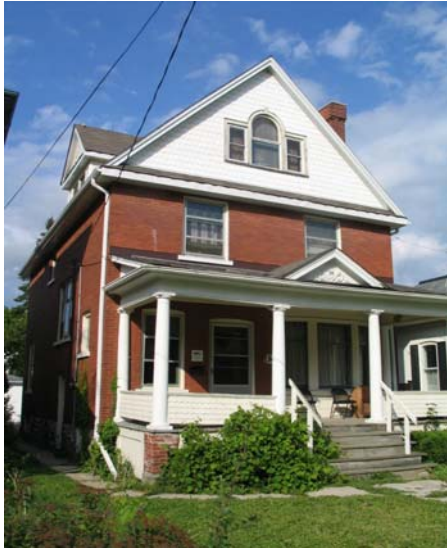
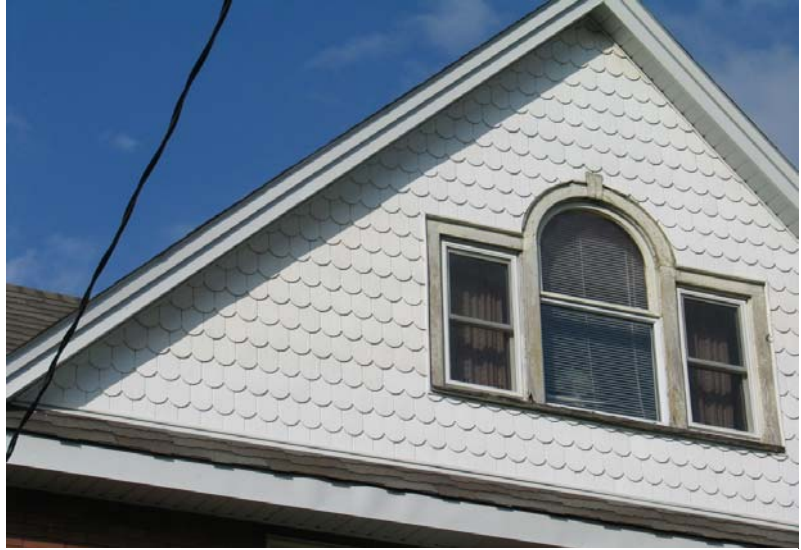
*34 Ellen Street East, replacement of cedar shingles*

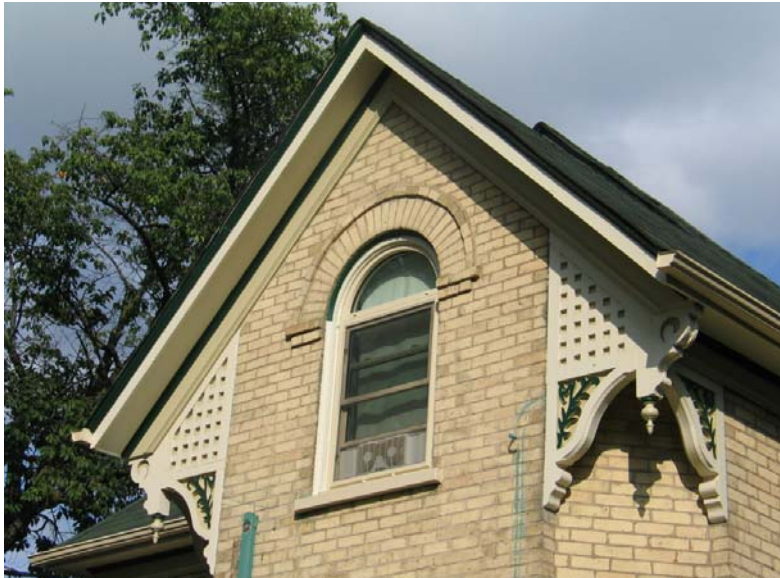
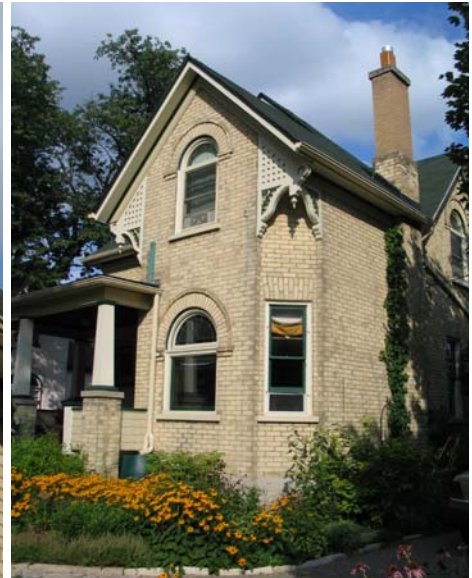
*33 Mansion Street*

*There is evidence that some previous version of the rain downspout from the roof gutter was installed across the face of the decorative roof brace. This error in judgment may have taken place when the house was first built or anytime over the last century, but bad design and technical decisions need not be preserved in a Heritage Conservation District*

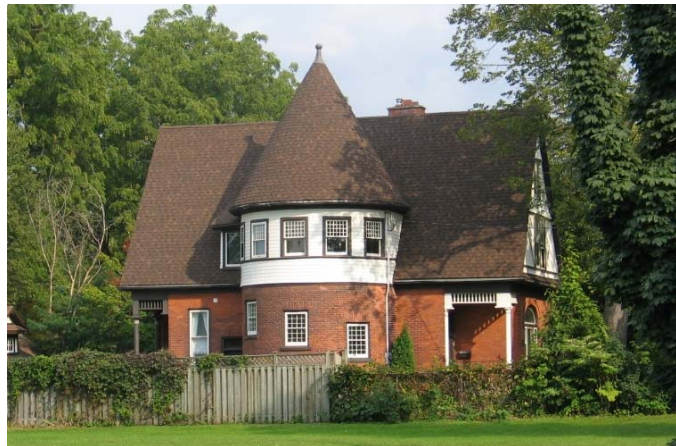
*Example of appropriate, well-maintained roofing material, and colour for heritage buildings*

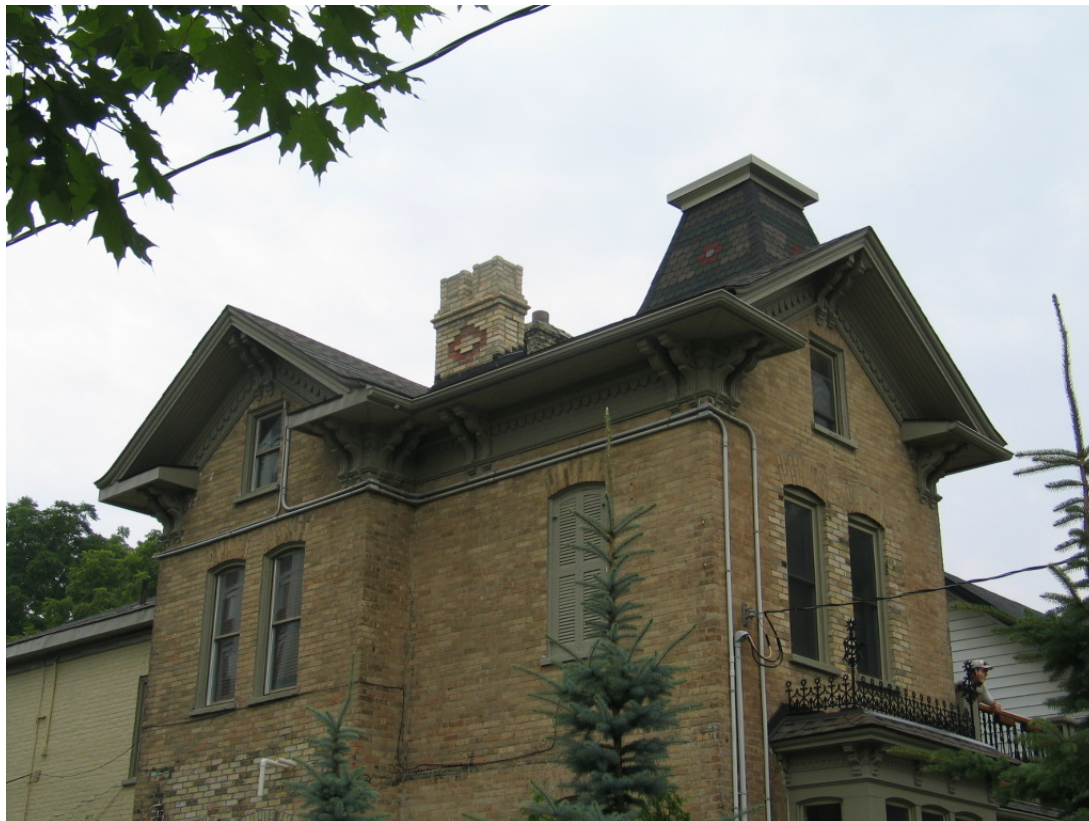
*31 Margaret Avenue -decorative brick chimney missing top courses*

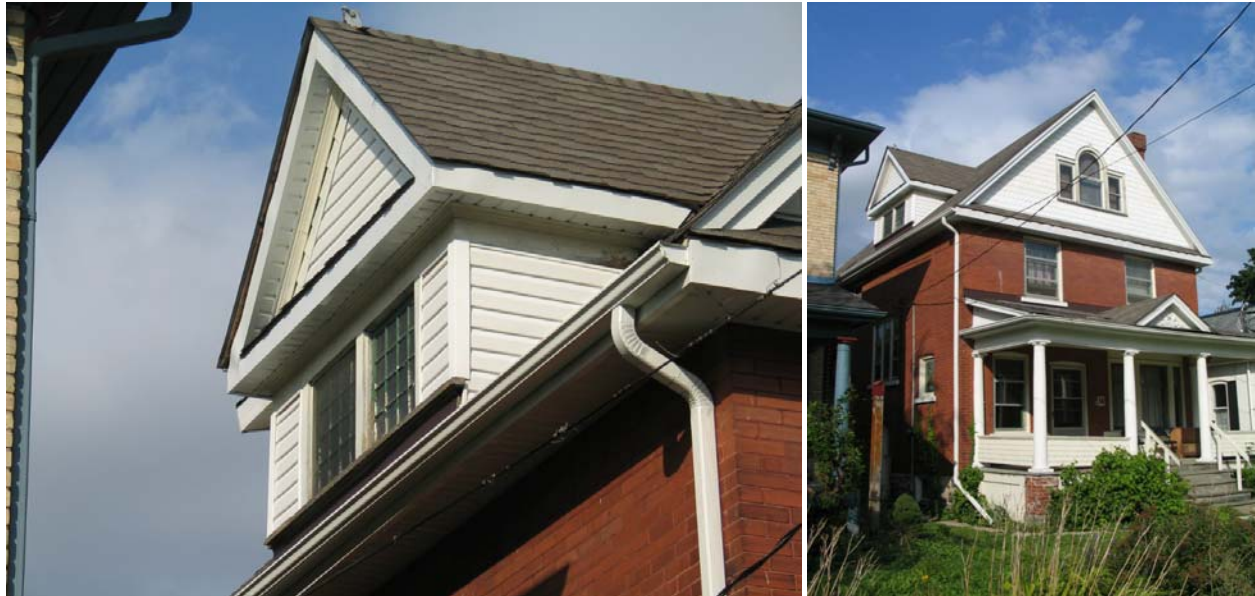
*34 Ellen Street East -Dormer reclad*

The intricate details of wood trim and special shingle patterns are very exposed to weather deterioration in inaccessible locations. In addition, small, intricate roof planes intersect to create additional ridges, hips and valleys that are most vulnerable to snow accumulation and damage from wind scouring. Small, remote rain gutters may also exist that fill with leaves and debris and foster rot. Often, turrets and dormers are constructed with minimum overall exterior wall thickness and roof thickness preventing adequate insulation and ventilation to avoid heat loss and complications of ice damming.

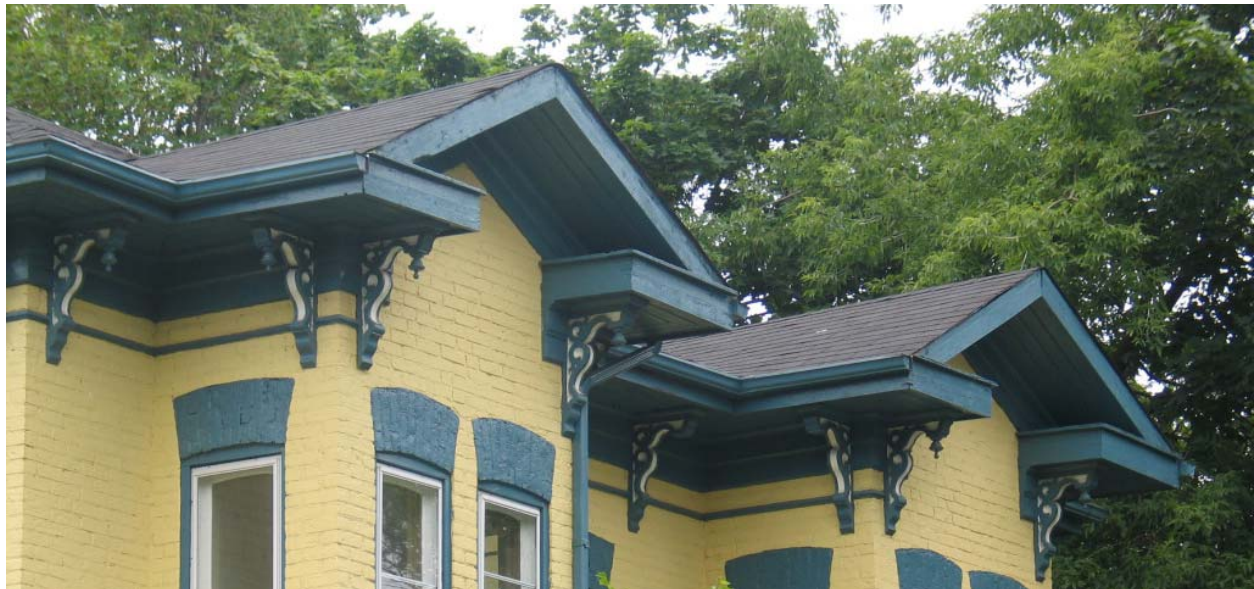
*143 Queen Street North*

Many homeowners have chosen to clad soffits and fascias with prefinished metal or vinyl to cover a host of problems with a brand new guaranteed finished surface. The guarantee is a hollow promise. The cladding system itself is based on the flimsiest of sheet materials dependent on the structural support of the original trim materials underneath. Where the support is damaged, the new finish can cover, but it cannot hide underlying problems, such as rot or physical damage. The soffit itself is generally well protected from weather and hence inclined to be a favoured location for wasp's nests.

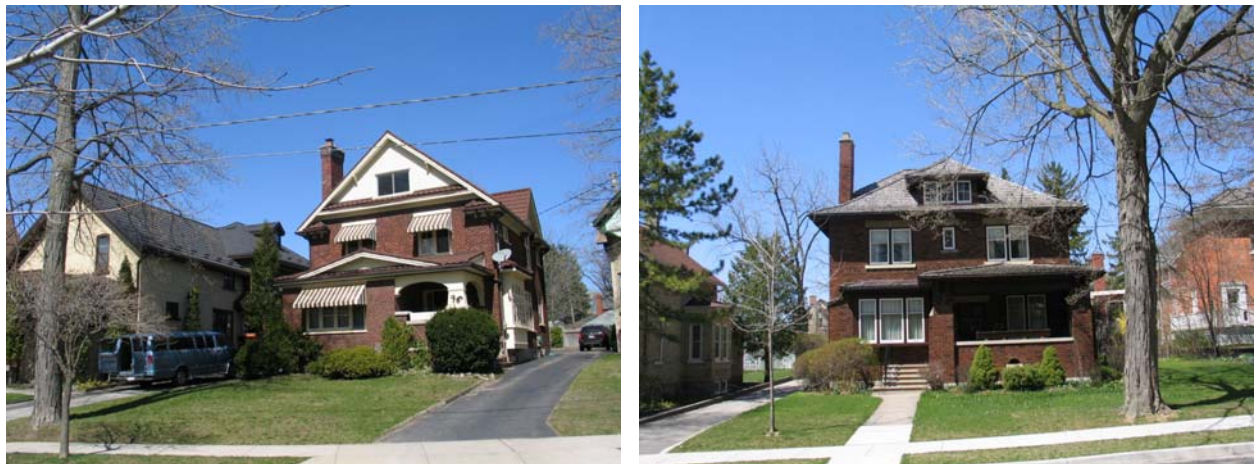
*76 Ahrens & 32 Maynard rugged brick houses from 1917 - 1945*

Most of the early brick dwellings in the Civic Centre Heritage Conservation District (pre 1950) were constructed of “solid” brick, meaning two or three layers or “wythes” of brick formed the structural component of the wall. The concealed wythes were often of less attractive brick that had manufacturing defects or were less well fired. These walls were constructed using one of

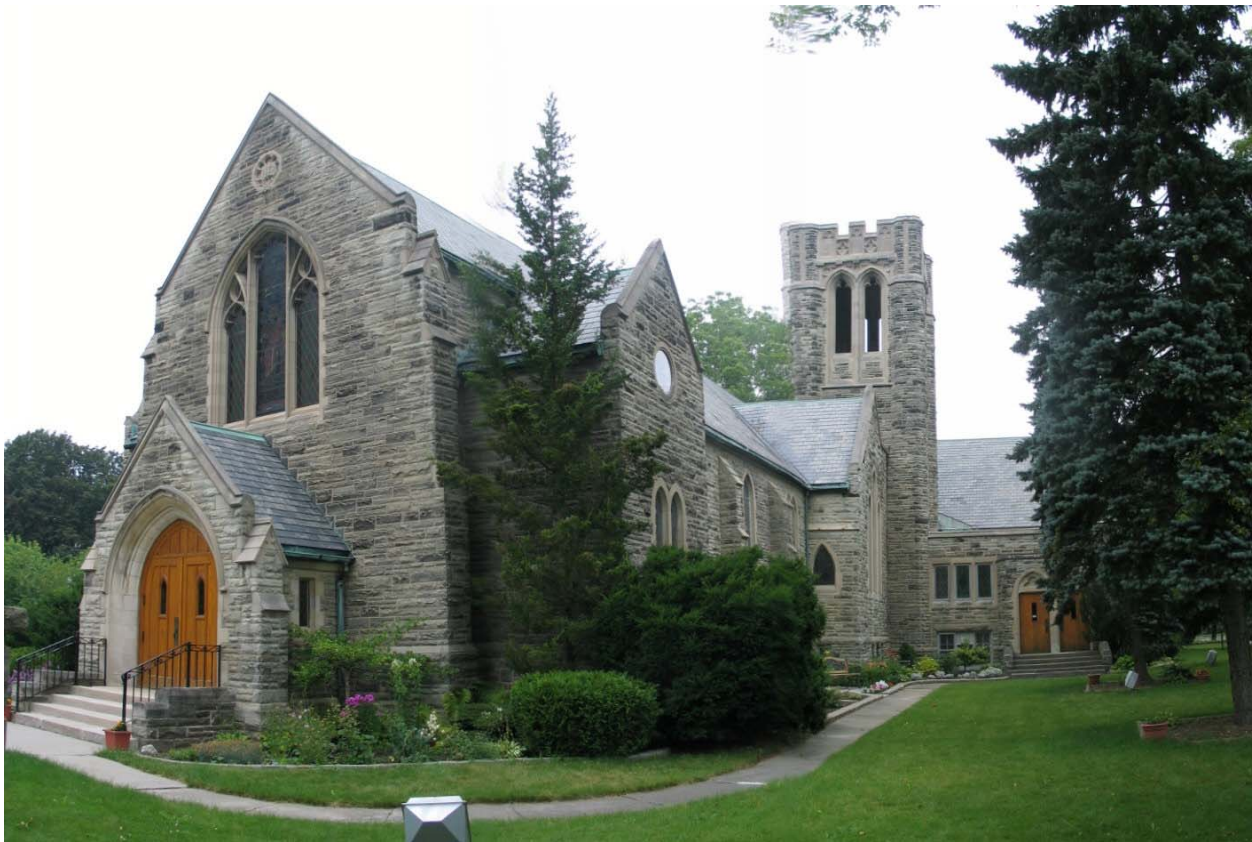
*116 Queen Street North – Stone Church of the Good Shepherd*

The most significant use of stone in the CCHCD is for the church hall of St. Andrews Church on Queen Street, and a little further up Queen Street for the construction of the Church of the Good Shepherd. At numbers 20 and 26 Roy Street, stone veneer and trim was used on two adjacent houses to achieve the appearance of an English Tudor cottage.

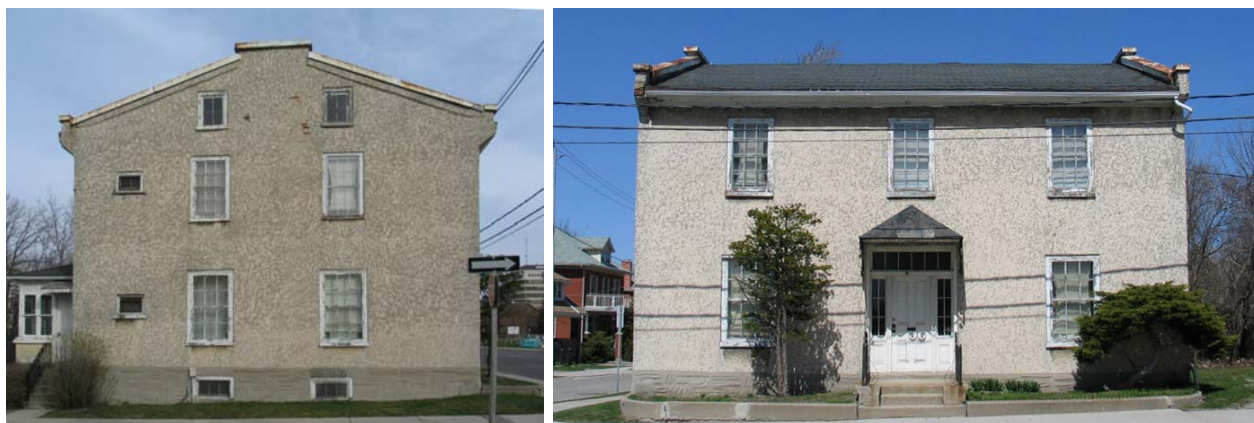
Stucco is a generic term that refers to an applied coating of cement based plaster and finished with one of a variety of textures ranging from smooth-trowelled to coarse-trowelled to spray finish to pebbled and several others. Sometimes the finished texture is then painted with a coloured paint for additional protection and decoration. A number of buildings in the Civic Centre Heritage Conservation District have a relatively distinctive pebble-dash stucco finish.

*74 Weber Street West and side elevation*

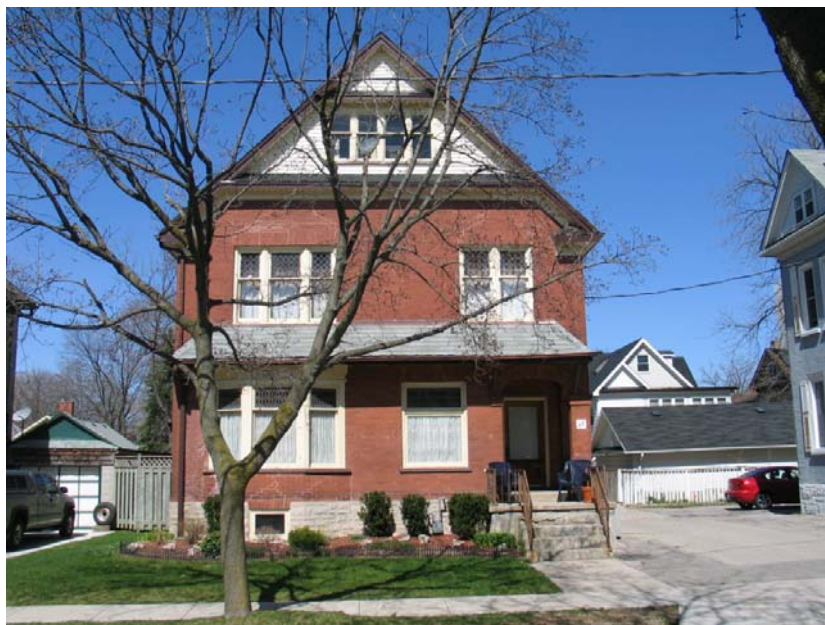
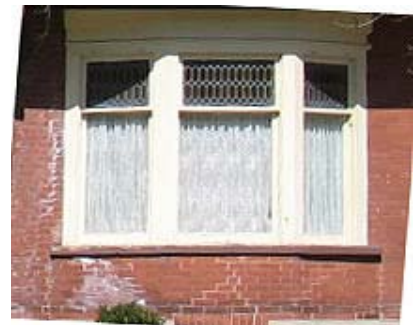
*58 Roy Street – leaded glass panels in upper sash of windows*

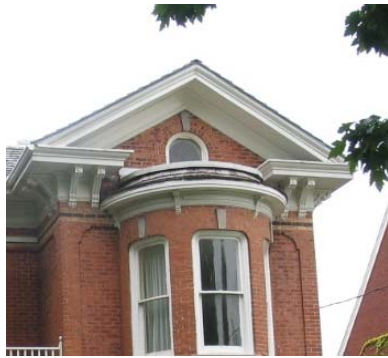
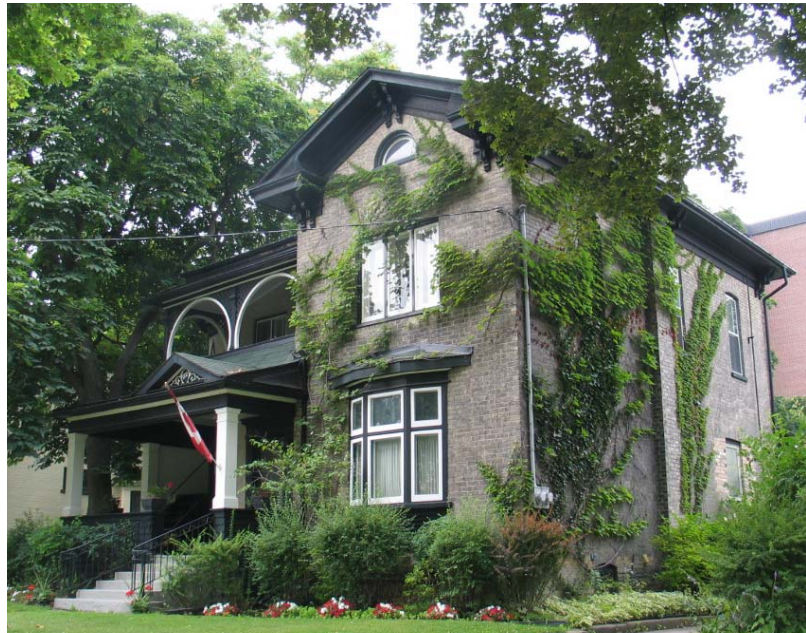
*Examples of decorative trim throughout neighbourhood*
