# Victoria Park – Inventory, Assessment and Project Prioritization

Q23-115 – Report (Phase 1 – Victoria Park Master Plan)

City of Kitchener

March 2025

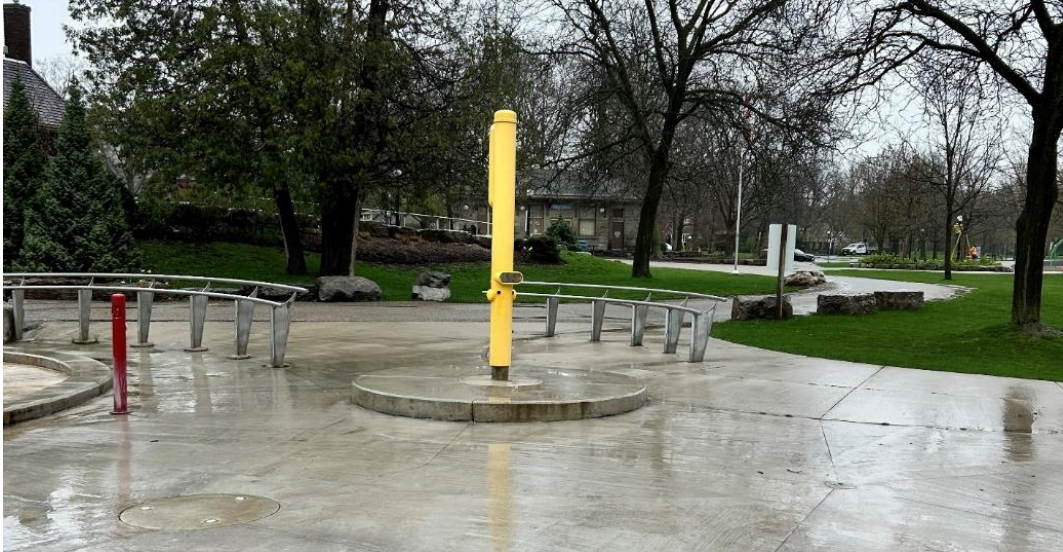
**Figure 1: Existing Above Ground Splashpad Infrastructure Consisting of a Yellow Periscope Feature**

As for the features, many of the elements are dated and functionality was limited to non-existent on some (see photos below). It was determined through conversation that many of the features had been turned off from the manifold due to poor functionality resulting in a general lack of optimal performance. This was determined to be true of both above ground or upright features as well as some of the ground spray elements.

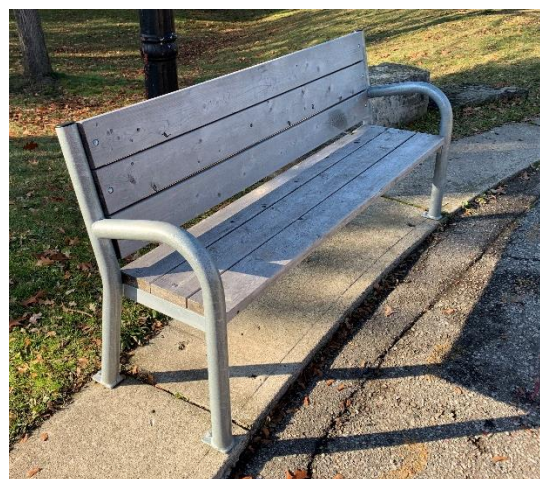
**Figure 13: Robin Galva Frame Bench**

This surface mounted bench is located along the pathways near the playgrounds, although the concrete bench pad and the adjacent asphalt are not flush. The bench consists of a hot dipped galvanized frame and three wood slats for the back and three wood slats for the seat. The bench has metal armrests at either end of the bench and is supplied by Michael's Stabling Developments Inc. The height of the bench is 460 millimetres from finished grade to seat, meeting the minimum accessibility seat height requirement of 46 centimetres.

The paved surfaces surrounding the bench should be flush to reduce the possibility of tripping hazards, especially as the bench is located near the playground and will have children running towards the bench. The asphalt pathway in front of the bench should be raised to create a flush transition between the asphalt and concrete strip that the bench is located on.

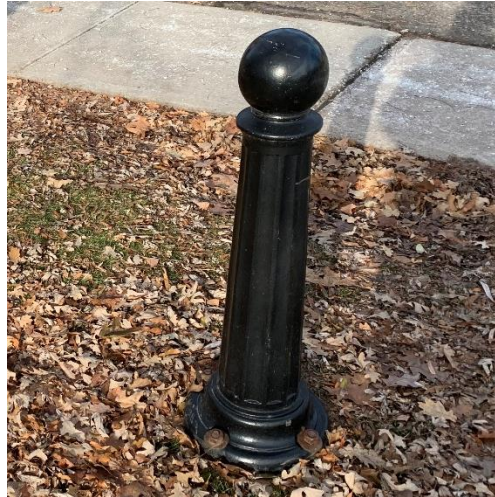
**Figure 18: Fluted Bollard**

with black painted hardware. The bollards are painted black, with some bollards rusting and peeling. The supplier and manufacturer of the bollard is unknown.

It is recommended to monitor the bollards as the structure of the bollard is in good condition. The mounting hardware should be replaced with galvanized steel hardware to prevent further rusting and impact to the structure of the bollard. Over time, the bollards should be replaced to be consistent throughout the park with other bollards and site furnishings, creating a cohesive site furnishing look and feel.

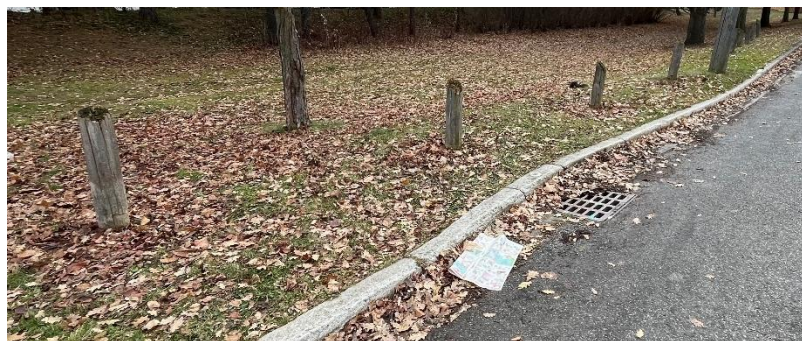
**Figure 21: Timber Bollards**

The pressure treated round timber bollards located along Devon Street are approximately 500 millimetres in height. The bollards are direct buried and have weathered over time.

It is recommended to remove the bollards. They appear to have been used to keep vehicles from being parked on the grassed boulevard before trees were established. To keep vehicles off the grassed boulevard it is recommended to replace the timber bollards with large boulders or armour stone, strategically placed to prevent vehicle traffic and can

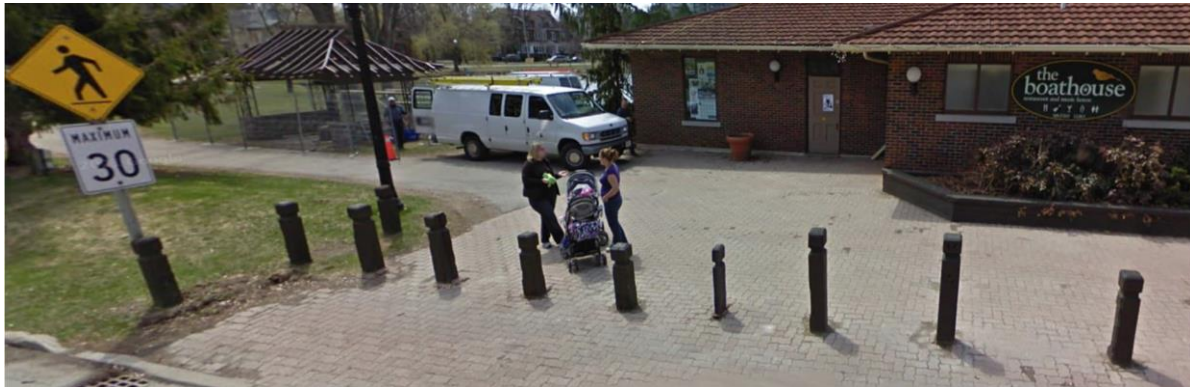
**Figure 23: Timber Bollards at Boathouse April 2009 (Google Streetview Image)**

The bollards have settled over time, leaving the two at different heights. The bollards are remaining from the original timber bollard installations in front of the boathouse prior to 2009. They are no longer providing a functional use in their location and no longer match other bollards within the park. It is recommended to remove the two bollards if there is not a functional reason for their installation at this location.

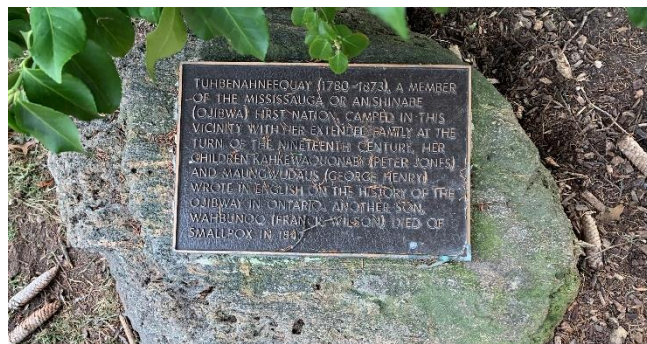
**Figure 25: Tuhbenahneequay Memorial Plaque**

Located on a rock adjacent to the Day of Mourning memorial between the pavilion building and Bridge #1117 (bridge near the canoe monument), a plaque has been installed to recognize Tuhbenahneequay, her life and her connection to the park at the turn of the nineteenth century. The plaque is not integrated into the park, and it easily goes unnoticed along the pathway as it is located low to the ground on a large boulder, adjacent to a shrub.

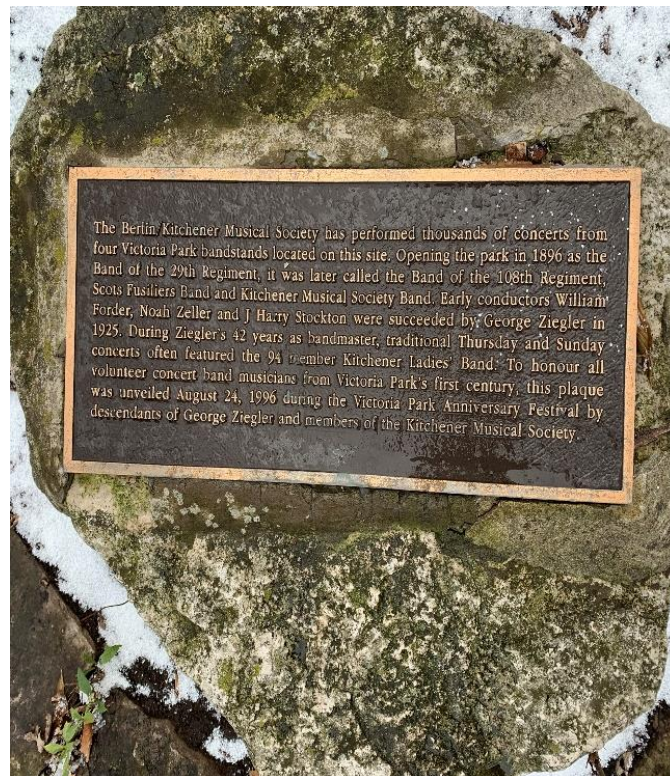
**Figure 27: Berlin Kitchener Musical Society Plaque (2023)**

A plaque has been installed commemorating the Berlin Kitchener Musical Society, located on a larger boulder adjacent to the Kitchener Rotary Band Stand on Roos Island. The bronze plaque has been replaced with an aluminum replica of the original bronze plaque that was vandalized. The plaque is clearly visible as visitors approach the band stand and the surrounding gardens, although the plaque could be emphasized through the addition of vegetation to draw the eye to the area.

The plaque has been incorporated into the updates completed on Roos Island in 2024, allowing for clear visibility within the garden as you approach the band stand. The rock that the plaque is located on has also been cleaned during the Roos Island renovations. The plaque was replaced in 2024 with a non-bronze plaque after it was stolen. If salt is used on the pathways on the island, it increases the probability for the plaque to be damaged. Raising the plaque can increase the legibility and allow for all users to easily read the sign. The increased height of the plaque also allows for plantings to be located around the base of the plaque and provide enhancement opportunities for the garden creating year-round interest through colour and texture.

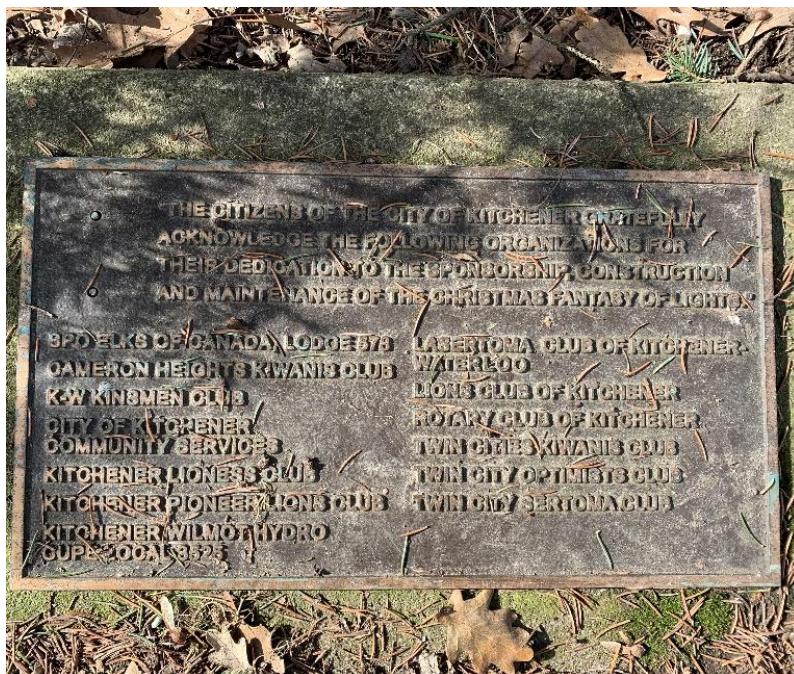
**Figure 30: Christmas Fantasy of Lights Plaque**

The City has added a commemorative plaque to acknowledge the organizations that have continually contributed to the construction and maintenance of the Christmas Fantasy of Lights. The plaque is located on a small concrete pad under a coniferous tree across the road (Jubilee Drive) from the Boathouse, along Jubilee Drive. The bronze plaque consists of a black background and faded gold trim and text.

This plaque is the most hidden plaque due to its location under a coniferous tree. The plaque is regularly covered in pine needles, leaves and debris reducing the chance of it being identified. When a commemorative plaque is installed, it should be easily seen so the individual(s) are properly recognized by the community. Each plaque should be in an area that is relevant to the person, organization or event that is being recognized. The plaque should be in an area that is regularly used for the Christmas Fantasy of Lights event, to connect and provide recognition in an area that displays the holiday lights.

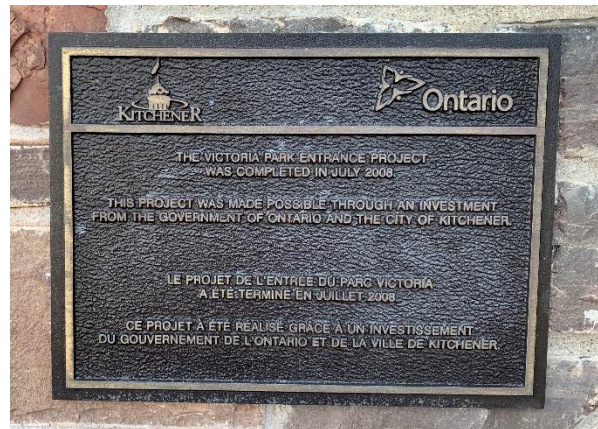
**Figure 32: Victoria Park Entrance Project Plaque**

The stone entrance feature at the Gaukel Street entrance welcomes visitors to the park and has a memorial plaque installed on the stone facade. The bronze plaque is black with a gold border and gold text commemorating the completion of the park entrance in July of 2008.

The plaque does not require maintenance or replacement at the time of inspection. It is built into the stone entrance feature and is clearly visible as you enter the park off Gaukel Street. It can be monitored in the future to ensure regular maintenance is addressed, reducing the chance of damage or full replacement in the future. If other plaques within the park are updated, it would be recommended to update this plaque to ensure consistency throughout the park.

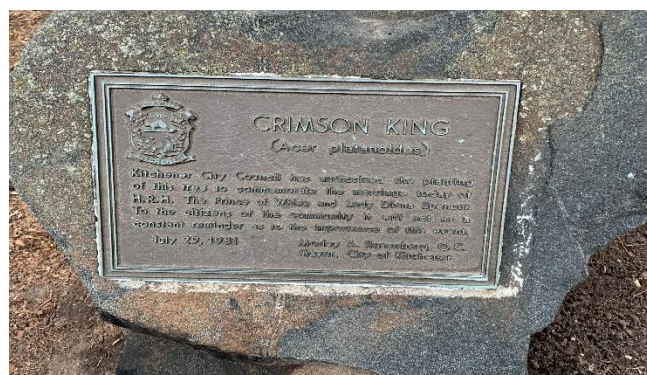
**Figure 33: Crimson King Plaque**

The Crimson King plaque is located on a large stone located under a crimson maple tree located to the northeast of the Boathouse and across the pathway from the Decorative Pavilion (pergola 1 in the Building Condition Assessments) The bronze plaque embedded in the stone is dedicated to the marriage of H.R.H. The Prince of Wales and Lady Diana Spencer.

Located on a large stone under a Crimson Maple tree, the plaque is located off the ground reducing the chance of salt damage from the trail. The overall plaque is difficult to read due to the size of the font and the height of the plaque mounted on the stone. To enhance the message of the 'Crimson King', the area around the plaque and tree could incorporate crimson maple leaves printed into the pathway or printed onto a commemorative plaque made of formed aluminum or galvanized steel through laser cut or engraving.

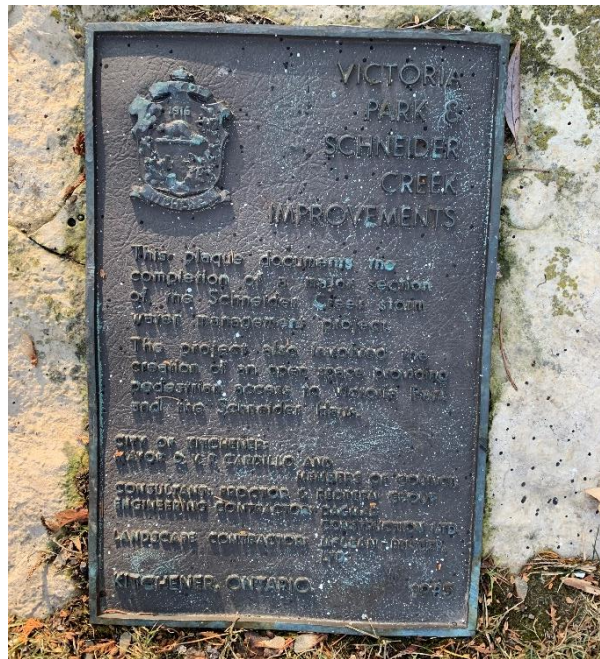
**Figure 35 Victoria Park & Schneider Creek Improvements Plaque (December 2023)**

Located near the intersection of Roland Street and David Street is a bronze plaque documenting the completion of a major section of the Schneider Creek stormwater management project in 1985. The plaque location is not clearly visible due to the height level and location adjacent to the pathway. The plaque was stolen in late 2024 and has not been replaced.

stormwater infrastructure. The plaque should be replaced with material that is less desirable for theft and vandalism resistant.

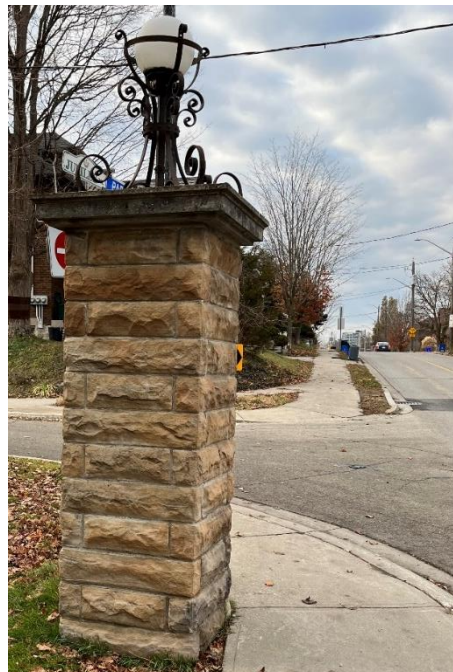
**Figure 41: Entry Feature at Jubilee Drive and Devon Street**

At the intersection of Jubilee Drive (where it changes to Park Street) and Devon Street there are two 12-course high rock face natural stone entrance piers built on concrete footings. The two stone entrance piers are in good condition with minor damage to the bottom of the eastern pier. The concrete coping stone on each of the entrance piers appears weathered but are still in good condition. The globe light with decorative metal base affixed to the top of the concrete cap appears to be weathered slightly. The stonework and jointing of the entrance piers is in good condition.

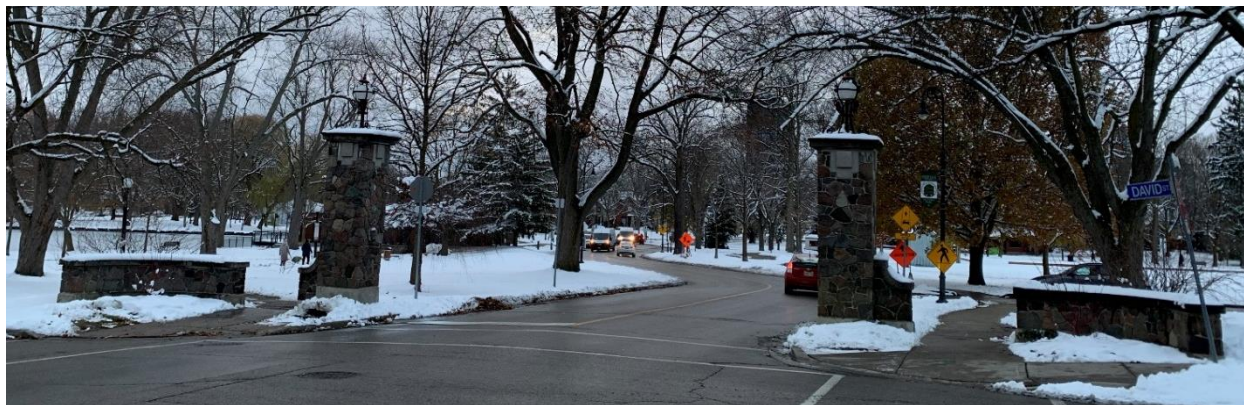
**Figure 42: Jubilee Drive and David Street Entrance Features**

The two stone piers at Jubilee Drive and David Street are key features at one of the main entrances into the park. This is also one of the busiest vehicular entrances to the park. These stone mosaic piers have detached curved knee walls with elevated foundations. A pedestrian sidewalk runs between the piers and the knee walls, complemented by surrounding plantings. Each mosaic pier displays four concrete signature stones—one on each side below the concrete cap—and is topped with a concrete coping stone fitted with a globe light on a decorative metal base. On the interior side of the piers, adjacent to Jubilee Drive, a small metal eyehooks, a small metal eyehook on each pier likely once secured a string or chain barrier to restrict vehicular access. Evidence of past restoration, such as repointing, is visible on the piers and knee walls; however, multiple sections of the curved knee walls show missing mortar between the capstones and the wall. Furthermore, the placement of the piers relative to vehicular traffic creates a blind spot that poses a hazard to pedestrians crossing Jubilee Drive.

The general recommendation is to raise the foundations above grade for each structure, to better mitigate salt and ice related deterioration, while ensuring overall character is maintained. This recommendation should be applied when replacing the existing structures or adding new ones in the future. Additionally, annual inspections are advised to monitor mortar degradation and damage caused by salt or vehicular impacts, with assessments ideally conducted in late spring to identify any winter-related damage from salt or snowplows. Finally, the coping stone on the fourth structure at the Joseph Street entrance should be reinstalled immediately to prevent further deterioration and eliminate safety hazards related to potential detachment.

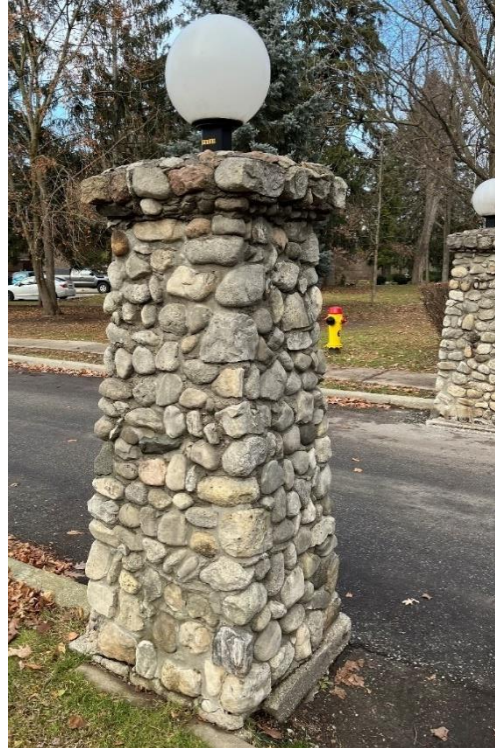
**Figure 43: Entry Feature at Schneider Avenue**

At the Schneider Avenue connection to Victoria Park there are two fieldstone veneer piers built on concrete foundations. The piers appear to have been constructed prior the road and curb installation as the curbs have been cast around the piers. The width of the road is also reduced between the piers as they are situated partially within the asphalt roadway, indicating they were installed prior to the current road installation and configuration. As a result, the clear width of the road is not wide enough for two vehicles to comfortably fit between the piers. The width of the roadway on the park-side is less than the width of the road on the residential side of Schneider Avenue creating a bottleneck between the piers entering and exiting the park. Adjacent to the piers is one electrical cabinet inlaid near the base, the integrity of the electrical components is unknown at the time of inspection. On the interior roadside of the piers is one metal ring per pier that appears to have been used to attach a string or chain barrier to restrict vehicular access to the park from Schneider Avenue. On the top of each pier, affixed using base plate and bolts is a large globe light. The globe lights are affixed to the cap of the pier that is fabricated using fieldstones. The

fieldstones are installed using a similar method to the rest of the pier structure. The piers have evidence of restoration through repointing.

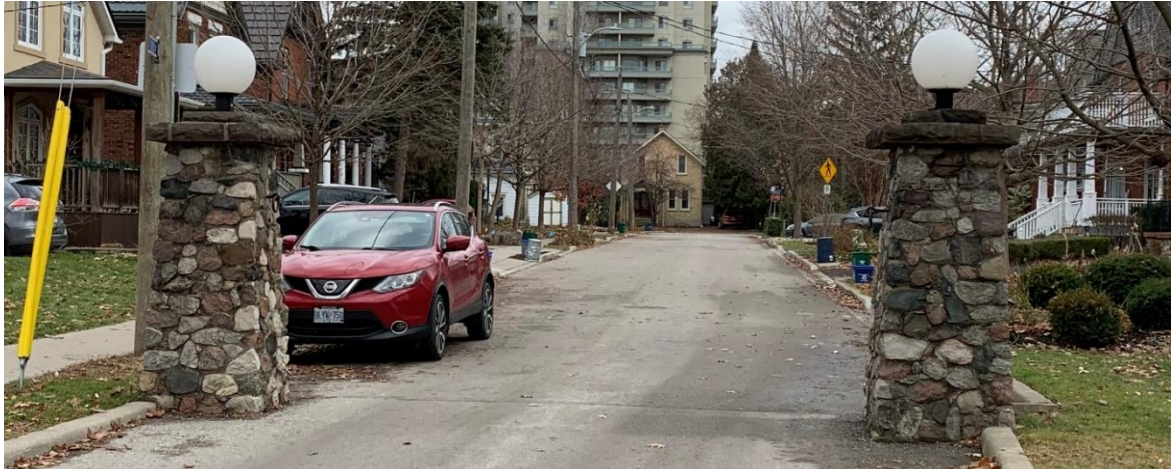
**Figure 44: Entry Feature at Dill Street**

The entrance at Dill Street includes two split-face fieldstone veneer piers on concrete foundation flush with asphalt paving. The piers have been constructed prior to the road reconstruction resulting in the curbs being cast around the piers and the width of the road bottlenecked between the piers as they are situated partially within the asphalt roadway. Due to the roadway narrowing between the piers, it is not wide enough for two vehicles to fit between the entrance piers. On the interior side along the roadway, each pier has a metal ring that appears to have been used to attach a string or chain barrier to restrict vehicular access to the park from Dill Street. The top of the structures have one large globe light per pier that is affixed to the sandstone cap using base plate and bolts. The cap is constructed using limestone blocks, filled with concrete and topped with a limestone piece where the light is bolted to. There is evidence of past restoration through repointing.

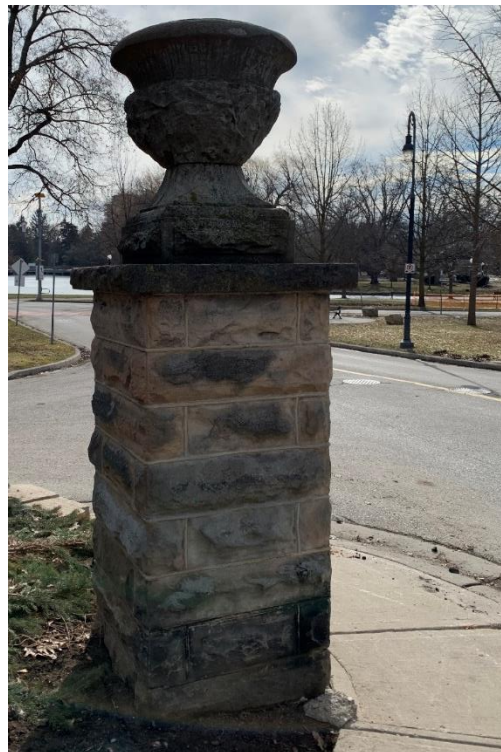
**Figure 45: Entry Feature at Jubilee Drive and Water Street**

Where Water Street connects to Jubilee is a busy intersection into the park with an abundance of traffic that flows through the park at various times throughout the day. The connection consists of two rock-faced limestone brick veneer piers that are eight courses high. The piers have a concrete coping stone with decorative planters situated atop that are planted seasonally. The piers have embedded footings and convex joints.

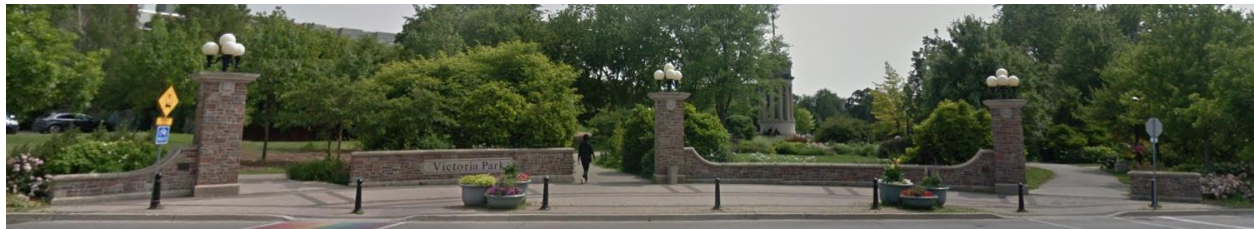
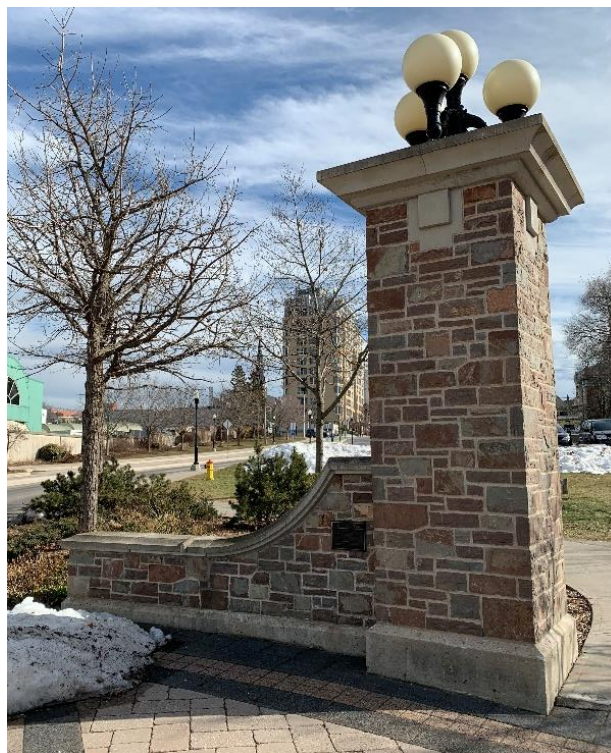
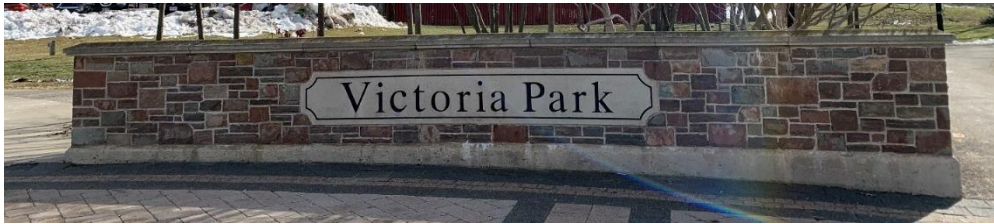
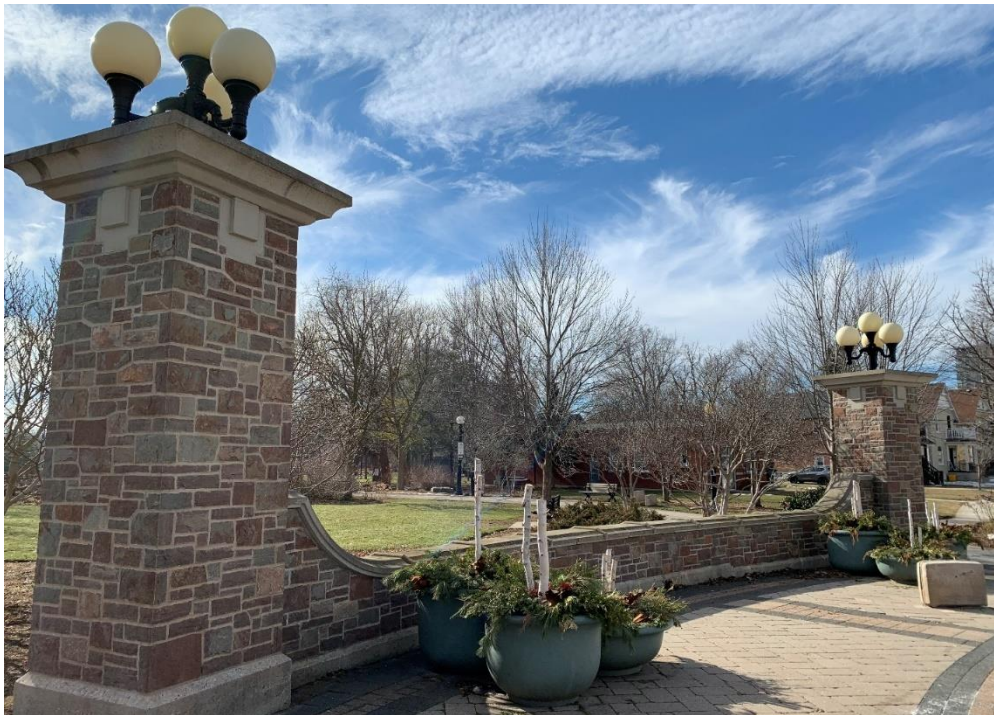
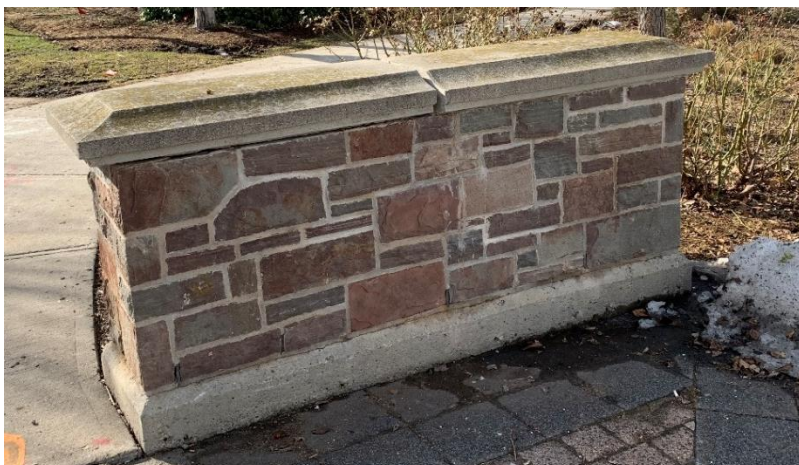
The Joseph Street park entrance is the largest entrance feature throughout the park, and it is for pedestrian access only. The feature consists of four natural stone piers and walls. The southeast entry pier and knee wall has a coping stone, sloping up to the pier on the west side. To the west of this, there is a waist-height wall with coping stone and a concrete inlay for “Victoria Park” along the street frontage. Further to the west, there is a knee wall with one pier on each end and a sloped coping stone connecting these on either end. The fourth feature of the Joseph Street entrance located furthest to the west is a knee wall with a coping stone. While at the time of our investigation the stone was still on the wall, it appeared to be dislodged, creating a likely safety hazard. The top of each pier has four signature stones, one on each side.

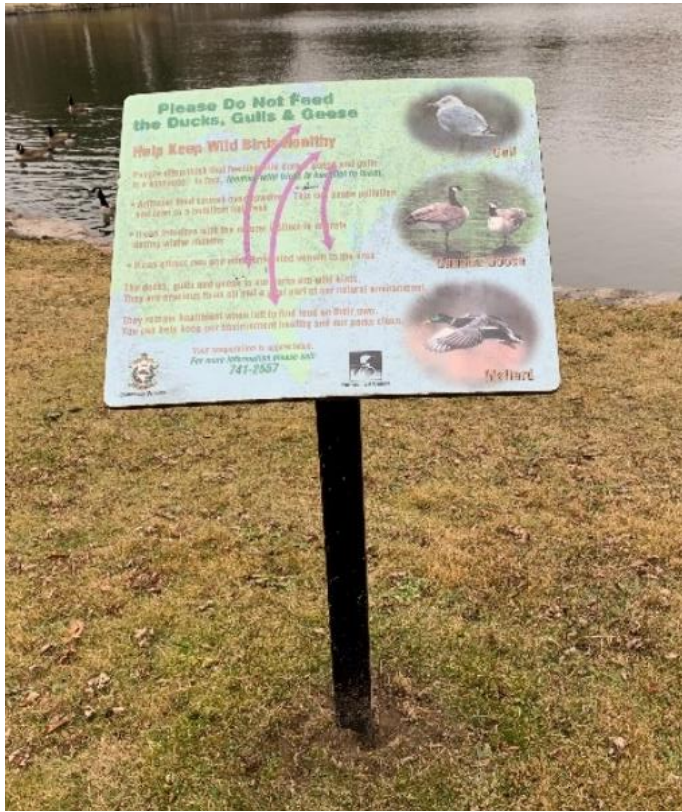
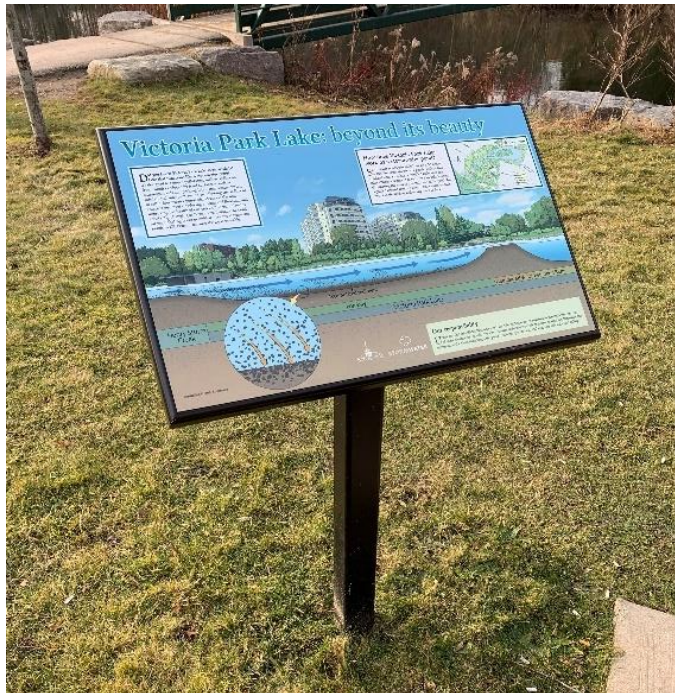
Victoria Park has multiple information signage located throughout the park that consists of an infographic sign mounted at a 45-degree angle on an embedded steel post. The information signage includes signs for *Please Do Not Feed the Ducks, Gulls & Geese*, and *Victoria Park Lake: Beyond Its Beauty*.

The signs are in good condition. Accessing the signs can be difficult over the grass as there is not a direct accessible path that is directed towards the signs. As a result of the signs located off the path, it is recommended that an accessible path be provided so that all users can access the signs.

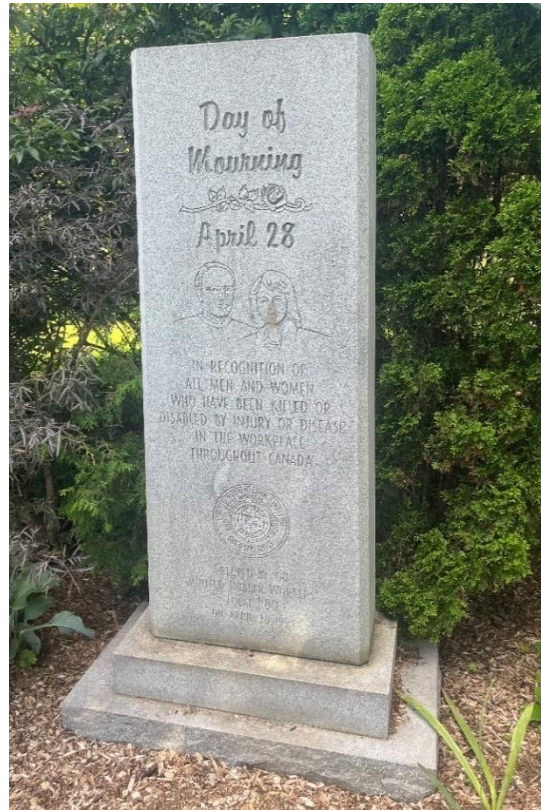
**Figure 53: Day of Mourning Monument**

The Day of Mourning stone monument was installed on April 28, 1993, by the United Rubber Workers Local 80, in recognition of all men and women who have been killed or disabled by injury or disease in the workplace throughout Canada. The stone monument is surrounded by vegetation at the corner intersection of a main pathway through the park between the pavilion building and bridge number 1117 (bridge located near the canoe memorial).

The Day of Mourning stone monument is in good condition and is easily visible. The garden around the monument should be improved by augmenting the planting varieties for all-season interest through colour and textures. The stone monument should be cleaned periodically to ensure a longer lifespan of the monument.

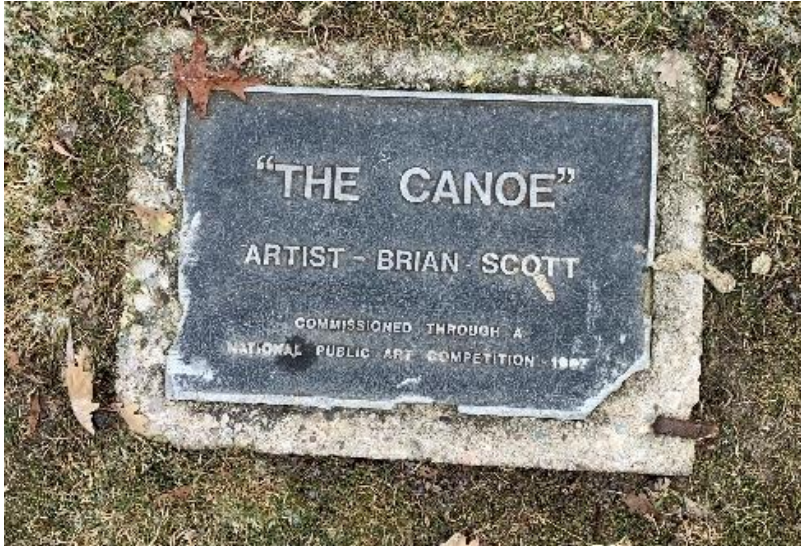
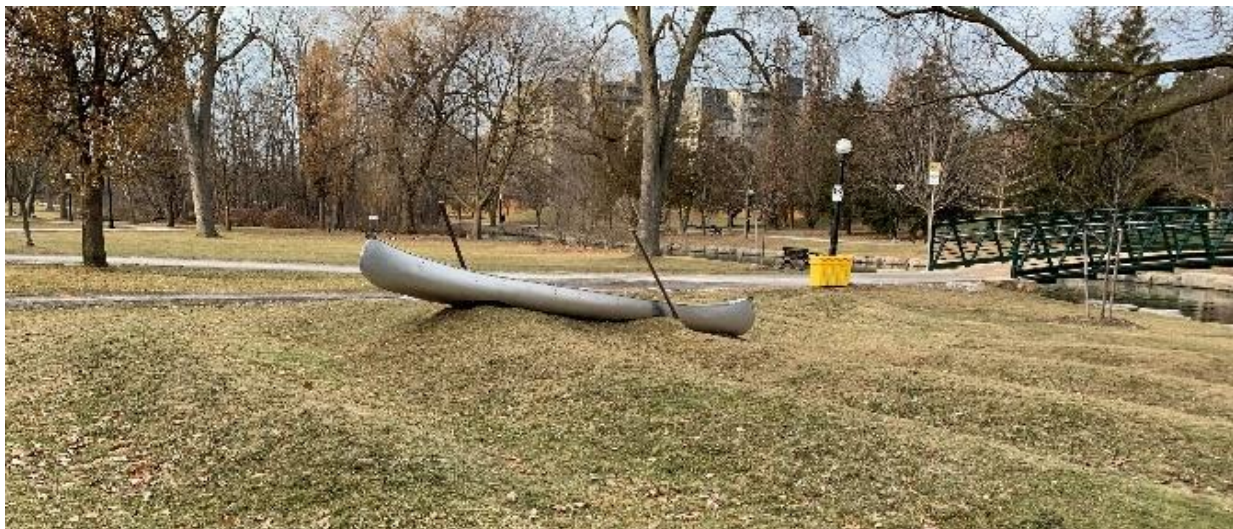
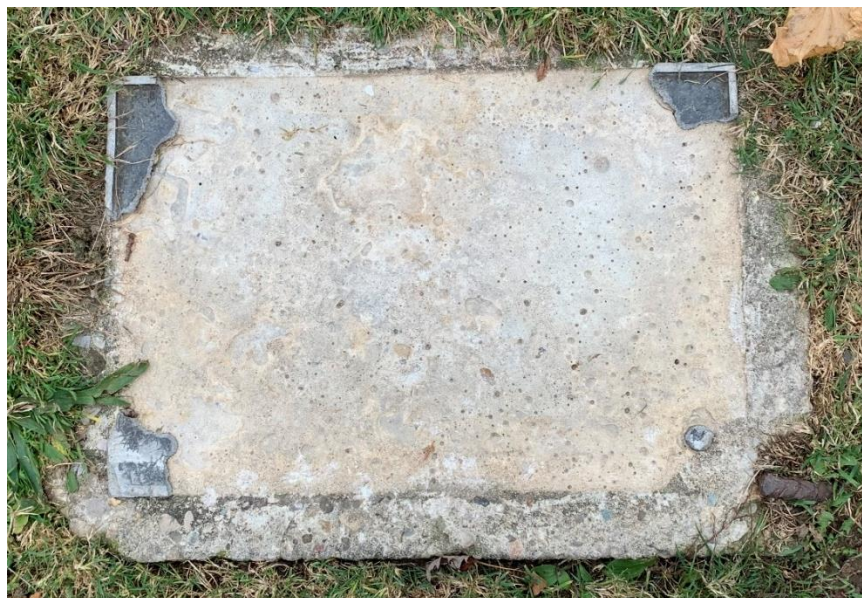
Adjacent to 1117 Victoria Park Lake Pedestrian Bridge number 3, there is an art piece called “The Canoe”, installed in 1997. The aluminum canoe has been placed to evoke a ride through the grassy waves of Victoria Park. The landscape surrounding the canoe has been graded to create the grassy waves. The interior of the canoe has been designed with mirror-polished stainless steel to reflect the sky, contributing to the canoe becoming a vessel that reflects the environment. (Public Art\_The Canoe, n.d.) Adjacent to the canoe, closer to the pedestrian trail was a bronze plaque with the project name (“The Canoe”), artist (Brian Scott) and commissioning information (Commissioned through a national public art competition). The plaque has since been stolen in late 2024 and was not replaced at the time of inspection. The bottom right corner of the

concrete base for the plaque has a piece of rebar curved over the concrete which can cause a tripping hazard.

“The Canoe” art installation plaque was located on a stone placed flush with the ground. Unfortunately, this was reported stolen by the City of Kitchener in late 2024, leaving behind a small concrete base with a rebar protrusion that has become a tripping hazard. The former location and orientation of the plaque was too obscure and easily missed.

This unfortunate event can serve as an opportunity to re-evaluate the installation. It is recommended to consider relocating the plaque and upgrading its materials to a vandal-resistant option—such as anodized aluminum or a durable composite—that is less attractive to theft. Additionally, enhancing visitor engagement by incorporating a digital display or a discreet QR code, which links to a concise, interpretive description of the artwork, can enrich the overall experience. This contemporary approach not only improves safety and durability but also deepens the contextual narrative for visitors.

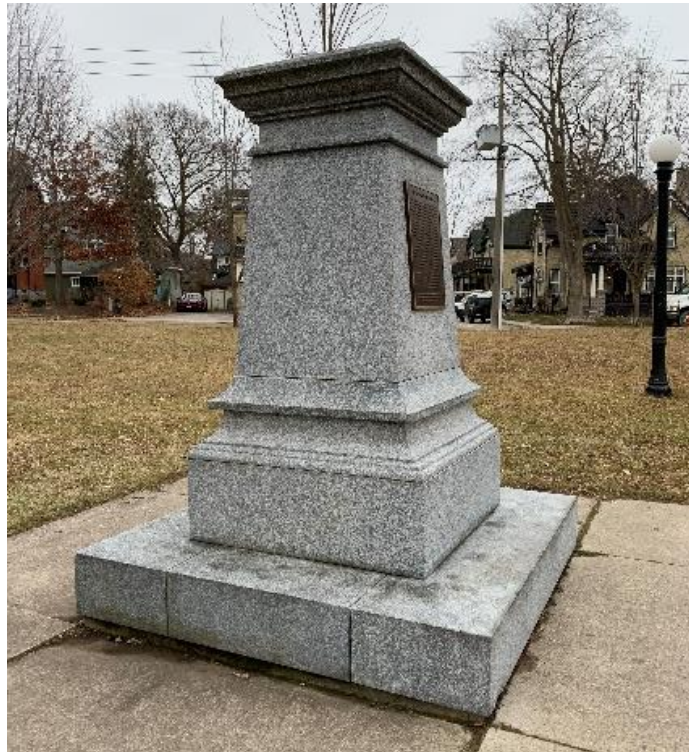
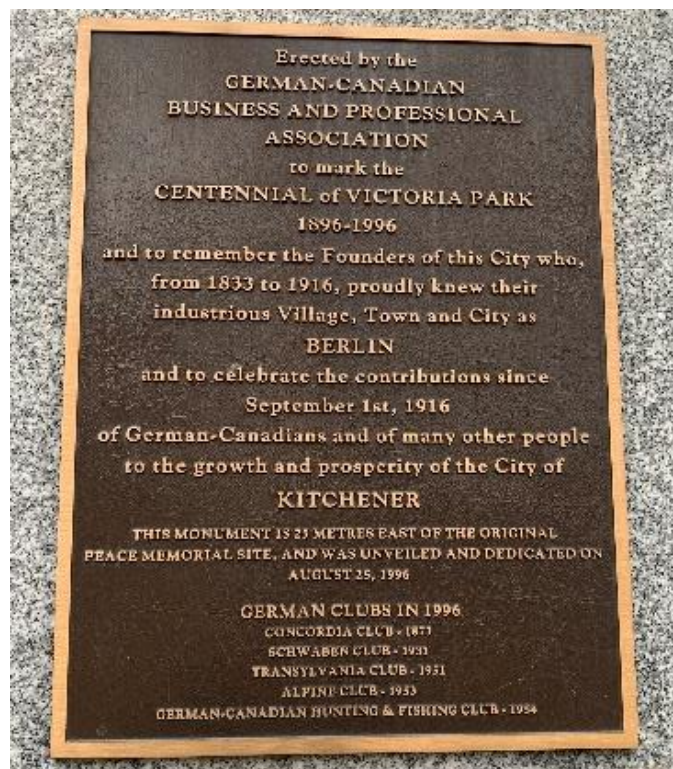
The Peace Memorial was re-erected in Victoria Park by members of the German Canadian Business and Professional Association (GCBPA) in 1996 to honour a piece of Kitchener’s history and the centennial anniversary of Victoria Park. In replacement of the missing bust of Emperor William 1<sup>st</sup>, the GCBPA facilitated the installment of a bronze plaque on one side of the pedestal to memorialize the history of the bust-less monument. The pedestal is located along the pathway between the boathouse and the intersection of Jubilee Drive and David Street.

The monument pedestal and plaque are in a good spot within the park, located along the pathway. The location allows users to step off the path and not disrupt the flow of traffic, while having the space to read the plaque and pause to understand the meaning.

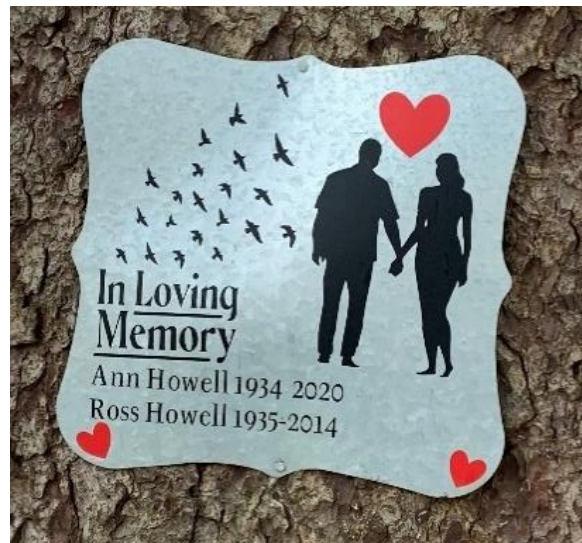
**Figure 59: In Loving Memory**

The trail connecting to the Pavilion parking lot from the northeast side has a sensory garden, and one of the larger coniferous trees has a galvanized steel memorial plaque. The memorial plaque can be seen when walking through the garden towards the parking lot.

The sign is clearly visible on the tree and is easy to read, but it is only visible through one direction along the path. Additional ways to ensure the sign is visible from all directions along the path could be investigated. The sign is in good condition and appears to have been installed recently.

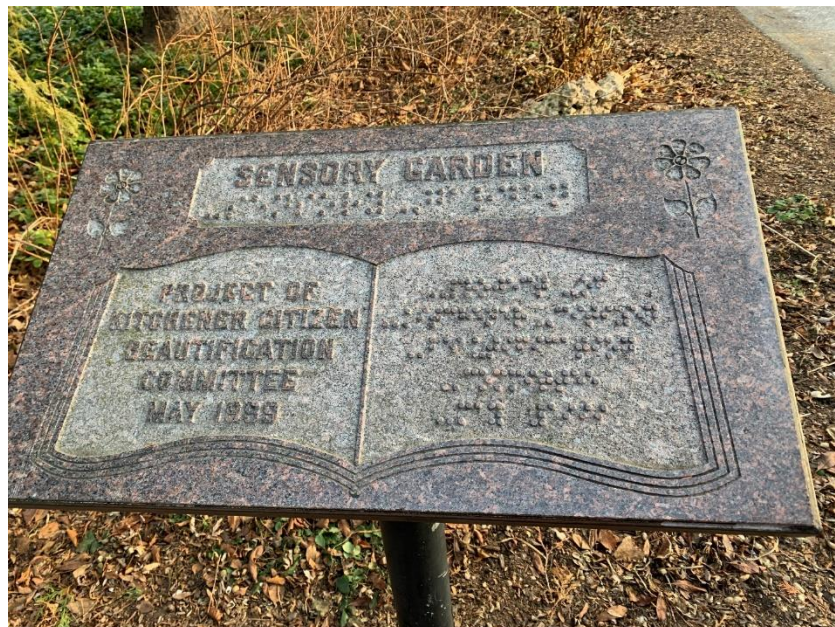
**Figure 60: Sensory Garden Sign**

The sensory garden was a project of the Kitchener Citizen Beautification Committee completed in May of 1999. The garden consists of a variety of perennials and grasses and ornamental stones placed throughout. An embossed granite plaque on black HSS post direct buried in the garden area states the group responsible for the Sensory Garden. This information is also available in braille on the plaque.

Increasing the maintenance of the plant materials within the garden area could increase the use of the sensory garden. An additional recommended upgrade to the area would

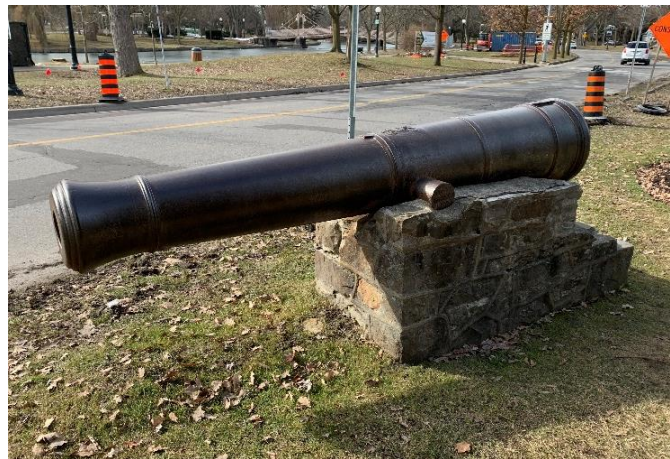
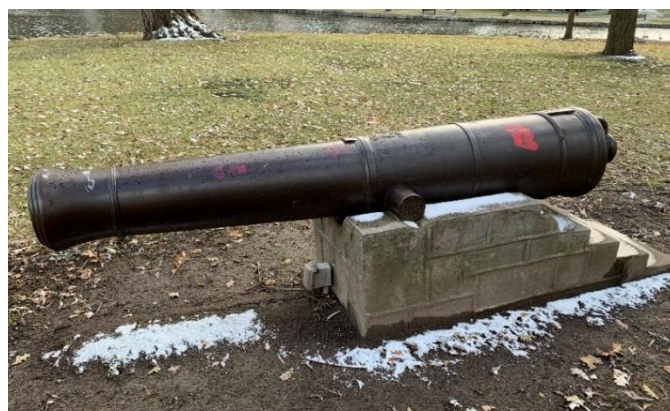
The park has two classic cannons with one located on Roos Island overlooking Victoria Lake and the other located at the base of the Queen Victoria statue. The cannons are some of the oldest items within the park.

The stone and concrete bases of the cannons require structural repairs or complete replacement. The cannons appear to be in good condition, with a few paint spots that can be cleaned off. A sign or plaque could be located near the canons to provide

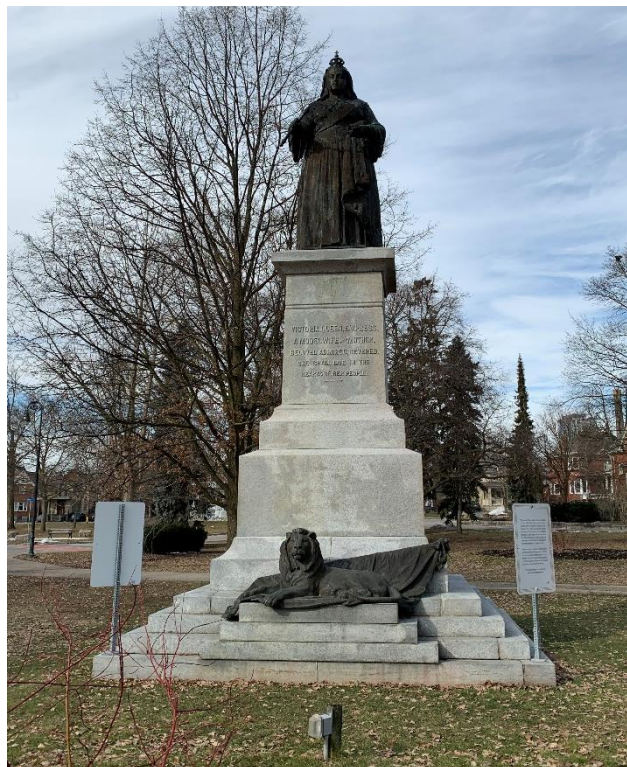
**Figure 63: Queen Victoria Statue**

The Queen Victoria statue was installed in 1911 along Jubilee Drive. The statue consists of a stone structure with a bronze Queen Victoria sculpture and lion sculpture at the base. The commemorative monument was created by artist Raphael Zaccagnini (or Zaccaquini) and commissioned by the Imperial Order of Daughters of the Empire (IODE), a national women's charitable organization in Canada, in 1909. The statue and accompanying lion were unveiled in May 1911 by Governor-General Earl Grey. (Public Art - Queen Victoria, n.d.) At the base of the statue are two metal signs recognizing the history of colonialism in Canada and provides a link for more information that visitors can visit to learn about what is being done with the statue.

The Queen Victoria statue is in good condition structurally. The area surrounding the statue does not provide an accessible path to allow park users to walk directly up to the statue. The inclusion of a concrete or asphalt pathway around the statue will allow park users to walk directly up to the statue. Additional vegetation and low growing gardens

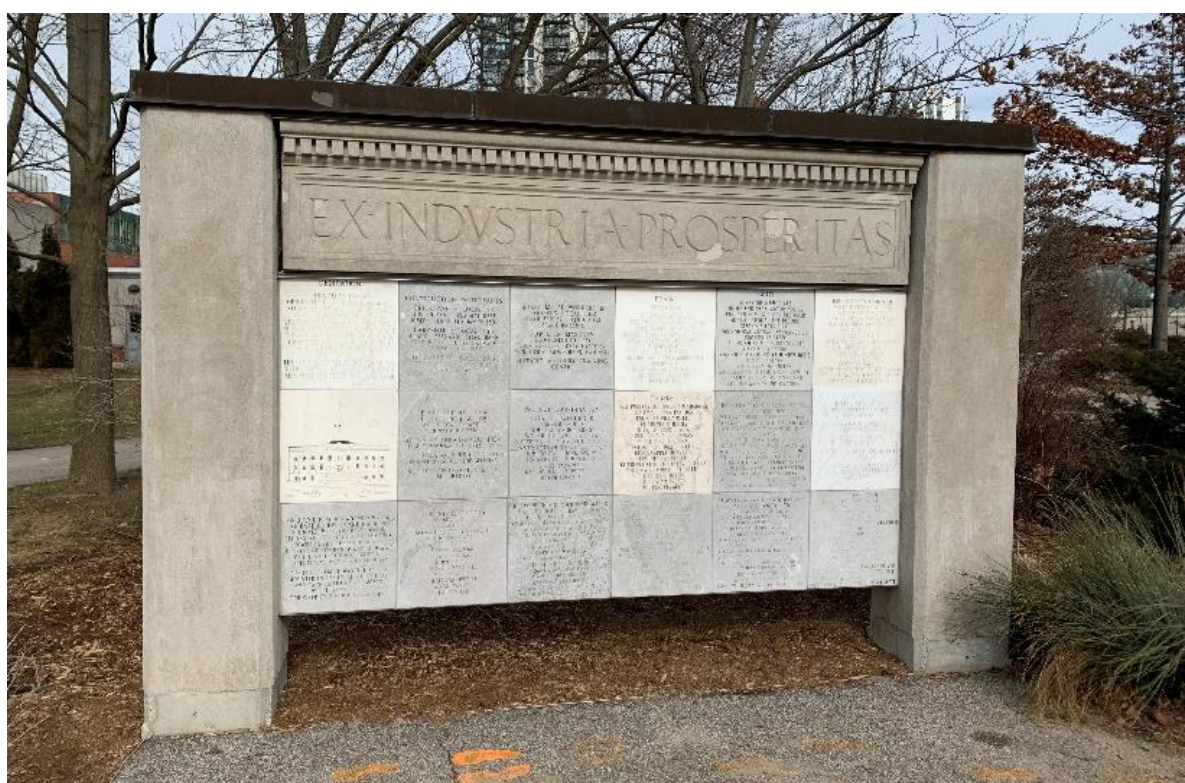
**Figure 64: Ex-Indvstria-Prosperitas Lintel**

Located adjacent to the Clock Tower is a stone monument with multiple names and companies that have contributed to the development of the City. The lintel at the top of the structure reads *Ex industria prosperitas* in Latin, meaning 'Prosperity through Industry'. The lintel was originally mounted in the former City Hall and carries the City's motto. The monument includes a dedication for the Clock Tower, a list of construction participants, donors, the project co-ordination team, and a picture of the old City Hall with the Clock Tower located on top.

The lintel is in good condition, with no visible damage or cracks, although some of the writing on the lintel has become difficult to read. Investigating ways to improve legibility on the lintel would be beneficial and allow users to clearly read the names and information provided.

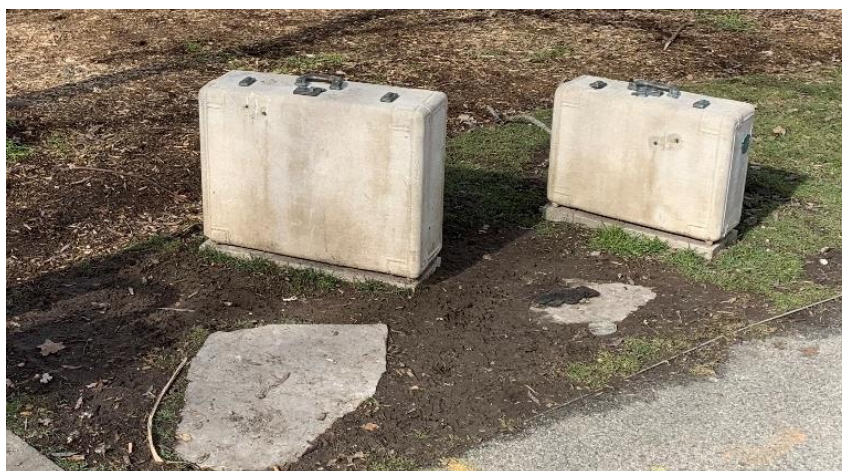
**Figure 65: The Luggage Project**

The Luggage Project, installed in 2006, includes eight carved sculptures that are modelled after life-sized historic luggage pieces from various time periods. The carved sculptures are located beside the pathways near the Clock Tower and in the fountains near the Gaukel Street entrance. The sculptures were installed as a tribute to the migrants who arrived in the City of Kitchener and have made their homes within the region. (Public Art - The Luggage Project, n.d.)

The carved sculptures are in good condition, a few are weathered and have water marks, that could be cleaned and removed. Some pieces are also missing original bronze luggage tags. Through the City's Art & Creative Industries team, a restoration of these works is scheduled for 2025. The restoration also includes a possible relocation of one of the luggage pieces at the Joseph Street park entrance. Most of the sculptures are located within gardens and water features near the clock tower, however a few of the sculptures are located adjacent to the pathway on grass. The grass is hard to maintain in good growing condition due to pedestrian traffic. Pathway stones have been placed near the sculptures, but that does not provide a full path to the sculptures. It is recommended that a larger concrete base should be placed under the sculptures to improve the ease of maintenance of the area and reduce the need to repair the softscape adjacent to the sculptures and the pathway due to pedestrian damage. The concrete base should allow for a person or two to approach the sculpture and the base should connect to the path providing a smooth transition from asphalt or pavers to the concrete pad.
