# Victoria Park – Inventory, Assessment and Project Prioritization

Q23-115 – Report (Phase 1 – Victoria Park Master Plan)

City of Kitchener

March 2025

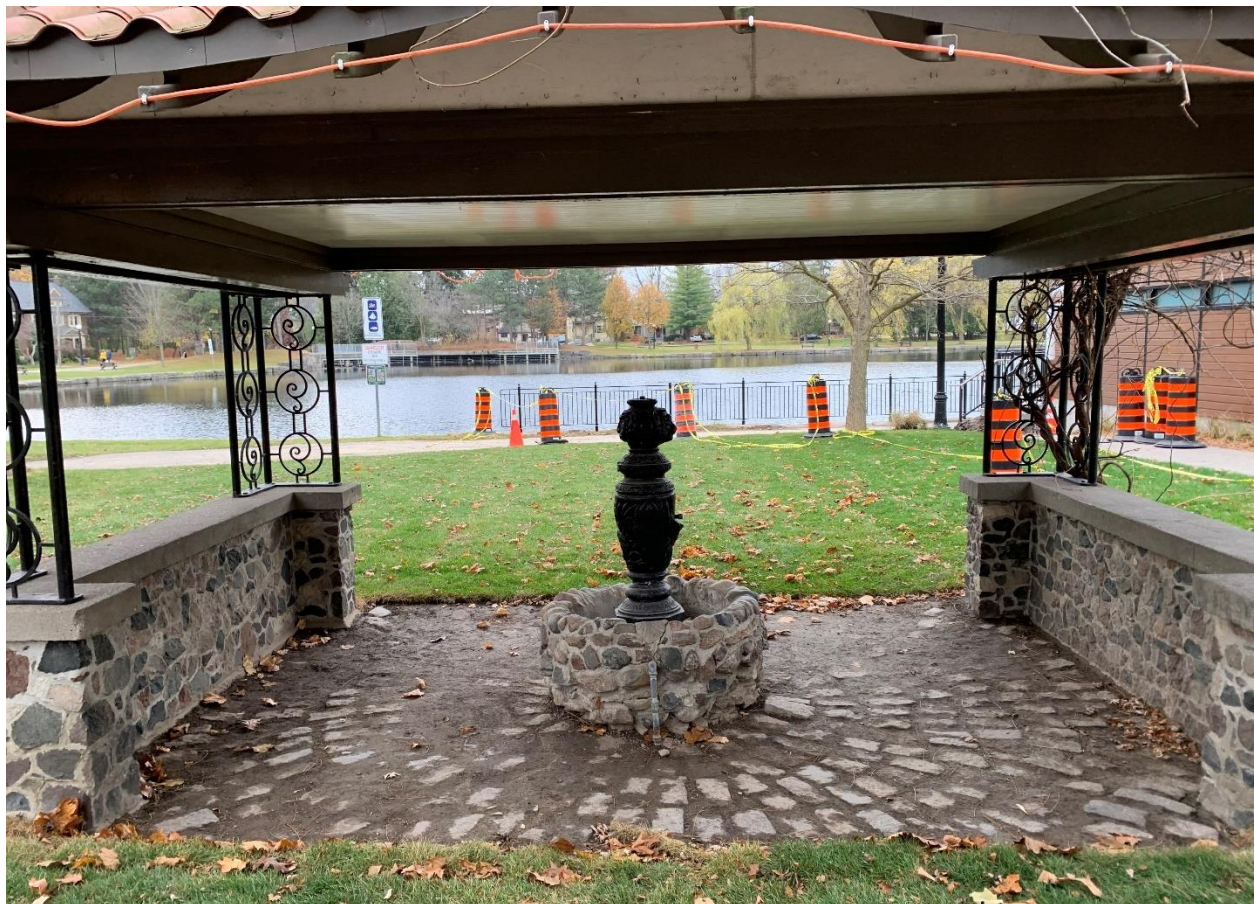
**Figure 66: Lion Fountain within Decorative Pavilion**

Located beneath Pergola 1—the decorative pavilion southeast of the Boathouse—the lion fountain is set in a cracked stone basin. The fountain is constructed either of cast iron or cast aluminum with a black paint finish, and it features two lion heads facing southeast and southwest. The concentric pavers around the fountain are mostly covered in dirt and many of them appear cracked or in poor condition. While there is an existing water supply pipe, the fountain was non-operational at the time of the visit.

It is recommended to remove and reinstate the pavers within the decorative pavilion that surround the fountain. Reinstating the pavers will create a smooth, level surface and reduce the chance of tripping or injury within the pavilion area. If the fountain is to be operational, it is recommended to inspect the mechanical components and repair as required. The stone basin structure should also be repaired to reduce the chance of the stones breaking off and creating a safety hazard. The lion fountain structure appears to

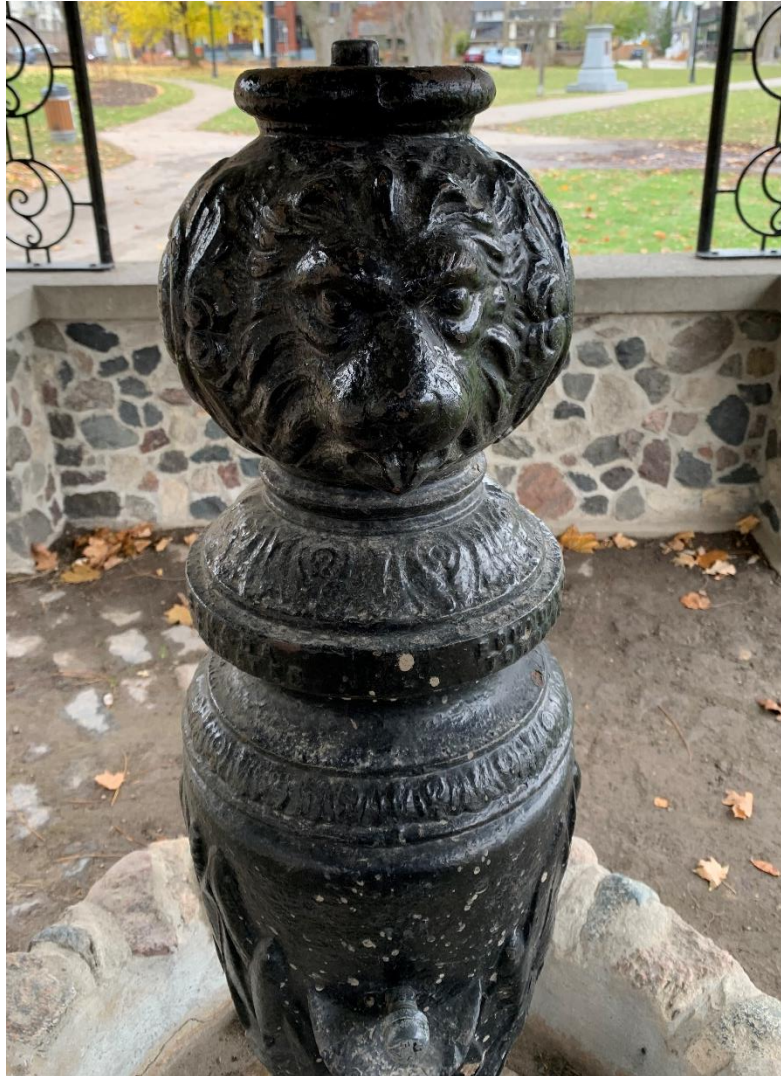
**Figure 67: Lion Face on Fountain**

be in good condition but has moss/fungus growing on it. It is recommended to clean the fountain and apply paint touch ups as required.

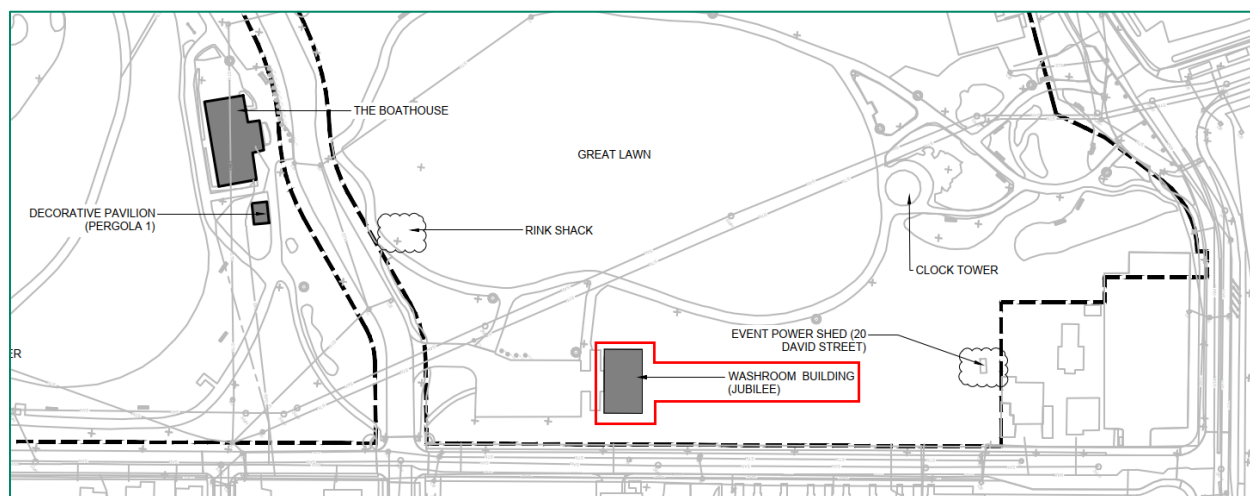
**Figure 70: Jubilee Comfort Station Key Plan (40 Jubilee Drive, Kitchener, Ontario)**

The Comfort Station on Jubilee has a gas fired furnace and roof exhaust for the washrooms both of which are original to the building that was constructed in 2014.

As such we concur with the WalterFedy Building Condition Assessment and that there is no need for replacement until 2034. All equipment is in good condition.

The Comfort Station on Jubilee has a men's washroom, women's washroom, and a janitor room. The building is equipped with an electric domestic hot water tank to provide hot water to the washroom plumbing fixtures. All plumbing equipment, fixtures, and piping are in good condition.

As such we concur with the WalterFedy Building Condition Assessment and that there is no need for replacement until 2034 for the plumbing fixtures and 2041 for the hot water tank.

recommends immediate testing and inspection of the fire extinguishers to ensure that they are operable and for a replacement to be provided if inoperable.

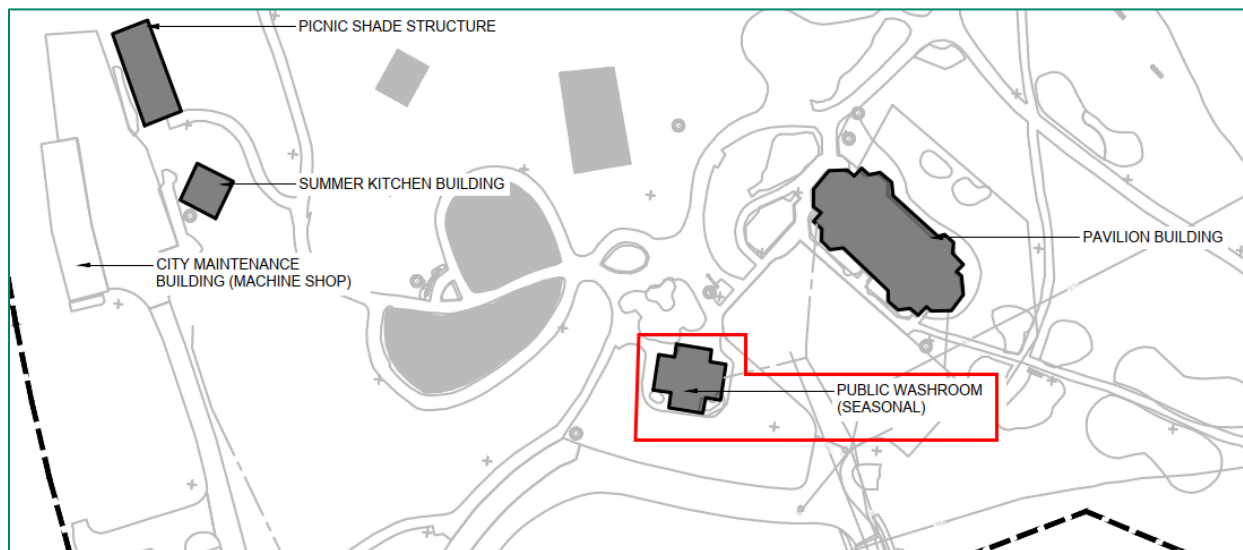
**Figure 71: Seasonal Comfort Station Key Plan (83 Schneider Avenue, Kitchener, Ontario)**

The Seasonal Comfort Station has four gas-fired unit heaters. Three are original to the building and should be replaced before the winter as there is no redundancy heating in the building and the units are ten years past their life expectancy. The electric entryway heater should also be replaced as it is in poor condition and past its life expectancy. The washroom exhaust fans are in fair condition and should be replaced by 2025 as they are assumed to be installed in the year of construction.

The Seasonal Comfort Station has a men's washroom, women's washroom, and a janitor room. The building is equipped with an electric domestic hot water tank to provide hot water to the washroom plumbing fixtures. All plumbing equipment, fixtures and piping are in good condition.

As such we concur with the WalterFedy Building Condition Assessment and that there is no need for replacement until 2030 for the plumbing fixtures and 2041 for the hot water tank.

As such AECOM recommends that a class ABC fire extinguisher gets added immediately. Vandalism and theft should be a priority consideration for appropriate location and placement.

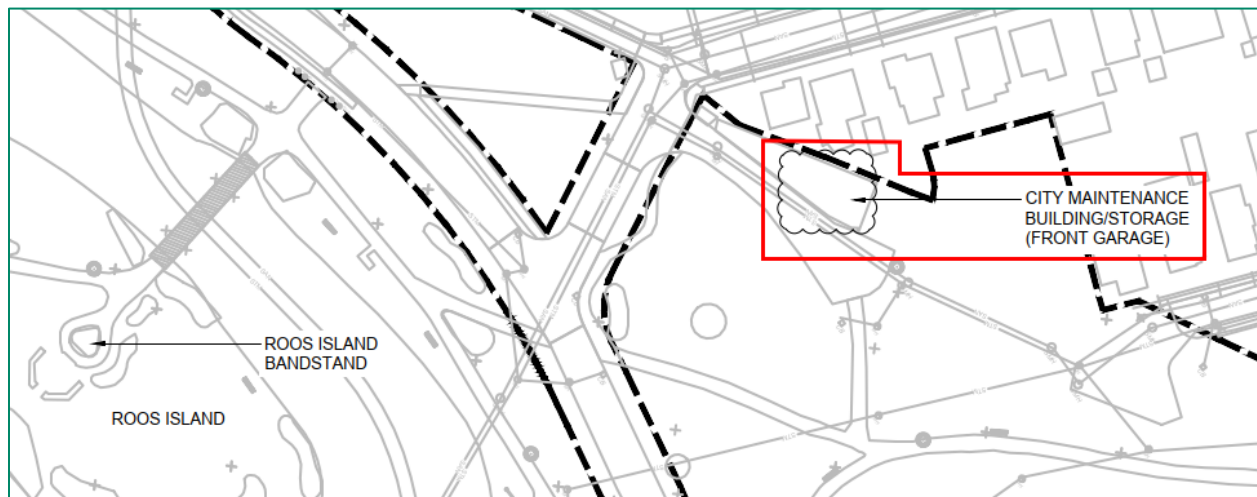
**Figure 72: Front Garage Key Plan (35 Water Street South, Kitchener, Ontario)**

There are no HVAC systems currently within the Garage. The city has expressed possible interest in making this a multi-season building. In that scenario, heating (and cooling if desired) needs would need to be reviewed, as well as insulation requirements.

The OFC and NFPA 10 requires that dry chemical fire extinguishers be inspected monthly, and undergo an internal examination every 6 years, as such AECOM recommends immediate testing and inspection of the fire extinguishers to ensure that they are operable and for a replacement to be provided if inoperable.

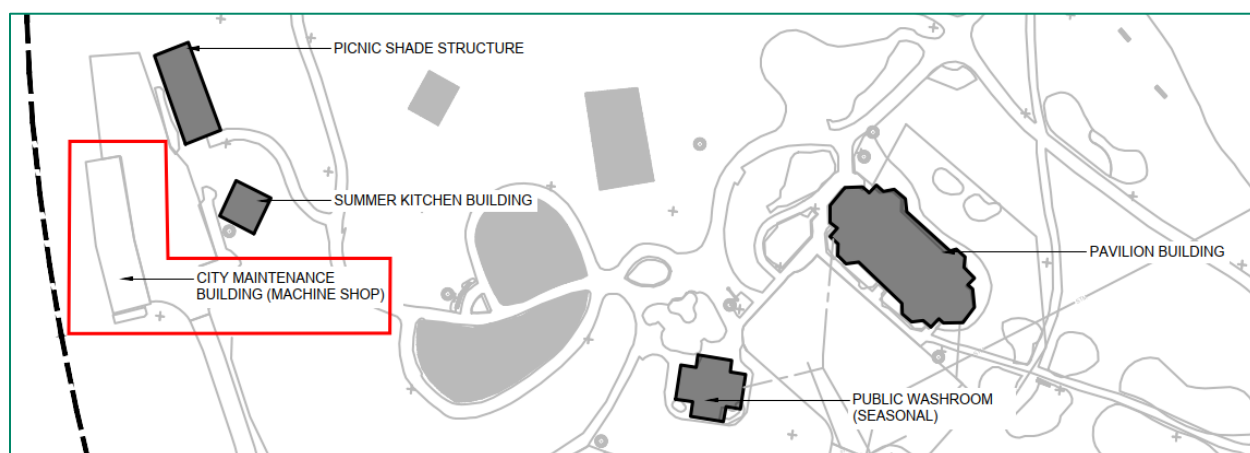
**Figure 73: Machine Shop Key Plan (35 Dill Street, Kitchener, ON)**

The Machine Shop is equipped with a natural gas storage tank, a gas-fired furnace, gas-fired unit heaters and exhaust fans. All unit heaters are over 30 years old and appear to be in fair condition. The exhaust fans, according to the ASHRAE Equipment Life Expectancy Chart:

Since the unit heaters remain in fair condition, consider replacement in the next five years. The exhaust fans appear to be in fair condition. We agree with the WalterFedy Building Condition Assessment study.

The Machine Shop has two washrooms and utility sinks. The building is equipped with an electric domestic hot water tank to provide hot water to the washroom plumbing fixtures. All plumbing equipment, fixtures and piping are in good condition.

The OFC and NFPA 10 requires that dry chemical fire extinguishers be inspected monthly, and undergo an internal examination every 6 years, as such AECOM recommends immediate testing and inspection of the fire extinguishers to ensure that they are operable and for a replacement to be provided if inoperable.

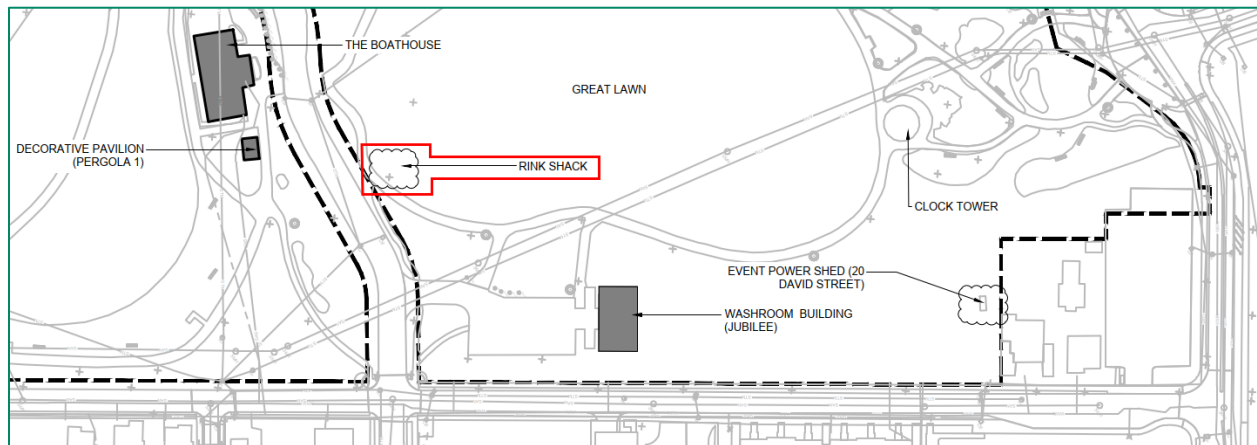
**Figure 74: Rink Shack Key Plan (50 Jubilee Drive, Kitchener, Ontario)**

There are no HVAC systems within the Rink Shack.

The Rink Shack contains a backflow preventer (BFP) serving the outdoor ice rink. The backflow preventer appears to be in good condition.

We do not agree with the Building Condition Assessment report that the backflow preventer needs to be replaced immediately. Backflow preventers should be tested annually in accordance with CSA B64.10 to ensure they are operational; a replacement only needs to be provided if inoperable.

As such AECOM recommends that a class ABC fire extinguisher gets added immediately.

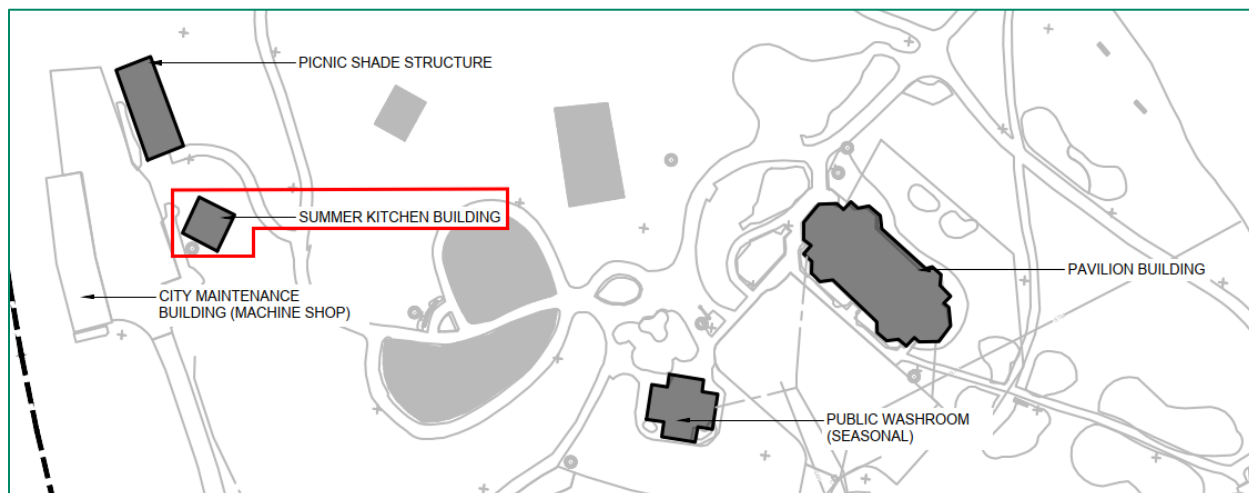
**Figure 75: Summer Kitchener Key Plan (32 Dill Street, Kitchener, Ontario)**

The Summer Kitchen has a wall mounted exhaust fan venting to the outdoors. The fan was installed in 1965 and is 40 years past its life expectancy of 20 years. Consider replacing in the next five years.

The Kitchen is equipped with a utility sink and hot water tank. The sink is in poor condition and should be replaced. The water heater is in very good condition having been replaced in 2020. It has been mentioned that the piping requires replacement. Consider replacing at the same time as the sink.

All fire extinguishers were replaced in 2015 and are in fair condition.

The OFC and NFPA 10 requires that dry chemical fire extinguishers be inspected monthly, and undergo an internal examination every 6 years, as such AECOM recommends immediate testing and inspection of the fire extinguishers to ensure that they are operable and for a replacement to be provided if inoperable.

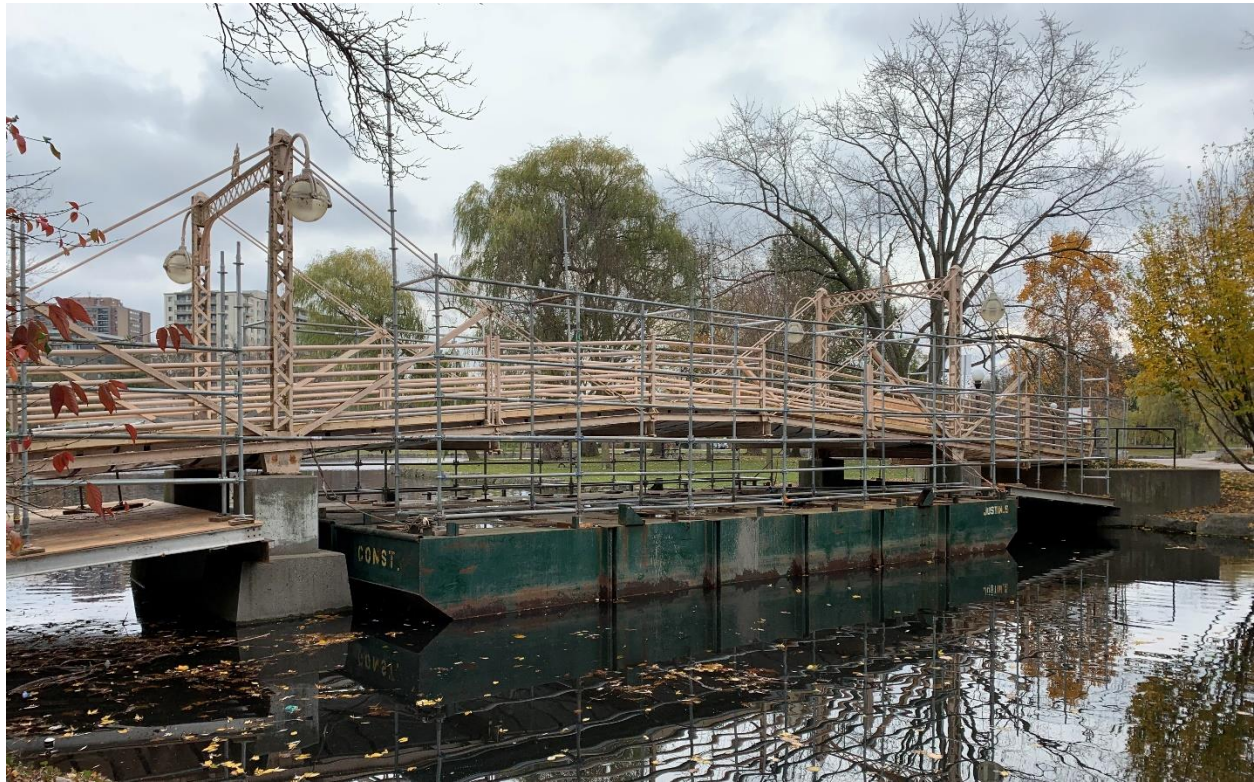
**Figure 77: Pedestrian Bridge 877 – November 2024 Construction**

At the north side of Victoria Park, there is a heritage cantilever steel truss bridge with a suspended deck connecting the pedestrian path adjacent to Jubilee Drive to Roos Island. The bridge was not assessed as part of the 2023 review due to it being fenced off. The City of Kitchener inspects their bridges every two years, the 2020 inspection was not provided to AECOM, therefore the 2018 inspection was reviewed. Built in 1896, the bridge is generally considered to have heritage value although it is unknown if any designation exists. In 2023 Phase 1 of a rehabilitation of the bridge was implemented. The longitudinal stringers were replaced, bearing plates were cleaned and painted and the deck boards were replaced. In phase 2 additional repair work is scheduled to be implemented in 2024 and will include replacing of the cross-tie bars and recoating the bridge and rail. It is anticipated that the bridge will require ongoing maintenance following the rehabilitation. At the time of inspections in November 2024, the bridge was under construction and additional inspections were not completed to determine the extent of work being completed.

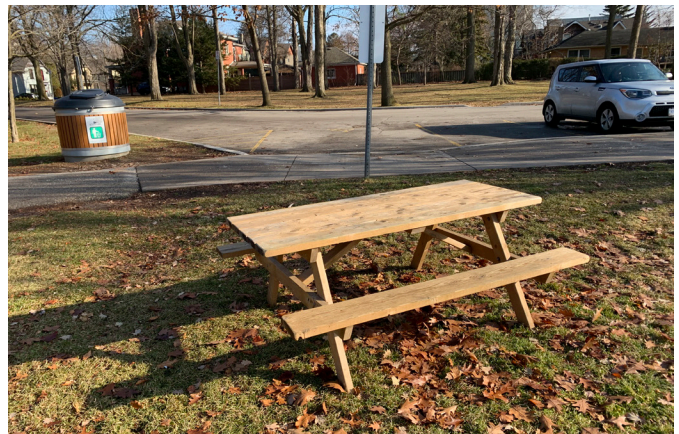
**Wooden 6'**

| Category Code | Component | Sub-Component | Material | Manufacturer / Artist | Serial Number | QTY/Units of Measure | Additional Info | Condition | Commentary | Intervention Type | Intervention Details Narrative |
|---|---|---|---|---|---|---|---|---|---|---|---|
| Furnishings | Picnic Table | Wooden 6' | Wood picnic table | - | - | 6' length; 1 unit | - | Fair | Wood picnic table has rusty washers and graffiti on wood planks. | Repair | Rusty washers are to be replaced to reduce chance of structural damage to the table. Graffiti is to be removed from the table. |

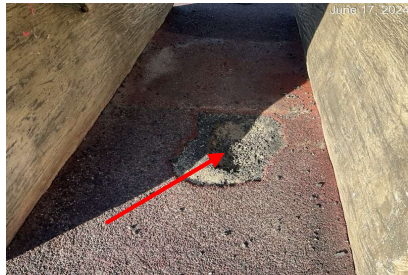
**#1 - Area 1 - Rubber surfacing is damaged (torn, loose, missing), receding from asphalt, and lifting from asphalt in spots**

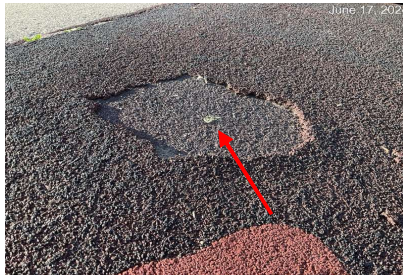
**#2 - Area 1 - Rubber surfacing is damaged (torn, loose, missing), receding from asphalt, and lifting from asphalt in spots**

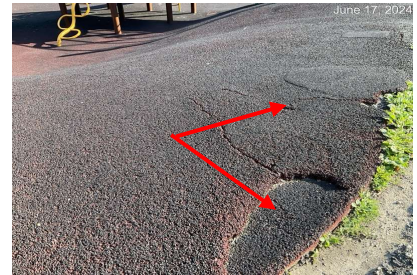
**#3 - Area 1 - Rubber surfacing is damaged (torn, loose, missing), receding from asphalt, and lifting from asphalt in spots**

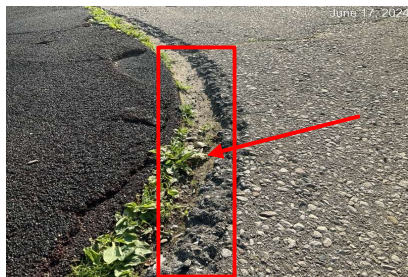
**#4 - Area 1 - Rubber surfacing is damaged (torn, loose, missing), receding from asphalt, and lifting from asphalt in spots**

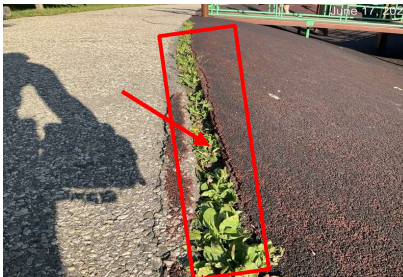
**#5 - Area 1 - Rubber surfacing is damaged (torn, loose, missing), receding from asphalt, and lifting from asphalt in spots**

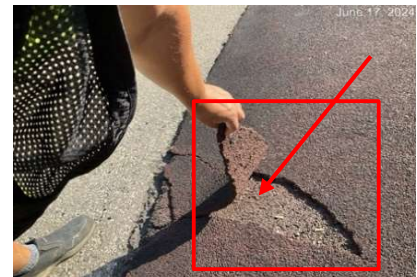
**#6 - Area 1 - Rubber surfacing is damaged (torn, loose, missing), receding from asphalt, and lifting from asphalt in spots**

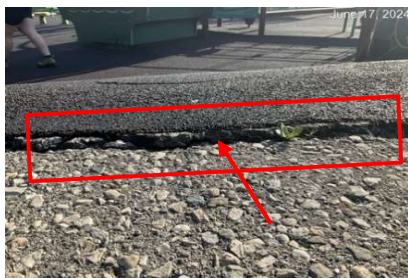
**#7 - Area 1 - Rubber surfacing is damaged (torn, loose, missing), receding from asphalt, and lifting from asphalt in spots**

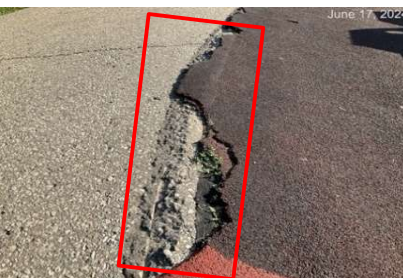
**#8 - Area 1 - Rubber surfacing is damaged (torn, loose, missing), receding from asphalt, and lifting from asphalt in spots**

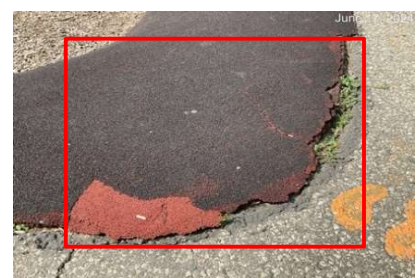
**#9 - Area 1 - Rubber surfacing is damaged (torn, loose, missing), receding from asphalt, and lifting from asphalt in spots**

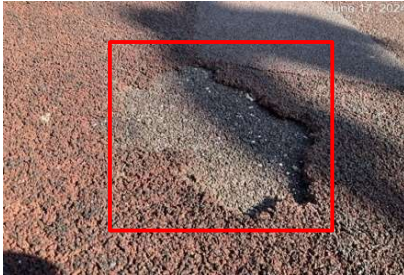
**#10 - Area 1 - Rubber surfacing is damaged (torn, loose, missing), receding from asphalt, and lifting from asphalt in spots**

1. Area 1 - The rubber surfacing is damaged (torn, loose, missing, lifting at edges) in several spots, particularly the perimeter. Recommend repairing the damaged areas and/or replacement of the entire rubber surface.

| 1 | Rubber Surfacing | 1 year | Yes - repair/replace | Yes | Yes | Short: repair or replace the rubber surface<br>Medium: drop test, clean and inspect regularly<br>Long: replace/repair as required | <b>\$100,000 (Repair)</b> |

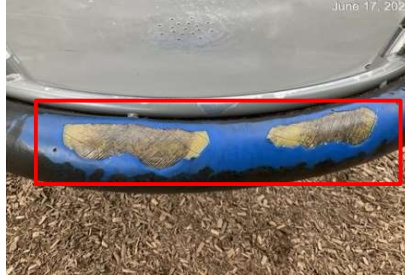
**#11 - Area 3 - Saucer swing seats are wearing (exterior rubber)**

1. The protective surfacing zone (PSZ) is short on one (1) side of the Saucer Swing Set. The PSZ measures ~ 1.5m, where a minimum of 1.8m is required. Repair.
2. The exterior rubber around the swing seats is wearing. Okay at time of inspection. Monitor.
3. See signage below.

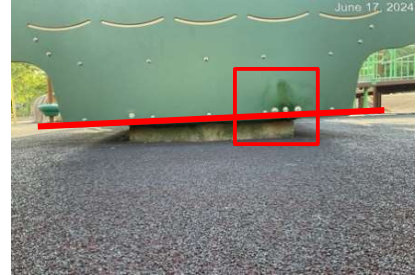
**#12 - Area 1 - The Glider that is attached to the playstructure is not level**

1. One (1) of the exterior plastic barriers at the glider of the playstructure is damaged (burned); no sharp edges present. Okay at time of inspection. Monitor.
2. The glider is not level. Monitor.

| Area | Equipment | Estimated Lifespan | Repair | Maintenance | Decommission | Recommendations (Short, Med., Long Term) | Estimated Cost |
|---|---|---|---|---|---|---|---|
| 1 | Playstructure | 6-8 years | Glider is not level; trip hazard present | Yes | No | Short: adjust glider<br>Med/Long: Inspect | <b>\$1500 (repair)</b> |

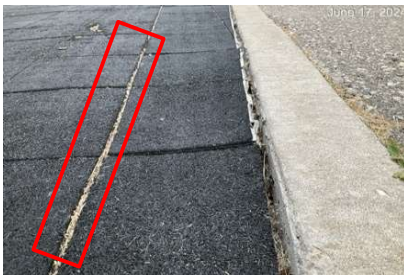
**#13 - Fitness Area - Rubber tile surfacing is uneven (heaved and sunk) and separated in spots**

5. Fitness Equipment - The rubber tile surfacing is in poor condition. The rubber tiles are uneven (heaved and sunk in spots) and separating (e.g. gaps between tiles). Recommend replacement of the rubber surface.

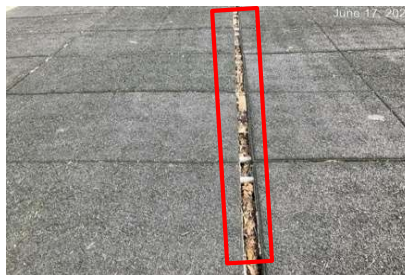
**#14 - Fitness Area - Rubber tile surfacing is uneven (heaved and sunk) and separated in spots**

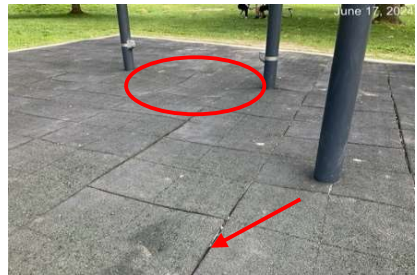
**#15 - Fitness Area - Rubber tile surfacing is uneven (heaved and sunk) and separated in spots**

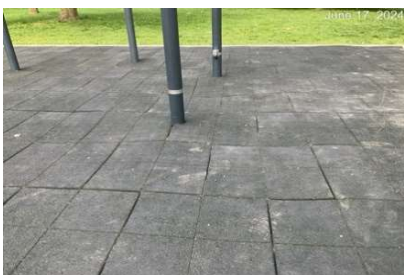
**#16 - Fitness Area - Rubber tile surfacing is uneven (heaved and sunk) and separated in spots**

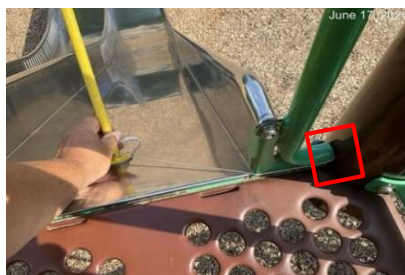
**#17 - Area 2 - String entanglement hazard present on the right side of the double stainless steel slide (between barrier rail and support post)**

1. There is one (1) entanglement hazard present at the right side of the double slide between the side barrier and the support post. Repair.
2. No other CSA-deficiencies found with playstructure.

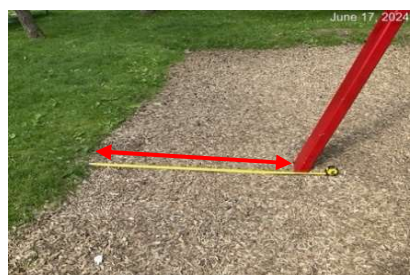
**#18 - Area 3 - Protective surfacing zone is short on one (1) side of Saucer Swing Set (measures ~ 1.5m)**

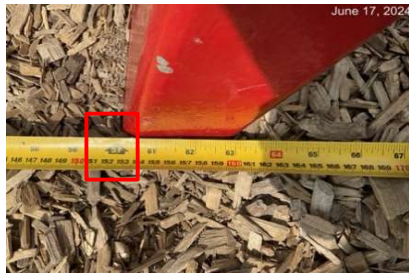
**#19 - Area 3 - Protective surfacing zone is short on one (1) side of Saucer Swing Set (measures ~ 1.5m)**

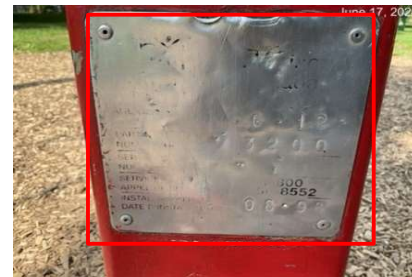
**#24 - Area 3 - Manufacturer's label at Saucer Swing is worn and not legible; user age group label not present**

| Area | Equipment | Estimated Lifespan | Repair | Maintenance | Decommission | Recommendations (Short, Med., Long Term) | Estimated Cost |
|---|---|---|---|---|---|---|---|
| 3 | Saucer Swing | 5-7 years | Signage | Yes | No | Short: replace existing labels (not legible) | <b>\$250 (repair)</b> |

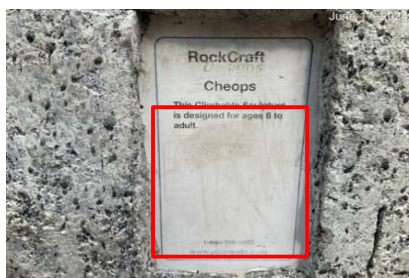
**#25 - Area 2 - Label at Boulder Climber is worn and missing info (not legible)**

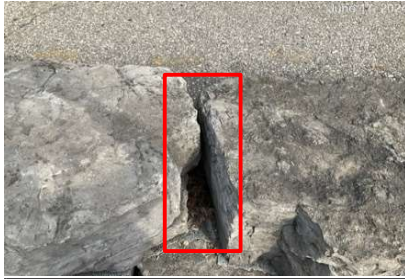
**#28 - Area 2 - Monitor adjacent boulders as large gaps are present that pose foot entrapment hazards**

1. The adjacent boulder retaining wall in Area 2 has several large gaps between the armour stone, which pose potential foot entrapment hazards. Monitor but recommend filling in the gaps between the stones (i.e. reducing the size of the gaps).
2. No faults found with the adjacent walkways.

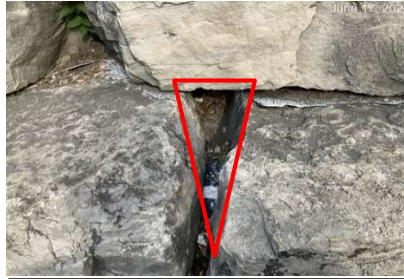
**#29 - Area 2 - Monitor adjacent boulders as large gaps are present that pose foot entrapment hazards**
